Abstract:

In this paper we attempt to study and compare current best industry practices for sealing around a simple circular pipe penetration using a polyethylene pipe boot, a spray-applied polyurea connection, and a taped boot, common in polyethylene under slab vapour barriers. In order to evaluate the strengths and weaknesses of options available to the designer, the properties of each of the sealing techniques were documented along with considerations for consequences of failure, including the ease of repair, and the likelihood that long term performance/integrity will be maintained.

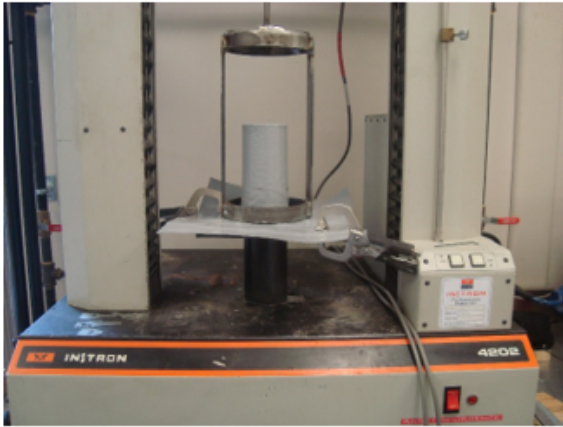
Configuration for pressing the connection downward.

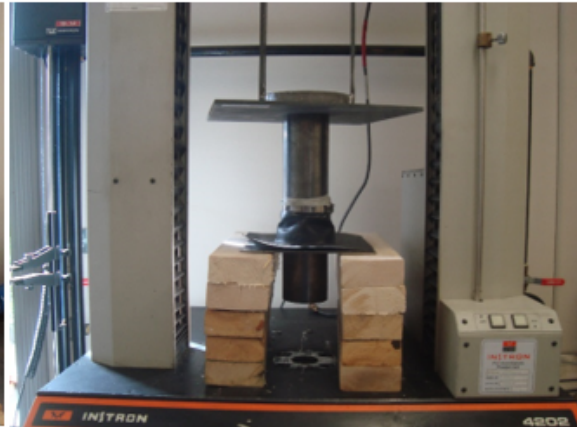
Configuration for pressing connection upward.

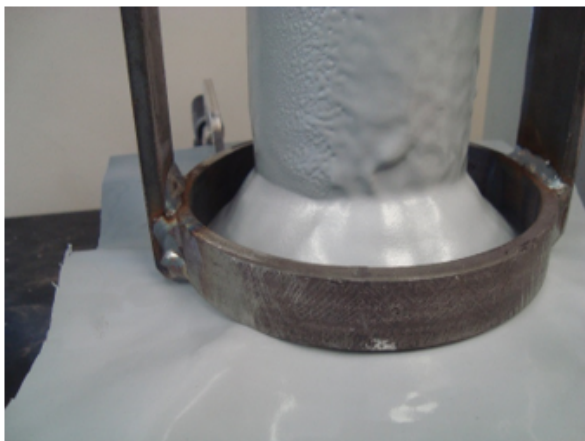
Stretching of Polyurea Boot Prior to Failure

The polyurea connection gave the strongest bond to the metal pipe, requiring much more force than with the polyethylene to displace the connection, and even under maximum force, the bond between the polyurea and the pipe was not compromised. The actual displacement to failure was similar to the average of the polyethylene pipe boot, but there was no case of rapid failure as when the caulking seal at the top of the boot was broken. Displacement was influenced by the lack of slack material allowed to stretch in our experimental configuration. Polyurea is actually a very stretchy material, and in an actual installation, the forces on the connection would be spread over a greater area. The complexity of installation is much lower with a spray-applied material, and the variation in performance between connections, even in more complex configurations, would be less than a polyethylene constructed pipe boot. Spray-applied connections are easily repaired with addition of more material. The added containment security and reduced/eliminated maintenance of the polyurea connection would be a factor in justifying the cost. In applications where there are many closely spaced penetrations, or complex in structure, the installed overall cost of polyurea may be lower than less expensive sheet goods.

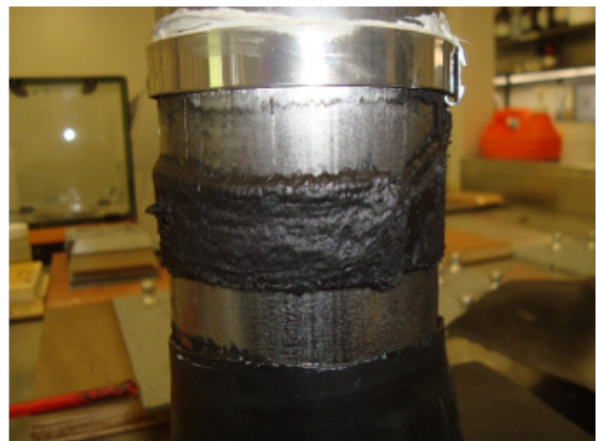
Failure of polyethylene boot Sample 2

Attachment	Force To Break Seal N (lbf)	Displacement to Break Seal (mm)	Failure mode
Polyethylene Pipe Boot (Technician 1)	1 360 (81)	47 (seal not broken)	Clamp ring slid down, smearing butyl caulking with it. No seal failure when test stopped
(Technician 1)	2 180 (40.5)	40 (seal completely failed)	Pipe boot slid out of clamp, clamp did not move. Butyl caulking slid down with the boot for a short distance before complete failure.
(Technician 2)	3 2000 (449)	62	Same as sample 1, pipe boot eventually broke at base
(Technician 2)	4 1500 (337)	11	Clamp ring slid down with pipe boot, but once urethane caulking at top broke a small leak appeared
Polyurea Connection	1 3800 (854)	50	Small region of connection between pipe and first 10 mm of skirt stretched until it broke. Area affixed to pipe did not move or separate.
	2 2800 (629)	38	Same as Polyurea Sample 1
Tape Connection	1 200 (45)	Immediate	Holes appeared immediately, 25 mm required to dislodge tape.

The polyethylene pipe boots showed inconsistency in their performance. This variation occurred within boots prepared by the same Technician, and between one Technician and another. With downward force the boots slid rather easily (40 to 80 lbf) in one set of samples but showed more resistance (350 to 450 lbf) in the second set. The deflection required to break the seal ranged from 11 to 62 mm. This would seem a natural reflection of the relatively complex construction technique that goes into a polyethylene boot, and the unavoidable variation in how closely the boot opening matches the penetration, the tightness of the clamp, and the ability of the clamp to hold the boot and move with it under force. Under upward forces, the results

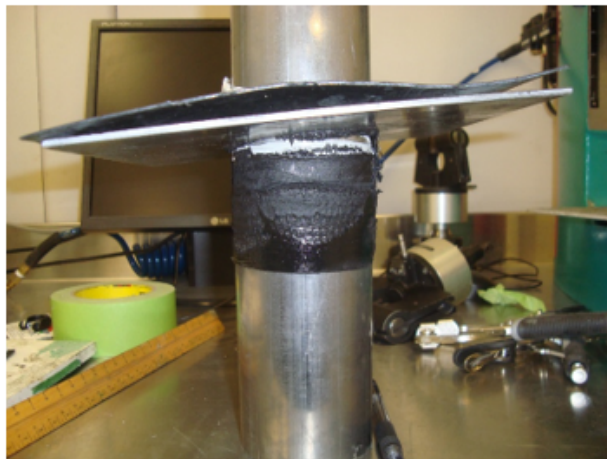
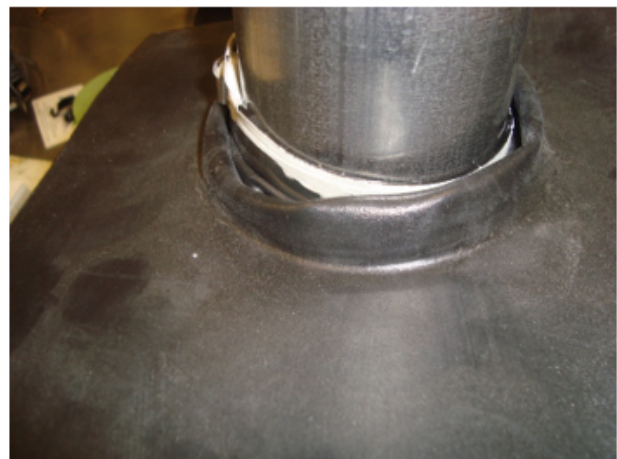
Polyethylene pipe boot pushed upwards to failure

Attachment	Force To Break Seal N (lbf)	Displacement to Break Seal (mm)	Failure mode	
Polyethylene Pipe Boot	1	850 (191)	48 (approx., ring did not slide up evenly)	Water test required to detect leak, see picture
	2	850 (191)	48 (approx., ring did not slide up evenly)	Sample as Polyethylene Sample 1
Polyurea Connection	1	Off Scale	35 (approx.)	Steel plate tore the polyurea because of lack of clearance polyurea unable to slide upwards.
	2	6000 (1348)	46.9	Water test pinpointed seal break accurately.
Tape Connection	1	80 (18)	Immediate	Holes appeared immediately.
	2	165 (37)	13.8	Extra tape added to better cover edge of cuts in film. Holes appeared at 13.8 mm, 247 N (55.5 lbf) was maximum strength of tape connection.

were more consistent and the displacement to break the seal was in line with the results where the force was in the opposite direction. In the design of a polyethylene pipe boot, there is a clear reliance on the skill of the installer, and in this case with two experienced technicians, they were unable to produce consistent performance with a very simple configuration. More complex boot configurations would amplify the uncertainty. The aging of caulking materials is also a concern in the long-term performance of a boot. In cases where the cost of a boot seal failure are considerable, the construction technique and regular maintenance of the boot would be critical.

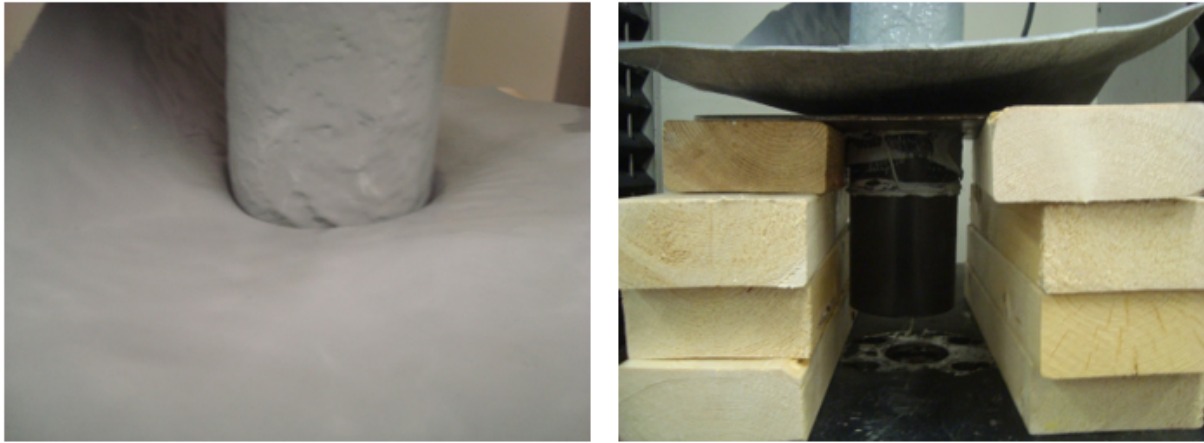
Polyurea connection pushed upwards to failure
