Case Study: Advanced Leak Detection for Tailings Management with eLagoon™ Technology

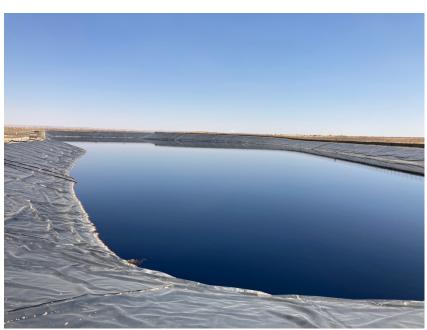
Picture of the surveyed facility.

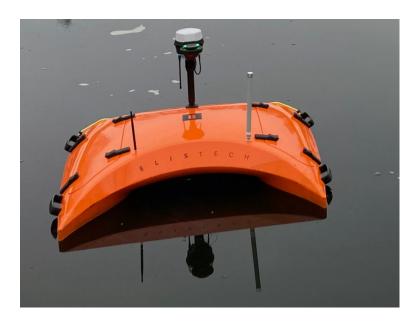
Picture of the $eLagoon^{TM}$ drone.

The eLagoon™ drone, designed for operation in toxic environments with its durable fiberglass construction, was deployed. It utilizes an advanced dipole leak detection system, refined through years of research, and integrated with proprietary software for real-time data collection and rapid analysis.

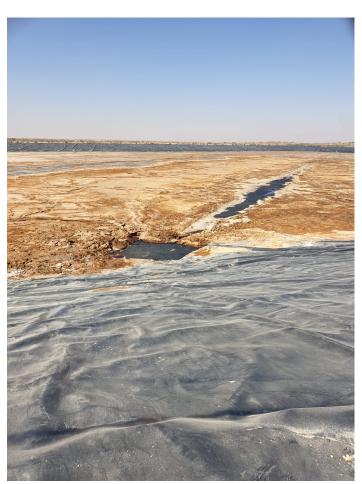
Typical sludge layers observed in the facility after complete liquid evaporation, taken during the subsequent summer.

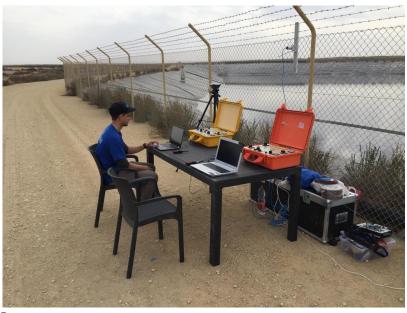
- RTK GPS Base Station: Provided precise positioning and mapping.
- **Connectivity Systems:** Ensured seamless communication between the eLagoon drone and the computer with data analysis software.
- **High volatage generator eSource 360:** A robust power source to supply uninterrupted operation of the artificial electric field, necessary for the survey.

Base camp.

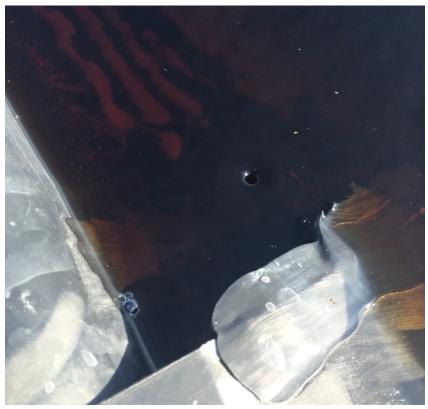
During the survey, significant anomalies were identified in both surveyed sections. The exact locations of the leaks were pinpointed using precise GPS coordinates and marked on a detailed map. Additionally, buoys were deployed at the sites for easy identification. Interestingly, one of the leaks was caused by a torn geomembrane weld, which was documented with a photograph.

A torn weld hole with a liquid vortex as it flows through the hole.

Thanks to the eLagoon™'s precise survey capabilities, the facility operator was able to only evacuate the excessive liquid covering the damage and to repair the damaged areas without the need for full drainage. Post-repair assessments confirmed that the leakage had ceased, demonstrating the effectiveness of the detection and the swift response enabled by the eLagoon™ technology.
