Composite pipelines: Analyzing defects and advancements in non-destructive testing techniques

Muhammad Waqar*, Azhar M. Memon, Muhammad Sabih, Luai M. Alhems

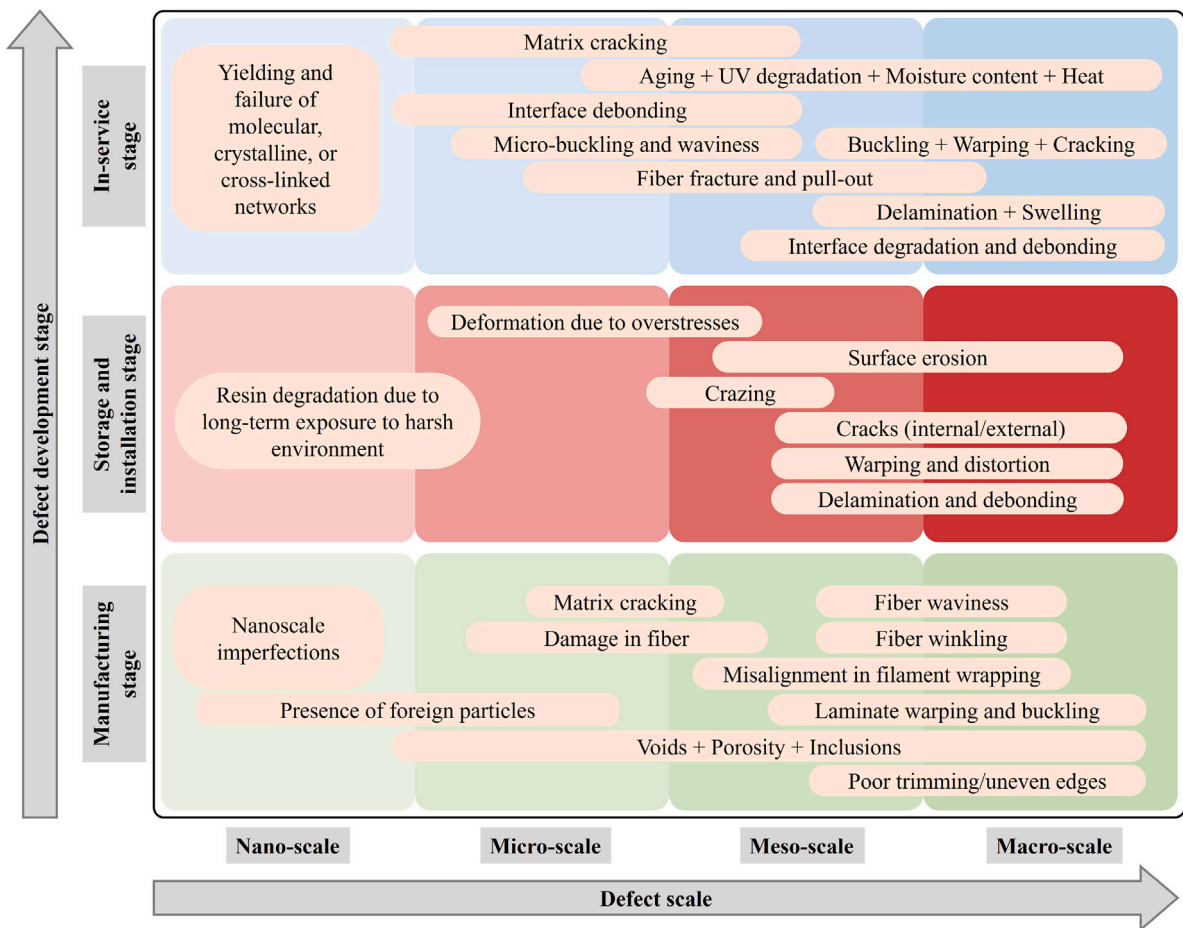
Fig. 1. Defect classification based on their potential scale that may develop in FRP products during manufacturing, storage, installation, and in-service stages.

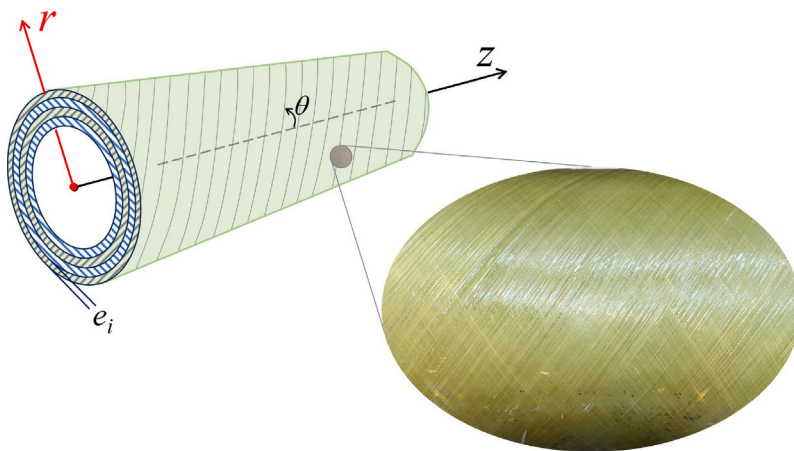
Fig. 4. Multi-layered filament wound fiberglass pipe with a zoomed patch from a real-life sample, illustrating the ply-angle $[\pm 55^\circ]_{12}$. The symbols (z, r) denote axial and radial coordinates, and e_i denotes the layer (ply) thickness.

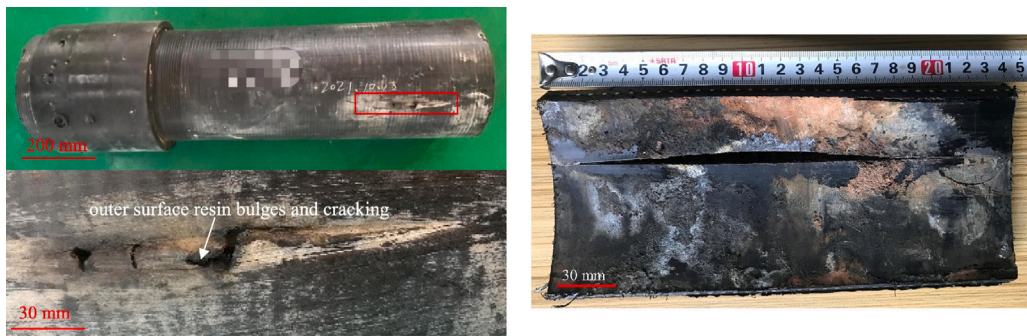
Fig. 14. Steel wire-reinforced composite pipe sample after 6 years of service with a crack [79].

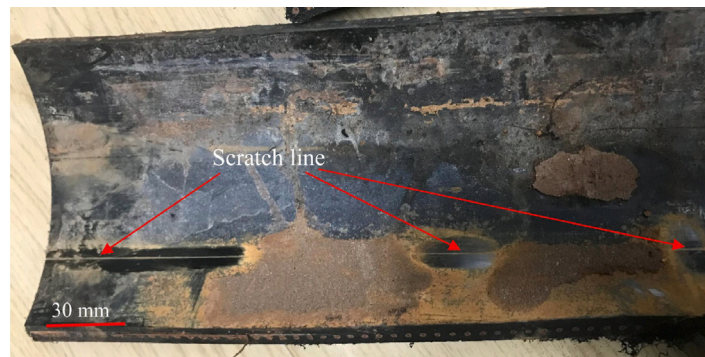
Fig. 15. Example of inner surface wear damage in a 6-year-old in-service steel wire-reinforced composite pipe [79].

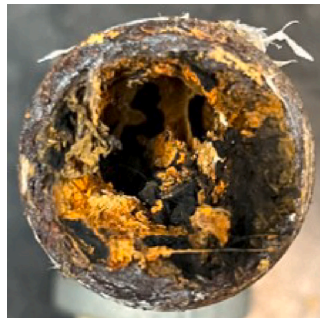
Fig. 19. Example of a blocked pipe due to depositions.

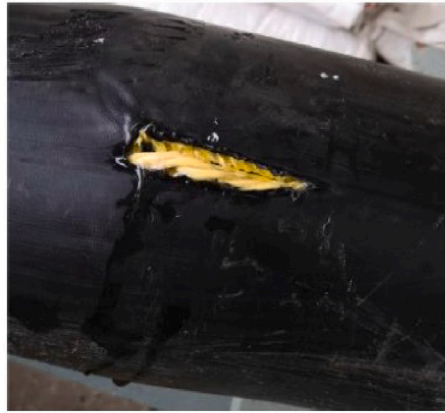
Fig. 20. Example of pipe burst subjected to quasi-static internal pressure with an external lateral dent in an RTP pipe [83].

While most of the defects mentioned above are either simulated in a controlled environment or observed in a non-functional pipe, some studies have also reported failures of FRP piping systems during their in-service and operational stages. Piping systems are intricate, comprising extensive pipelines with varied topologies, dynamic mechanical devices (e.g., pumps and valves), and many hydraulic appurtenances (e.g., bends, junctions, and flow controllers). Malfunctions in any of these components, such as valve jamming/slamming or excessive pump vibrations, can lead to severe problems. Intense operational activities can adversely affect an internally defected or even defect-free pipe system, resulting in service downtimes, outages, increased repairs, rehabilitation, and maintenance costs. In this context, several studies have documented issues with in-service fiberglass piping systems. For instance, [83] highlighted an in-service and internally pressurized pipe burst due to an external dent in the lateral direction, as illustrated in Fig. 20.

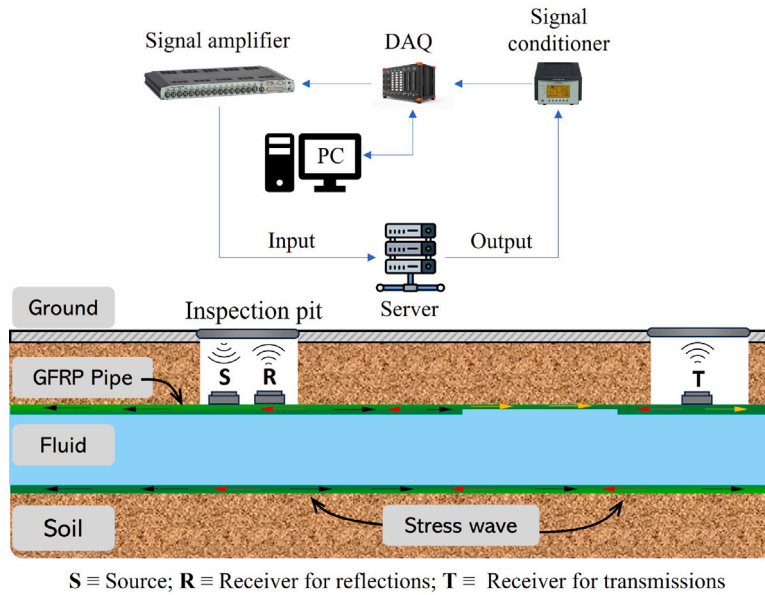
Fig. 22. Illustrative example of the guided waves ultrasonic technique. It involves an active wave source (S) which receives the signals from the operator and injects stress waves by means of local vibrations into the pipe walls. These waves are guided by the pipe wall and propagate in axial, radial and circumferential direction, depending on the dispersion behavior of the pipe and injected frequency bandwidth. The receiver can be configured in a (i) pitch-echo mode where receiver (R) would receive reflections from the abnormalities, or (ii) pitch-catch mode wherein receiver (T) would receive the transmitted waves.

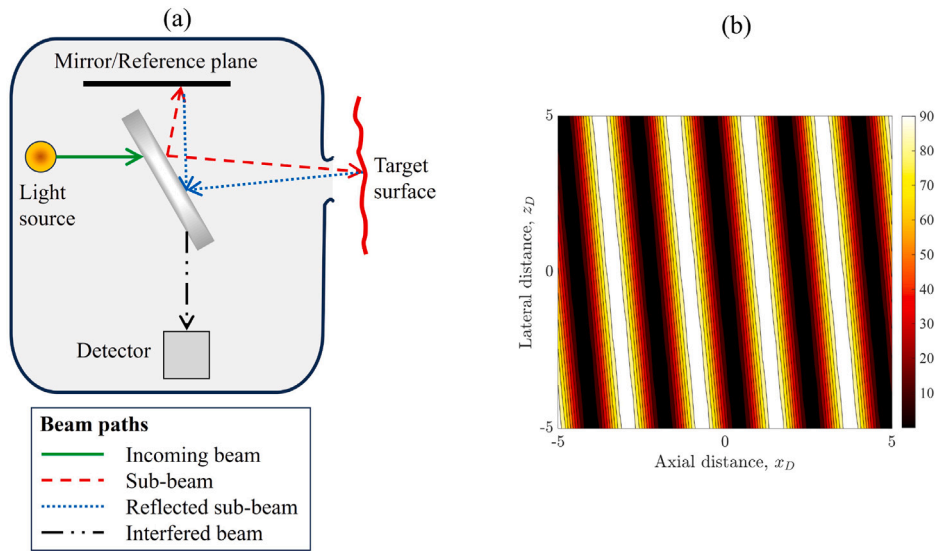
Fig. 28. (a) Configuration of Michelson's interferometer, (b) example of fringe pattern ([105] Note: the measured interference pattern is likely to be more irregular and less-dense).

The interferometer configuration shown in Fig. 28 is one of the simple configurations commonly used in shearography. Many other interferometer configurations are developed according to the application and study interest, ranging from small-scale laboratory experiments to astronomical observations and from localized material testing to large-scale structural health monitoring.

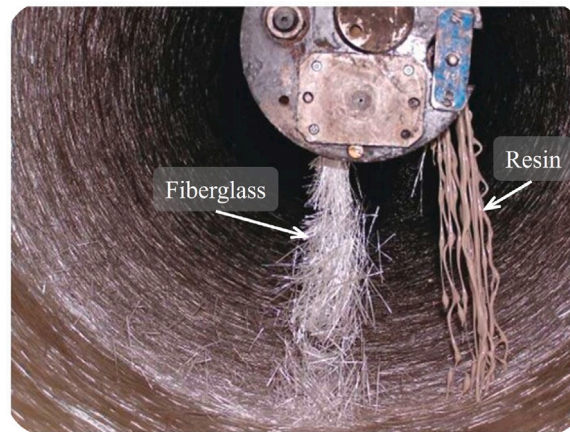
Fig. A.31. An illustration of the centrifugal casting process is shown, providing an inner view of a steel mold.
