Geotextiles and Geomembranes

Field trial of a reinforced landfill cover system: performance and failure

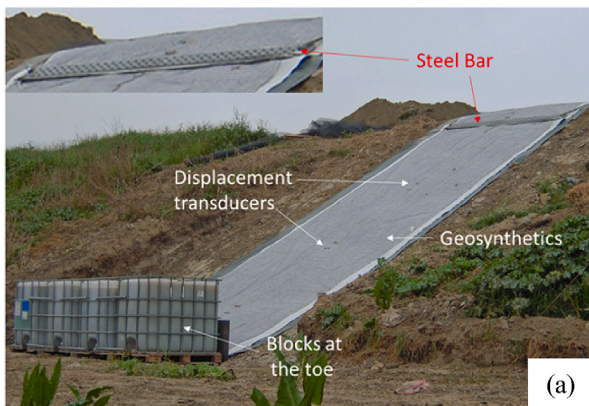
Fig. 3. Torretta landfill field trial: (a) geosynthetic layers, blocks, sensors, and steel bar; (b) final layout of the field test site.

removed to facilitate the failure during the induced collapse phase. At about 0.70 m from the top of the slope, the geogrid was also fixed between two rectangular steel bars to transmit the load of the entire slope to the remaining geogrid strip during the failure phase (Fig. 3a).

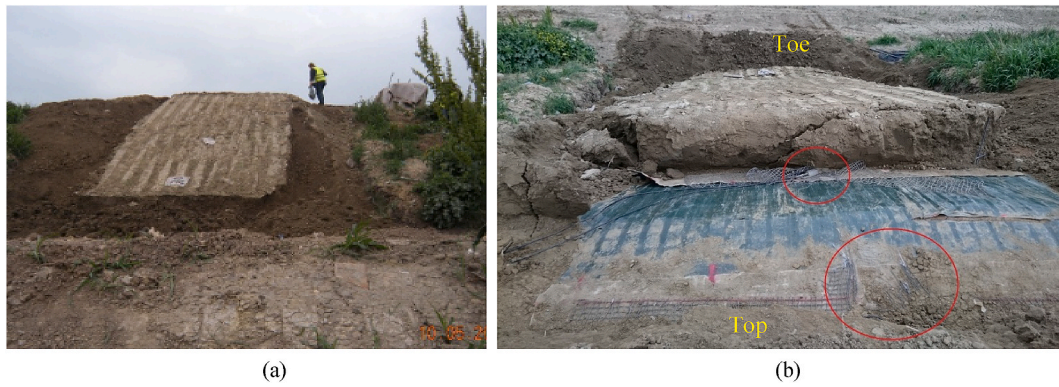
Fig. 5. (a) Slope after the removal of the soil at both sides; (b) failed slope and broken fibres (view from the top).

During the cutting, the slope remained stable, but a slow progressive separation between the edges of the cut fibres was observed highlighting a slow downward displacement. It was observed that the threads of the geogrid were subjected to high tensile stress. However, since no incipient failure was observed, the lateral soil along both sides of the slope section and some material at the foot were removed to eliminate their contribution to stability and to ensure that the whole weight of the soil along the slope was sustained only by the geogrid and the friction between the GMB and GCD (Fig. 5a).

The slope failed 9 h later under dry ambient. The critical slip surface of the system occurred along the interface between the geocomposite drainage layer and the geomembrane, as expected. During the controlled failure process, the soil, the geogrid, and the geocomposite drainage layer located on the slope behaved as a rigid body (Fig. 5b).

Fig. 5b shows that some fibres were chopped off in the central part, whereas those in the lateral sides were firstly ravelled and then broken. Probably, from 23:16, 7 h after the beginning, the lateral fibres started to break, increasing the displacement and leading to instability.

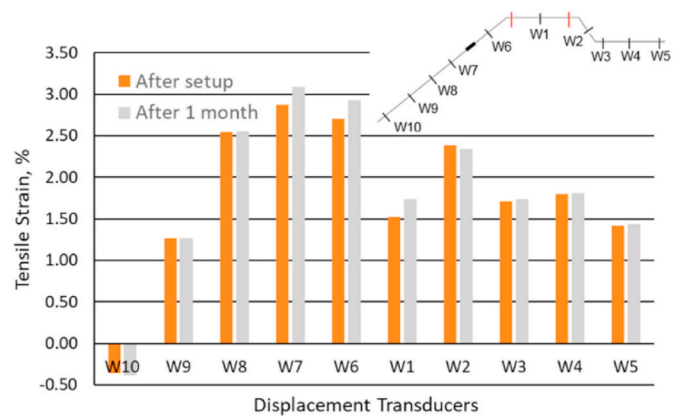
Fig. 6. Geogrid tensile strain recorded by the displacement transducers after setup and after one-month monitoring phase along the slope and in the anchor trench.

During the construction phase, the displacement transducers measured geogrid elongations up to +2.7%. Only the transducer W10, close to the slope toe, registered a compression value of -0.4% (Fig. 6). After the month of monitoring, the sensors W1, W6 and W7 registered a significant increase of strain (in the order of 0.2%). This variation developed over a longitudinal length of 1.8 m (0.75 m on the crest and 1.05 m along the upper part of the slope) and may have been caused by creep strain which was also indicated by the horizontal cracks at the top of the slope. The other displacement transducers registered only small variations, that is, in the order of 0.04%.

The strains measured by W1, smaller than those registered by W6 and W2 (Fig. 6), could be explained by the effects of the compactor passages during the installation procedure. In the elapsed time between the slope preparation and the induced failure test, rainfalls were monitored. Only rainfall events of small intensity occurred, and they did not influence either the behaviour or the state of stress of the slope (max. measured rainfall of 9.8 mm/day only for one day).

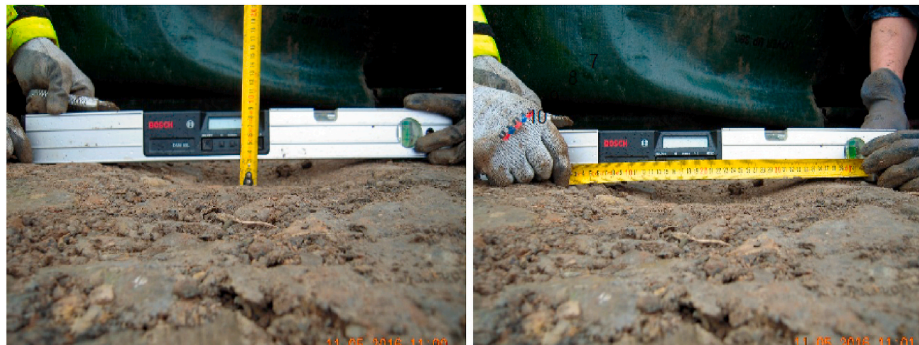
Fig. 7. Macro irregularities and depressions on the slope surface.

progressive relaxation of the whole system was observed following completion of the cutting, regulated mainly by the interface friction angle GMB/GDC and the ground macro irregularities (Fig. 7) along the sliding surface, due to the construction procedure. This caused an increase of the tensile load up to a stress level of about 80% of the geogrid ultimate tensile strength. Affected by the creep behaviour of the GGR, the failure developed over an elapse of about 8 h (from 17:12hr to 1:11hr).

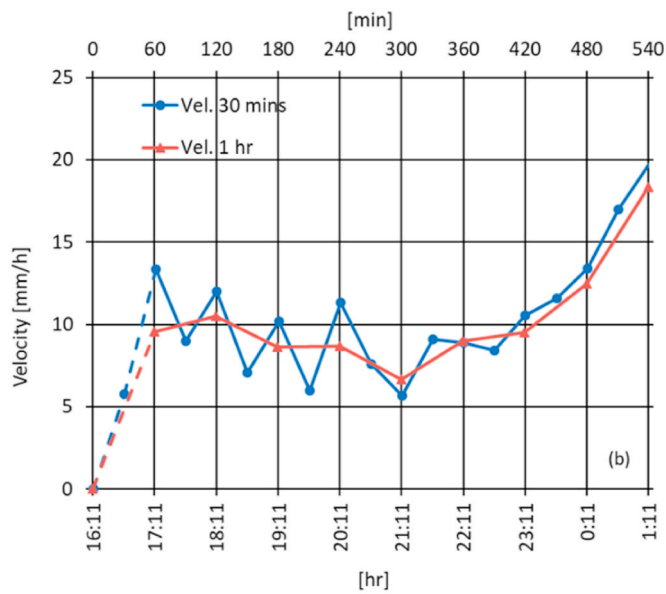
Fig. 10. (a) Soil block displacements; (b) variation of the slope block velocity during the induced collapse phase.

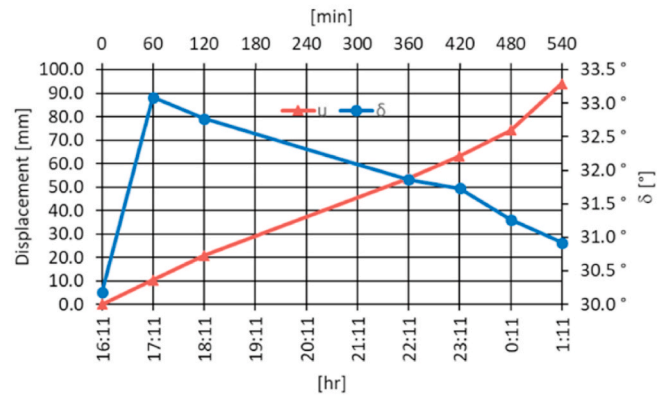
Fig. 12. (a) Average values of friction angles (δ) between GCD and GM, from W1 to the slope foot; (b) block displacement (u) and average values of δ from W6 to the slope foot; (c) block velocity u' and average values of δ from W6 to the slope foot.

For every displacement transducer, Fig. 12a shows the minimum average friction angle at the interface between GM and GCD required to comply with the equilibrium equation (2) between the generic W_i and the bottom.

The calculated friction angle between GM and GCD along the slope (W6–W9) initially ranged around 28°–30° for all displacement transducers and remained practically constant for W7 and W8 during the

Fig. 12b presents the variation of the friction angle versus the displacement of the soil block along the slope, showing an increase of the friction angle with small initial displacements up to a peak and then decrease when the displacements increase. Similar behaviour has also been observed in the laboratory (Fowmes et al. (2008), Punetha et al. (2019) and Stoltz et al. (2020)). The tests conducted by these researchers clearly showed a peak shear strength for relatively small displacements. After the peak and since 17:11 up to 23:11, the friction angle decreased linearly while the displacements increased linearly. Thereafter, there
