Risk assessment of electrofusion joints in commissioning of polyethylene natural gas networks

Electrofusion welding
Natural gas network
FMEA
Polyethylene

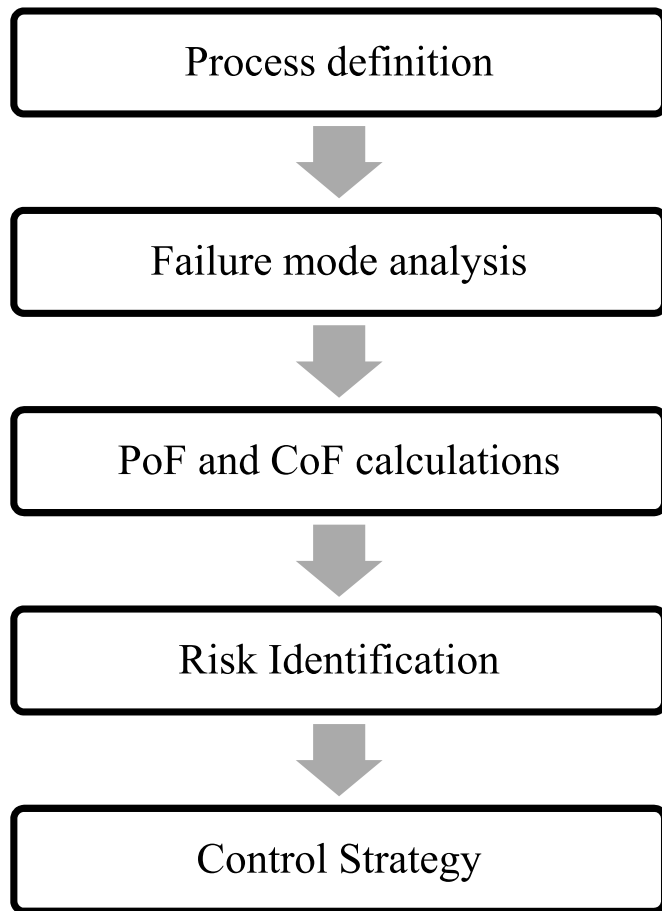
Fig. 2. Flowchart of the FMEA process.

FMEA is a systematic way of recognizing a failure mechanism in materials and processes [18]. It has many applications in the oil and gas industries. Fig. 2 shows different steps of the FMEA. It includes the following steps:

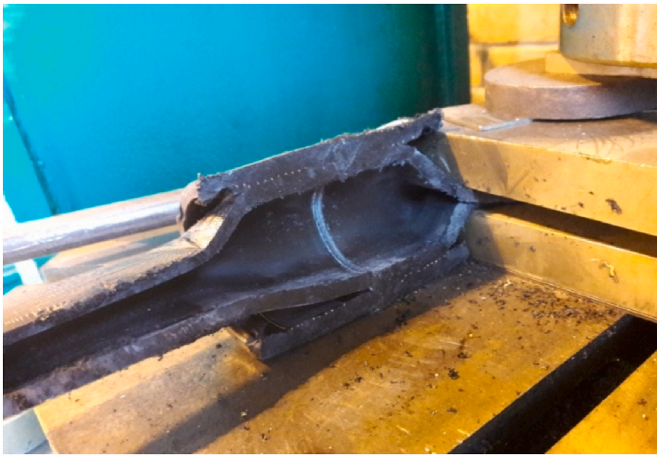
Fig. 8. Shows crushing de-cohesion test on electrofusion joints. Crushing tests showed no considerable differences between appropriately welded and defective joints.

Fig. 8 shows the crushing de-cohesion tests of this study. The crushing de-cohesion tests were performed on electrofusion joints containing man-made defects. Experimental data revealed that test results for all samples, including both appropriately welded and manipulated joints, fall in acceptable ranges in accordance with the Urmia Natural Gas Company's procedure. It can be concluded that these kinds of tests are not sensitive enough to recognize a defective joint from a non-defective joints. Consequently, it was not suitable for the goal of this research and therefore, decided not to continue with this type of tests.

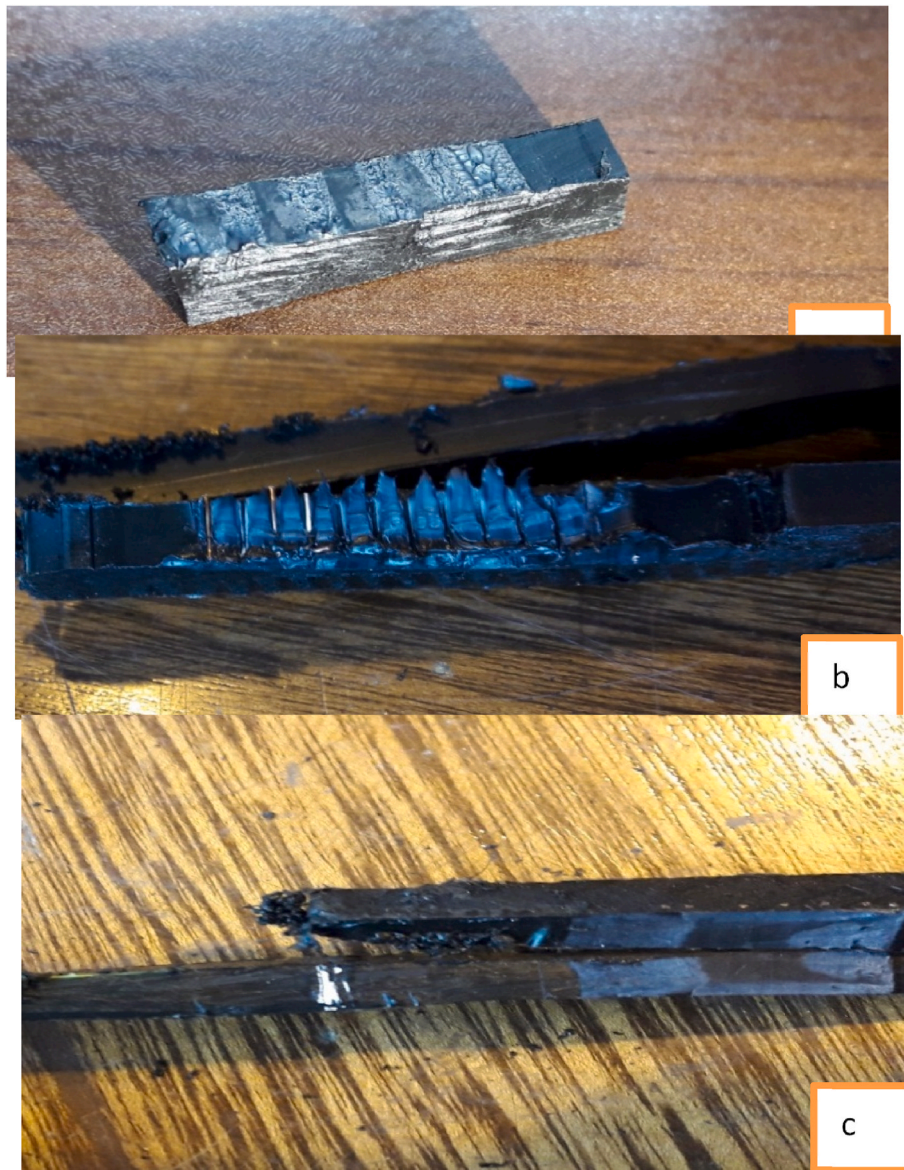
Fig. 9. Optical Macroscopy ($\times 50$) presentation of fractured surface of the electrofusion welding after strip-bend test containing, (a) improper scraping, (b) humidity, (c) lipid type defects.

Overall, the fracture surface of samples showed partially characteristics of both the ductile and brittle fractures in different fractions for three studied defect types. Fig. 11 shows the brittle fracture areas of samples related to lipid and moisture pollutants. A fully brittle fracture is obvious from the fractured surface of the sample for lipid type pollutant, while a better adhesion between the pipe and coupler could be concluded from the type of ductile fracture of the sample with trapped moistures. Table 9 summarizes the percentages of brittle and ductile fractures for different samples. It can be seen that the proper scraping is more critical for the integrity of the electrofusion joints. For improper scraping, the area percentage of the brittle fracture for all defect sizes were higher than 20%, so considered as unacceptable preparation. Therefore, even leaving a small area without scraping during the electrofusion welding could considerably reduce the strength of the joint. Although, the results of the strip-bend test fall within an acceptable range for all samples with humidity and lipid type defects. The brittle fracture percentages for lipid type pollutants were higher than those of
