Bituminous geomembrane: Successful alternative of distressed concrete canal lining built over expansive clays

ABSTRACT: This paper focuses on the application of Bituminous Geomembrane (BGM) for the waterproofing of new and existing earthen canals. The start of its application is about half-century back when USBR first time applied BGM in canal waterproofing and the first time BGM was used in waterproofing of a large dam by Coletanche in 1978 in France. In India, the first application of BGM has been done in one kilometer stretch of Pench Canal in Nagpur, Maharashtra which was given as a pilot project to Yooil Infra to arrest the seepage and enhance the stability of the canal. The area comprises expansive soil which has been problematic for canal banks stability, concrete lining failures, heavy seepage through banks and breaching of banks at different reaches of canal. The BGM application resulted in a complete stoppage of seepage through that section of the canal and no stability related problem was observed due to the elimination of drawdown conditions while and after the full flow of canal during monsoon. BGM is unique due to its properties of being flexible, high puncture resis

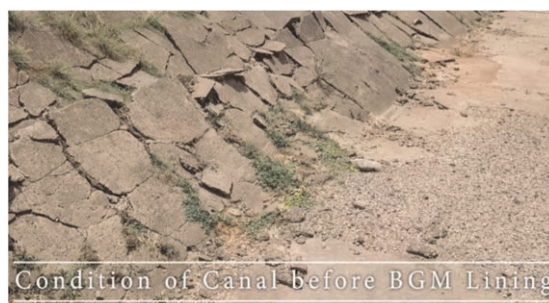
During the site inspection of left bank Pench canal, it is observed that concrete lining of canal is severely damaged (see Figure 2). Root causes behind the cracking of concrete lining of canal can be summarized as below:

Figure 2. Original condition of canal stretch.

Lining has joints at regular interval, through which seepage was taking place into the banks of the canal. General soil type along the canal alignment is expansive soil which is popularly known as “Black Cotton Soil”. Expansive soil exert pressure on the concrete lining due to volume expansion. As plain cement concrete is weak in tension, the expansion joint crack become wider, and sometimes new cracks develops in concrete lining.

Flowing water cause internal erosion below the lining of canal when enter in these cracks. During drawdown condition, situation becomes even worse when uplift force due to pore water pressure along with the swell pressure exerted by bank soil causing cracking of lining and sometime sliding of the whole soil mass into the canal.

A distinct disadvantage of Concrete lining is its brittleness. Thus, concrete lining frequently cracks due to contraction taking place from temperature change, drying and shrinkage and settlement of sub-grade.
