6th EURO GEO CONFERENCE

Geomembrane systems in The Netherlands and abroad risks and lessons-learned

R.H. (Rijk) Gerritsen
Witteveen+Bos Consulting
Engineers, The Netherlands

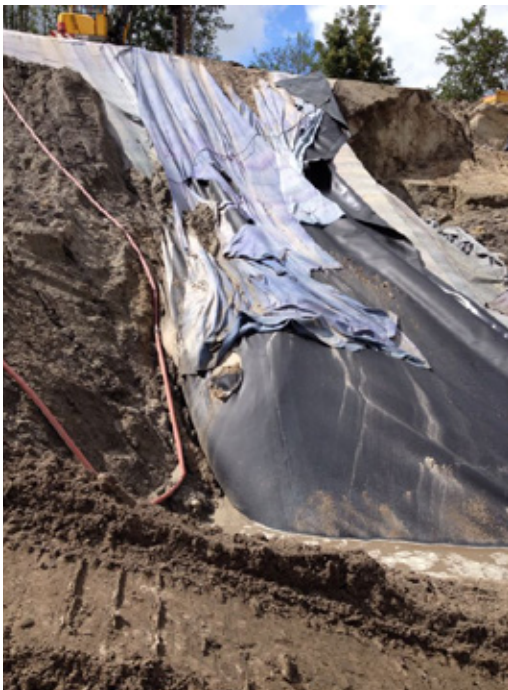
Figure 1 - Slope failure by stability problems after finishing the geomembranes caused by external water pressures versus insufficient backfill levels [Genap]

denominator in all three stages will be the limited knowledge of geomembrane systems, material properties and procedures. A lack of knowledge means that potential risks are not being recognized at an early stage, resulting in a possible major impact. An example of severe damage by a slope failure is given in figure 1.

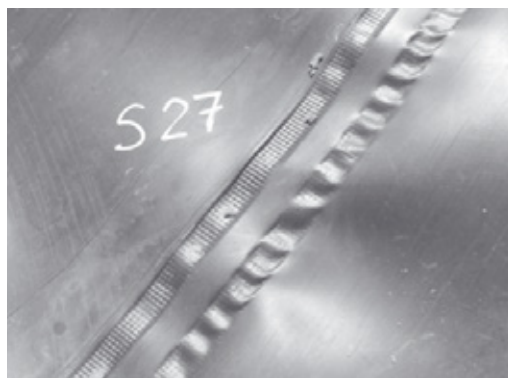
Figure 2 - Example of poor nip roller tracking in a HDPE wedge weld [Scheirs]

Welds and seams can be designated as the weakest points of a geomembrane. According to *Scheirs 2009* seams are regions with high stress concentration due to defects in seaming operations, the heat-affected zone (HAZ) and residual stresses. The welding quality depends on a lot of factors, knowing the presence of contamination on the geomembrane welding surface (soil/moisture), weather conditions, workmanship of the personnel involved, material selection, and proper inspection. In figure 2 to 3 several examples are given of defects designated at welds and seams.

Obtaining a high quality weld will require serious craftsmanship and experience. Factors to take into account to ensure welding quality are weather conditions (humidity, low and high temperature, abrupt changes of temperature, etc.). Wind, rain and pollution by means of mud or sand (blown by the wind into the joint) will also influence the quality of the welding. Also good maintenance of the welding machines is important to insure proper welding. The machine shall be cleaned after usage and it shall be free from any pollution to the heating and pressure rollers.

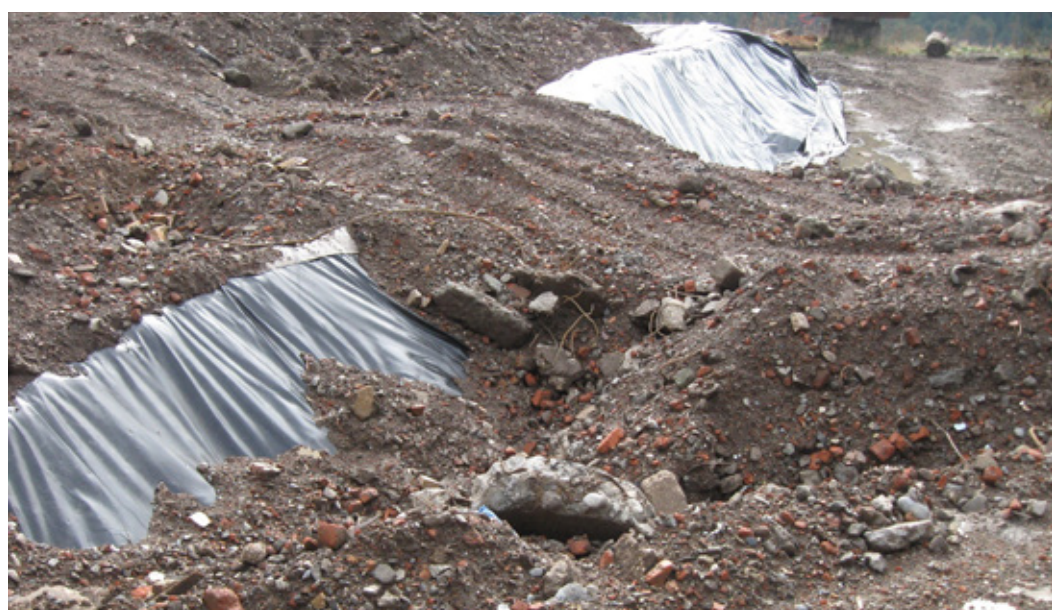
Figure 4 - The presence of sharp/big stones without protective geotextiles will significantly increase the risk on damaging the geomembrane [Gerritsen]

assessed that about 20% of the leaks occur at seams (improper welding), but over 70% (!) of leaks occur when the liner is covered by soil or stone. Based on these values and practical experiences the quality of groundwork's is showing a factor which is under-estimated in a lot of projects. The covering operation has to be seen as a very critical stage for the geomembrane. Related to this issue many examples in projects are known, observing unacceptable circumstances during the excavation or covering stage (see figure 4).

The subsoil on which the geomembrane will be installed needs also to be clear from sharp subjects which may puncture through the geomembrane. Measures can be taken for additional protection of the geomembrane. Since 2012 state-of-art geomembrane applications in The Netherlands are provided with protective non-woven geotextiles on both sides (bottom/above), see figure 5. In case of non-woven protective geotextiles attention should be given to the material type (polypropylene / polyester), minimum density, dynamic cone drop resistance and static puncture resistance. Applying a good quality non-woven will reduce the risk of perforations of the geomembrane significantly.

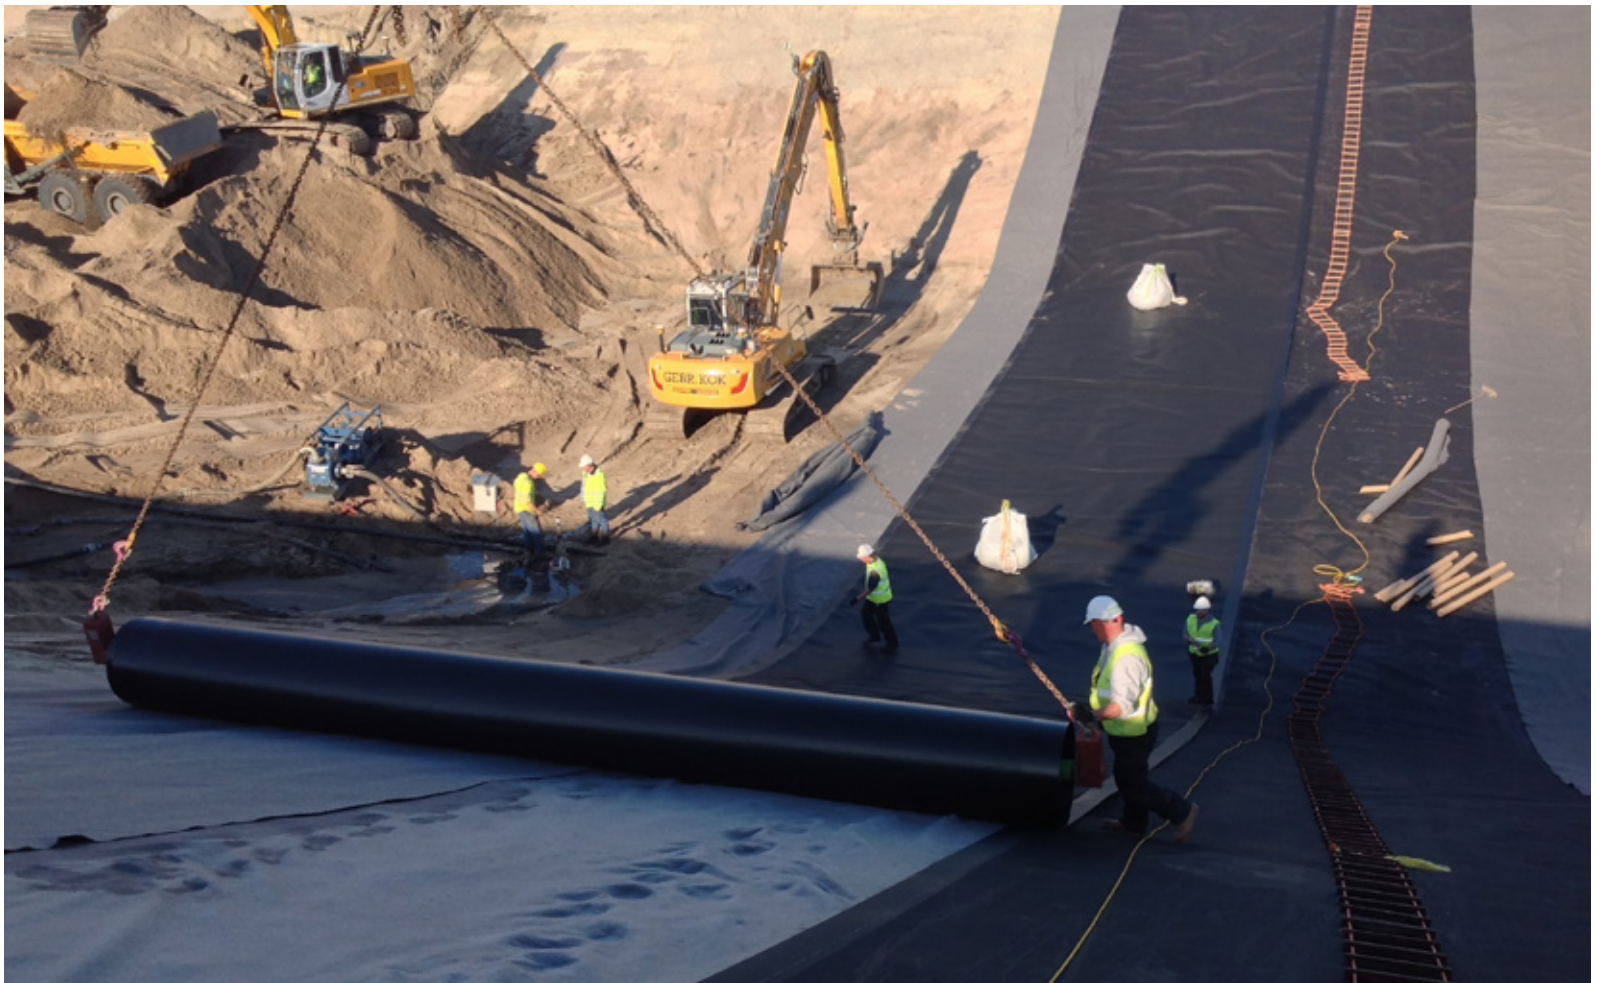
Figure 5 - Example of proper installation using a protective non-woven geotextile at the subsoil and topside of the geomembrane, working sequence with excavation works and installing method at large slopes [Gerritsen]

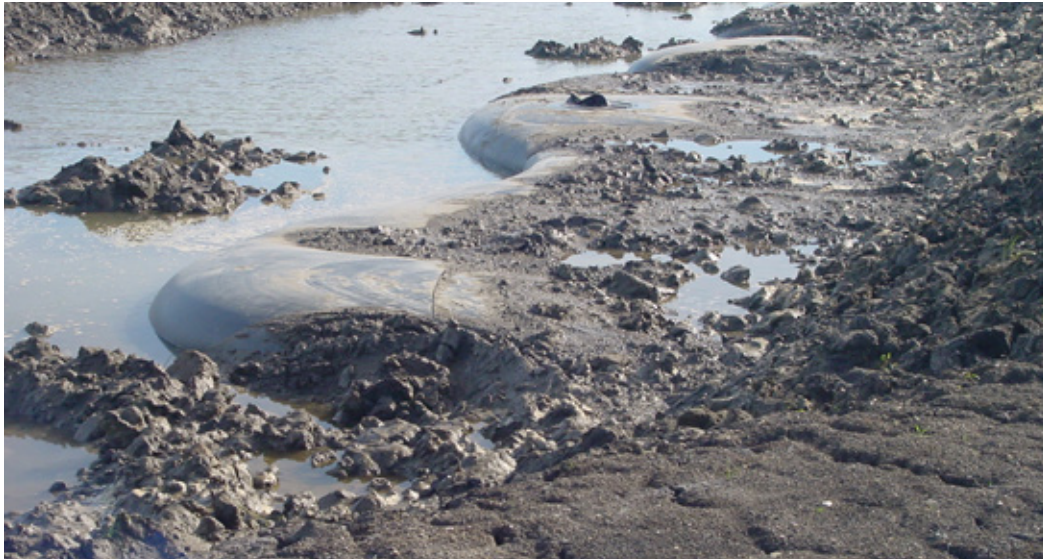
Figure 6 - Geomembrane 'whales' due to uplifting water pressure below the geomembrane related to improper backfilling levels [Genap]

An important attention point is the presence of groundwater affecting the stability of slopes and retaining structures. Groundwater levels and overpressures used for submerging geomembranes can have a significant effect on the stability of geomembranes and the deformation of retaining structures, used in cases of limiting space by vertical boundaries and fixations of geomembranes [Gerritsen, et al., 2014]. The conditions of groundwater are of major importance, and also the proper working of dewatering devices (deepwells, filters, etc.). In case the dewatering devices (pump generators) fail, a quick build up of water pressure can occur, this can cause severe problems to the

stability of geomembrane construction. Also excessive rainfall can lead to problems by rapid increasing groundwater levels, exceeding the design water levels or overflow of the working area. Several cases are known of groundwater conditions which damaged the excavated slopes or already installed geomembrane structure during the construction process (see figure 6).

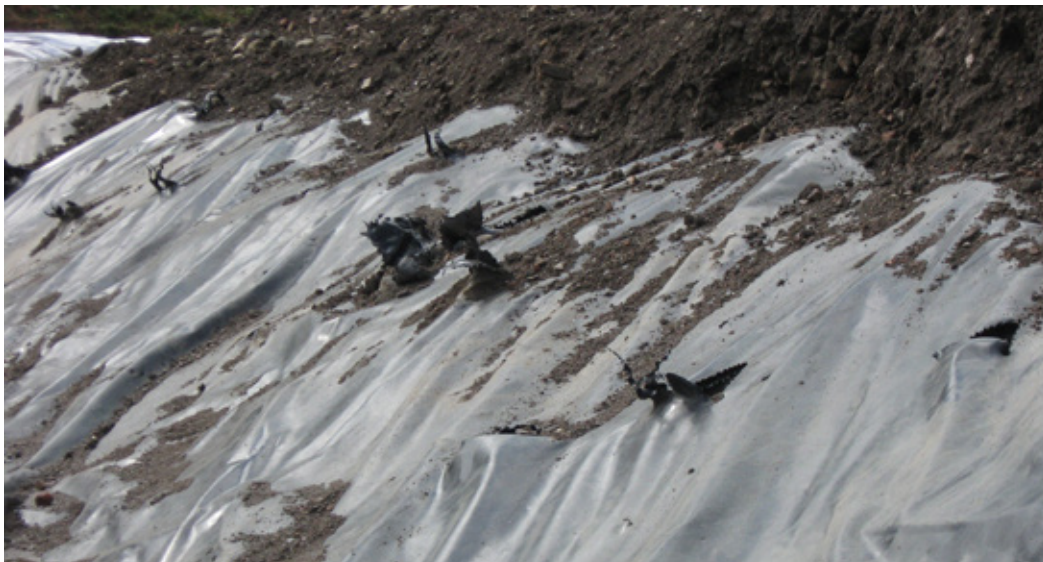
Figure 7 - Mechanical damage to a geomembrane anchoring trench by using wrong backfilling equipment (crane) and less instructed personnel on site [Gerritsen]

During the construction stage the geomembrane remains very sensitive for damage, knowing it can be exposed to all influences from transport, handling, weather influences, etc. During transportation and off loading full rolls may be damaged by means of insufficient packaging or due careless handling by drivers of fork lifters or cranes. Another cause is the impact of heavy equipment used on the construction site, causing mechanical damage by cranes, trucks, dozers (see figure 7).
