Challenges and opportunities with lined tailings dams

Tailings are currently classified by South African environmental legislation as potentially hazardous waste. When assessed against the legislated Waste Acceptance Criteria, platinum tailings are often classified as requiring a high-density polyethylene (HDPE) liner as a pollution-control barrier. This relatively new requirement brings environmental benefits, but does complicate the design, construction and operation of a tailings storage facility (tailings dam).

NEW TAILINGS DAM FOR MARULA MINE

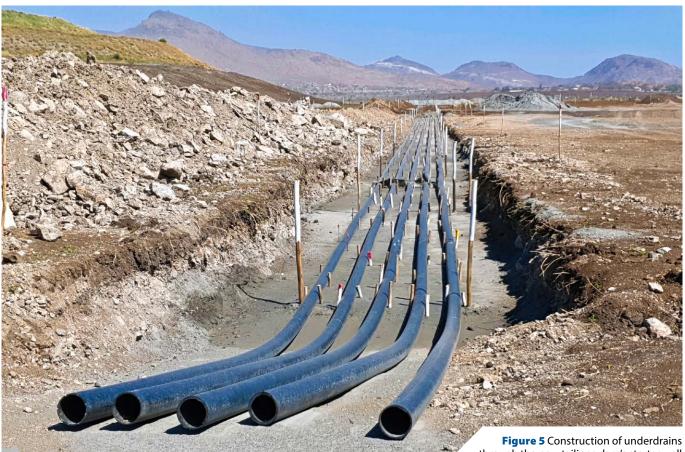
through the new tailings dam's starter wall

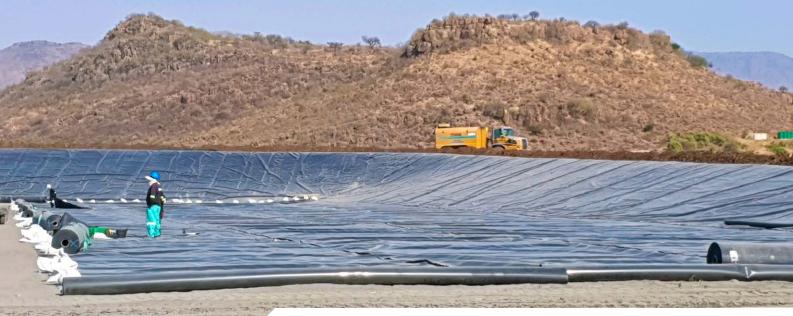
Figure 6 The Marula return water dam which is also being lined with HDPE as part of this project
