## Some current topics regarding geomembrane liners and floating covers for water storage reservoirs

**ABSTRACT:** Current issues in the renovation of water supply reservoirs by the replacement of old geomembrane liner and floating cover systems with new systems are discussed. Topics include sampling and testing, underdrain systems, material choices, floating cover access for maintenance and the impact of conductive geotextiles on leakage rates.

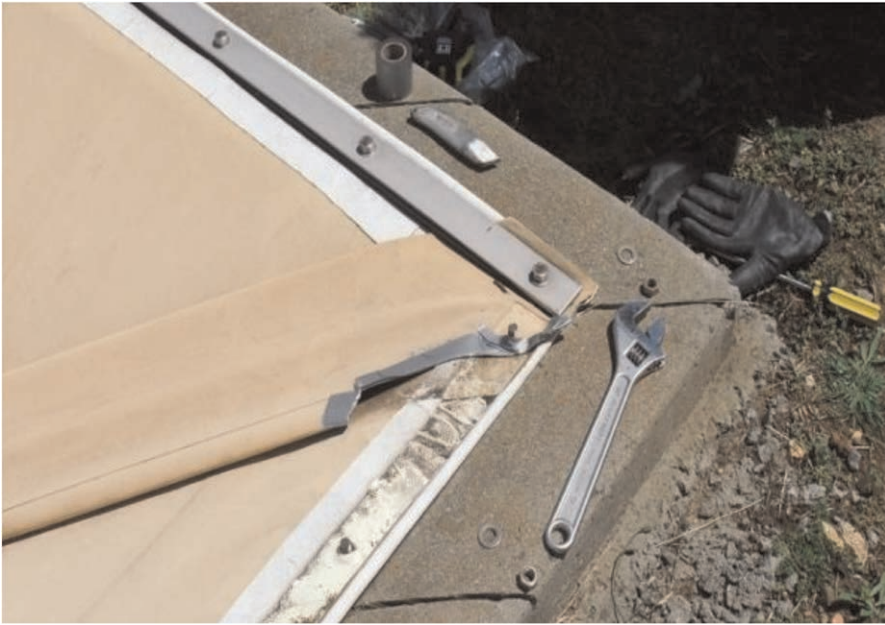
Figure 1. A small cover material sample taken from a ballast tube partly under a batten bar.

In many cases smaller and less obtrusive samples have been taken from weld flaps and under perimeter batten bar fixings (See Figures 1 and 2) and this has required the use of tests such as Oxidation Induction Time (OIT) and High Pressure Oxidation Induction Time (HPOIT). These analytical tests use small samples the size of a thumbnail to assess the remaining anti-oxidant capacity of the material and the OIT method is applicable to materials with mainly phenolic anti-oxidants and the lower temperature HPOIT is applicable to materials with mainly hindered amine anti-oxidants.

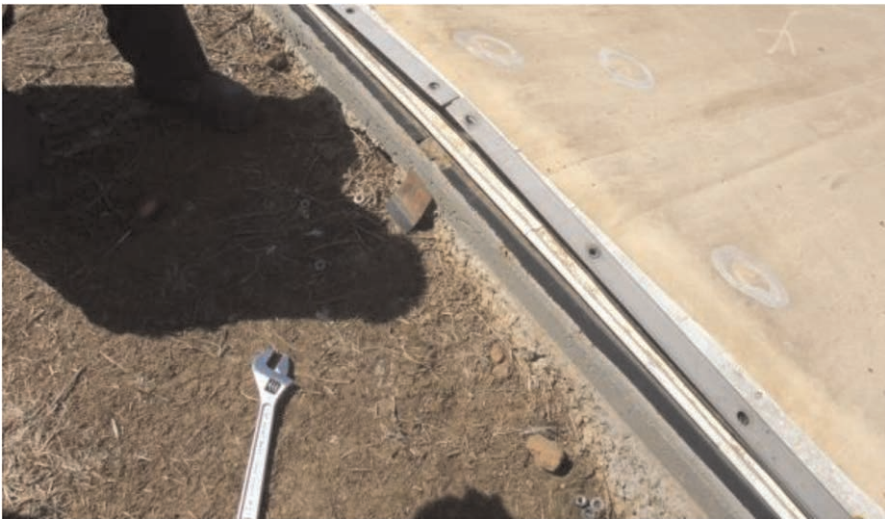
Figure 2. A small liner material sample taken from under a batten bar. This floating cover had many small marked holes which had been caused by embers from a grass fire.

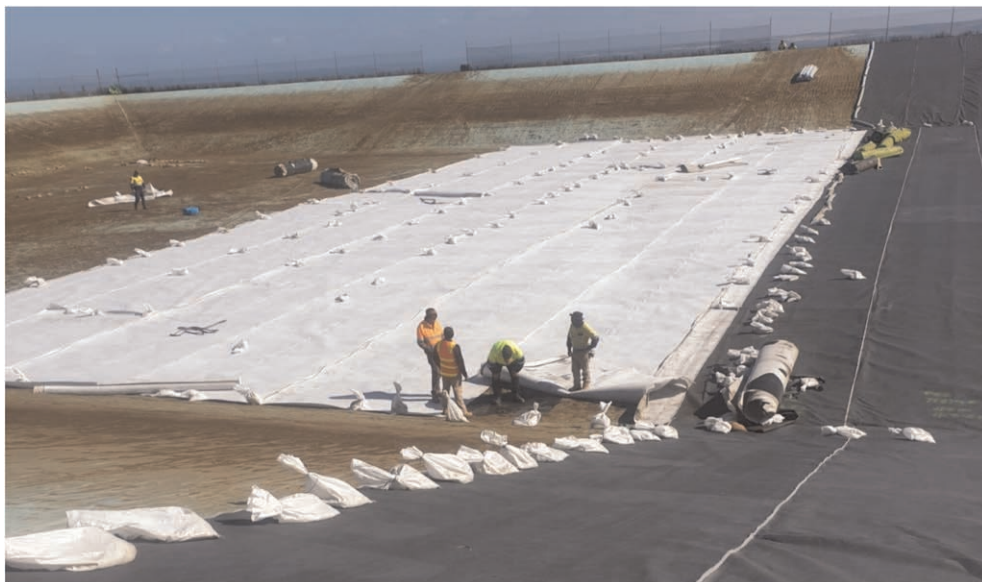
Figure 3. A reservoir with the old discoloured fPP liner being used as a secondary liner. The white material on the floor is a drainage geocomposite and the black material on the slopes and the floor is a conductive non-woven geotextile with a unit mass of about 350 gsm.

In some cases an existing concrete liner might be utilised and in others the old liner might be sufficiently effective to function as a secondary liner. There have been other projects where a choice has been made to install a complete new double liner system. See example in Figure 3.

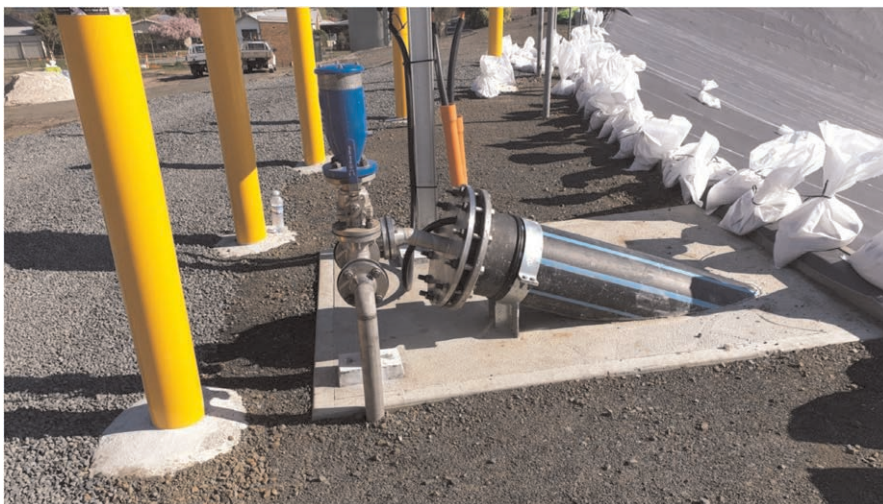
Figure 4. An underdrain water extraction system with a down the slope pipe with a bore pump.

Where a reservoir has an existing gravity underdrain pipe under the embankment that will be tested and utilised if effective. However, because of the difficulties involved with properly grouting the annulus around a pipe new under embankment bores are not used and a down the slope pipe with a bore pump installation is used instead. See Figure 4.

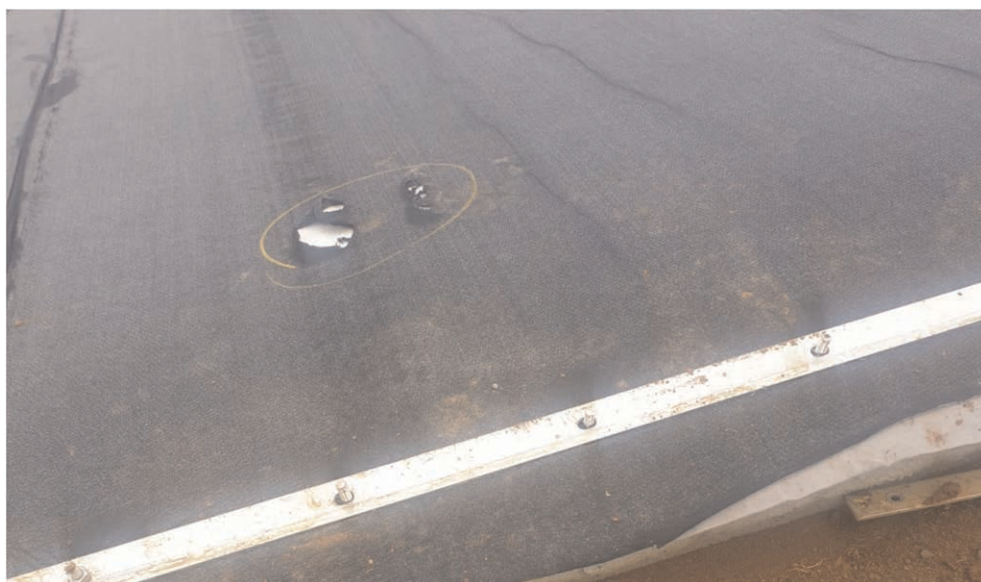
Figure 5. Holes in a conductive composite made by workers walking on it. These required patching to ensure adequate conductivity.

The conductive geotextiles based on needled non-woven geotextiles are quite robust and easily installed with overlaps seamed by a wedge welder. However, supply situations have occasionally made them unavailable, and a few projects have used a needle punched composite with a 150 gsm non-woven geotextile base and a thin conductive film of polyethylene. This has required a separate drainage layer and has been much less robust than the heavier conductive non-woven geotextile.

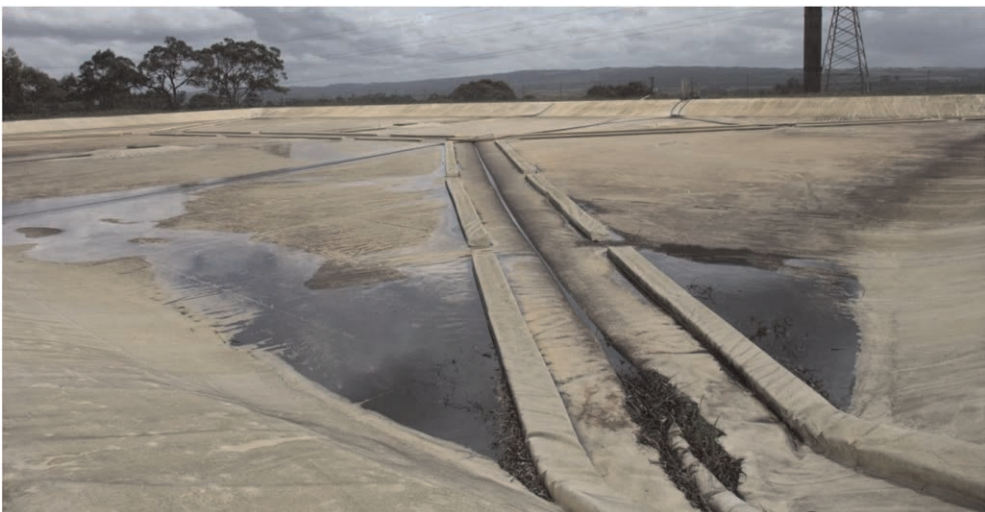
Figure 6. A floating cover with foam floats for tensioning and other floats for access walkways.

Figure 6 is an example of a cover with floats for tensioning each side of the ballast lines and additional floats for walkways. These often have openings in the float paths intended to allow surface water to move around and enter the ballasted trench area for collection and removal. Prevailing winds can cause the water to pond and windblown dirt and soil collect at those locations and make the ponding worse.

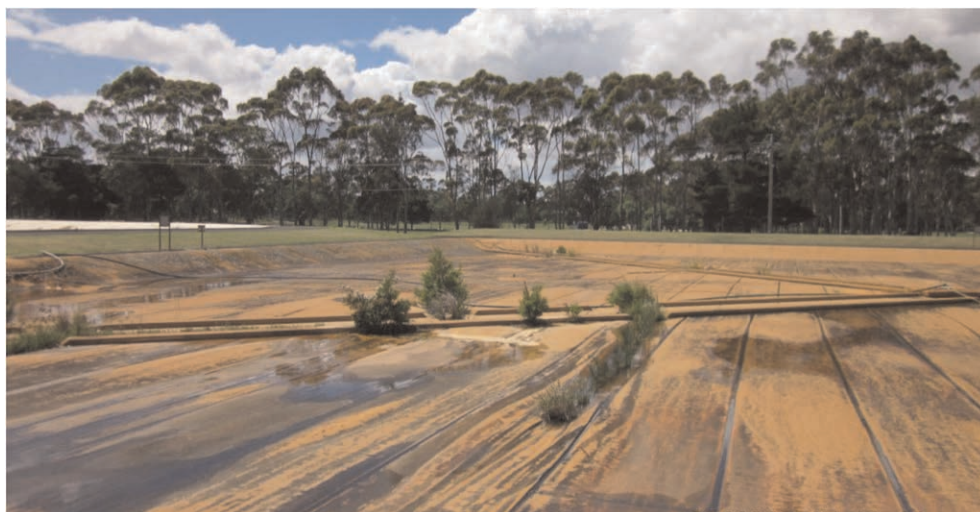
Figure 7. A 30 year old CSPE cover where a lack of maintenance has allowed vegetation to grow.

Especially on older floating covers there is a reluctance for personnel to use the access walkways to remove the leaves, soil and debris. There is also a reluctance to empty the reservoirs in order to carry out necessary maintenance and cleaning. In Figure 7 it can be seen how this can lead to substantial growth of undesirable vegetation.
