Mineral wool CUI mitigation improvements

Ricky Seto
ROCKWOOL Technical Insulation
14950 Heathrow Forest Pkwy, Suite 330
Houston, TX 77032
USA

ABSTRACT

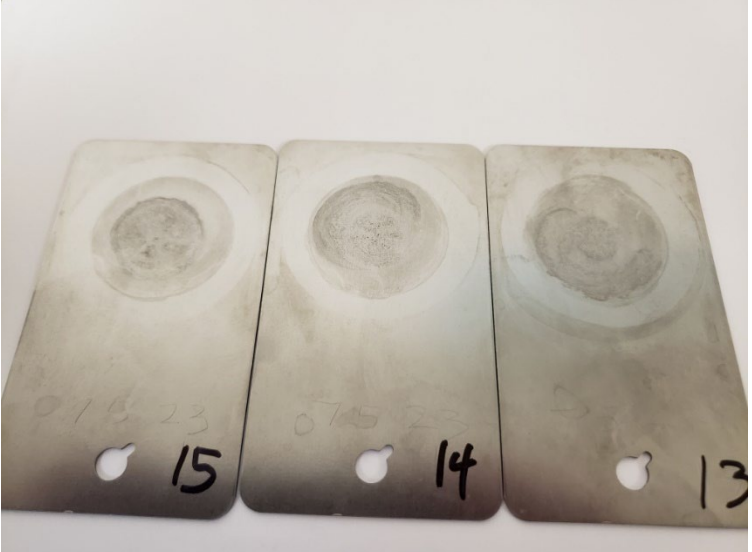
Solution	Average Mass loss corrosion rate (MPY)	Visual of coupon after cleaning
0 ppm	7.42

The image shows three rectangular metal coupons, labeled 15, 14, and 13 from left to right. Each coupon has a circular hole at the top and a smaller circular hole at the bottom. The coupons are light-colored with some darker, possibly corroded, areas. The coupon labeled 15 has a handwritten number '010-23' above the bottom hole. The coupon labeled 14 has a handwritten number '010-23' above the bottom hole. The coupon labeled 13 has a handwritten number '010-23' above the bottom hole.

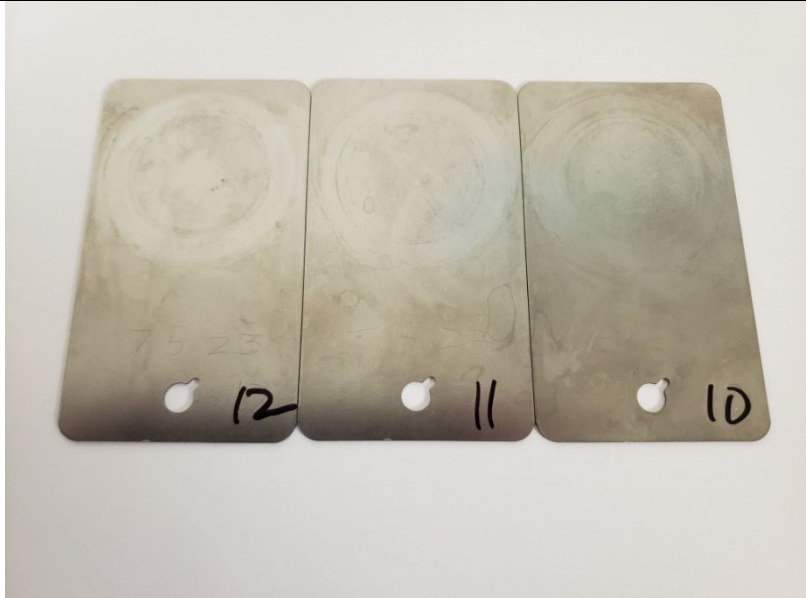
Expanded Perlite
+100ppm Cl

2.62

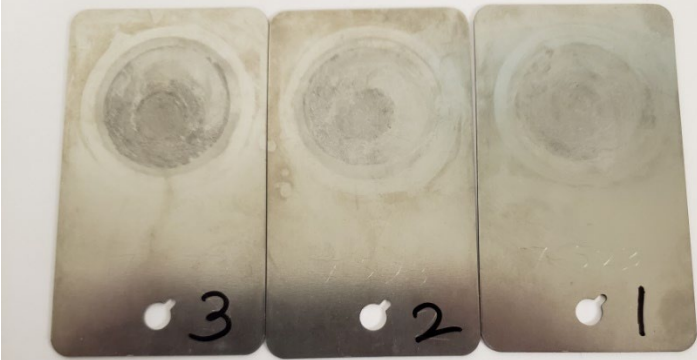
Aerogel+100ppm Cl	48.76

However, the aerogel material with 100 ppm chlorides does not perform to the same level as mineral wool with inhibitors, perlite, or calcium silicate. The corrosion level of aerogel with 100 ppm chlorides was in the 40+ MPY category, which puts it in the 5-ppm chlorides level according to ASTM C1617. There was a high probability of aggressive corrosion with aerogel that may lead to leaking under the PVC containers and subsequent contamination of adjacent samples—thus compromising the entire test. For this reason, aerogel was not included in the next higher levels of chloride tests up to 300 and 600 ppm chloride.

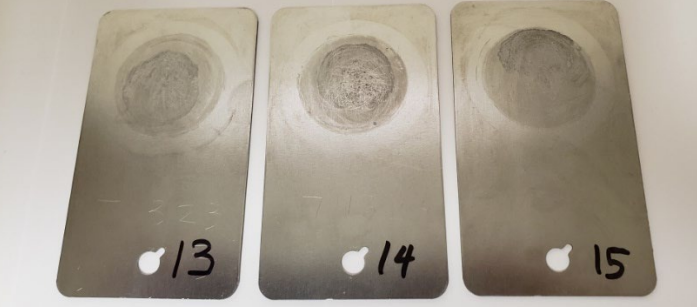
Solution	Average Mass loss corrosion rate (MPY)	Visual of coupon after cleaning
0 ppm	8.06

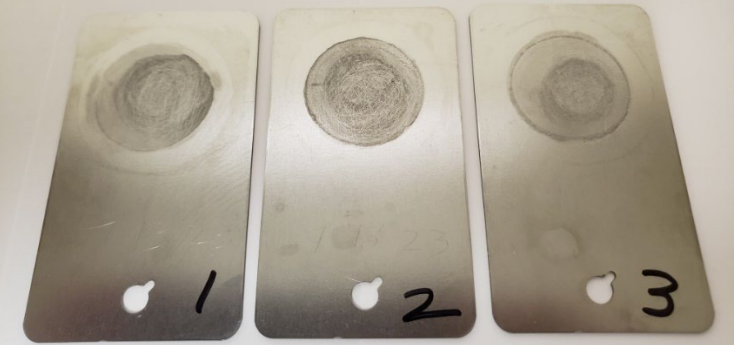
1 ppm	24.69

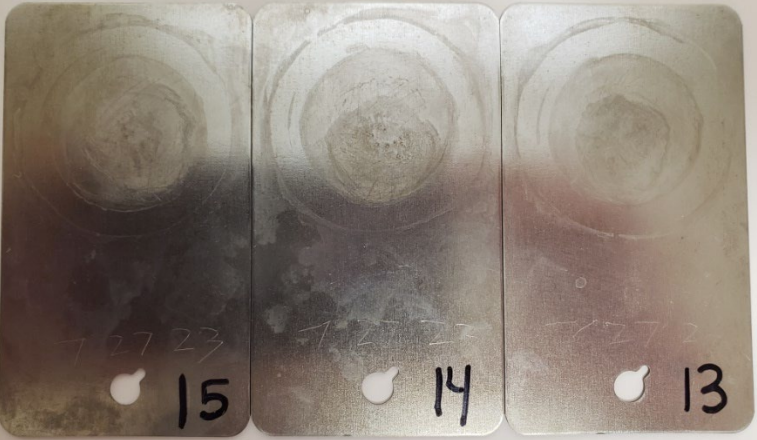
Solution	Average Mass loss corrosion rate (MPY)	Visual of coupon after cleaning
0 ppm	6.17

<p>Three metal coupons are shown side-by-side, labeled 15, 14, and 13 from left to right. Each coupon has a circular hole in the center and shows very little to no visible corrosion. The surface appears relatively smooth and metallic.</p>
1 ppm	25.54

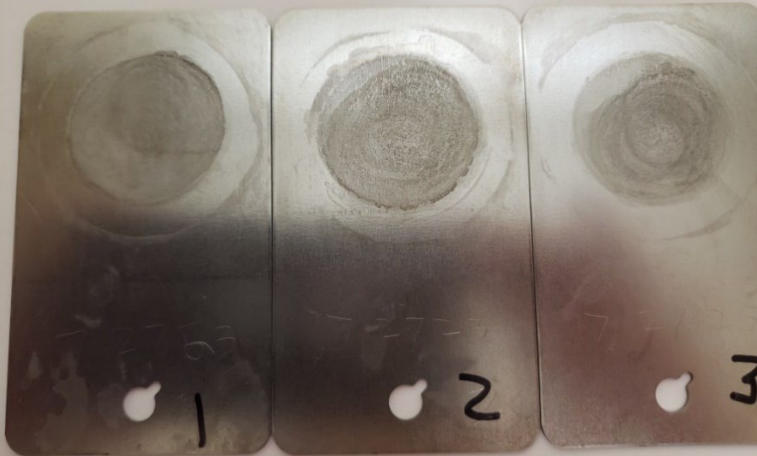
<p>Three metal coupons are shown side-by-side, labeled 1, 2, and 3 from left to right. Each coupon has a circular hole in the center and shows significant, dark, and porous corrosion products covering a large portion of the surface area.</p>

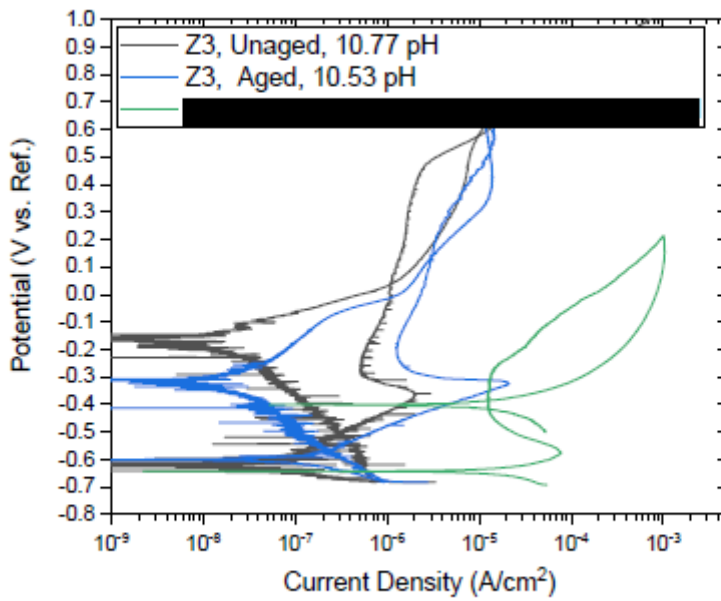
Figure 1: (a) CPP curves and (b) the anodic polarization curves collected in concentrated insulation extract solution from heat-aged and non-heat-aged mineral wool treated with corrosion inhibitor labeled as (Z3).

CPP testing with unaged mineral wool with inhibitors and heat-aged mineral wool with inhibitors both displayed an active passive region, as shown Figure 1. This suggests SCC is still possible.

Other studies with mineral wool without inhibitors have shown results indicating SCC especially when the pH dips below 9 after heat aging.^{6, 7} With heat aging, the mineral wool with inhibitors did not decrease in pH, as shown in Figure 1. This indicates a chemical difference not seen before, which could help explain why the specimens did not crack when exposed to the extracted insulation solution.
