GEOMEMBRANE SYSTEMS IN THE NETHERLANDS AND ABROAD - RISKS AND LESSONS-LEARNED

ABSTRACT: This article gives an overview of risks and lessons learned about geomembrane constructions in The Netherlands and abroad. Subjects that will be discussed will include risk-assessments and quantification of risks regarding geomembranes, welding procedures, stability issues of slopes, backfill and retaining structures, installation damage by handling and weather circumstances, and external influences after completion. The aim of this paper is to emphasize an integral approach during the entire process and importance of acknowledging quality risks to all involved companies. The success of a watertight and durable installation will depend on an integration of design aspects, materials, construction issues and quality assurance. To avoid risks during lifetime attention shall be given to proper restrictions, maintenance issues and monitoring of leakage/durability. The article presents examples, to illustrate risks and lessons learned.

This article is supporting a specialty session at the Eurogeo6 congress Ljubljana (Slovenia) in September 2016. A full colour summarized version of this article is pu

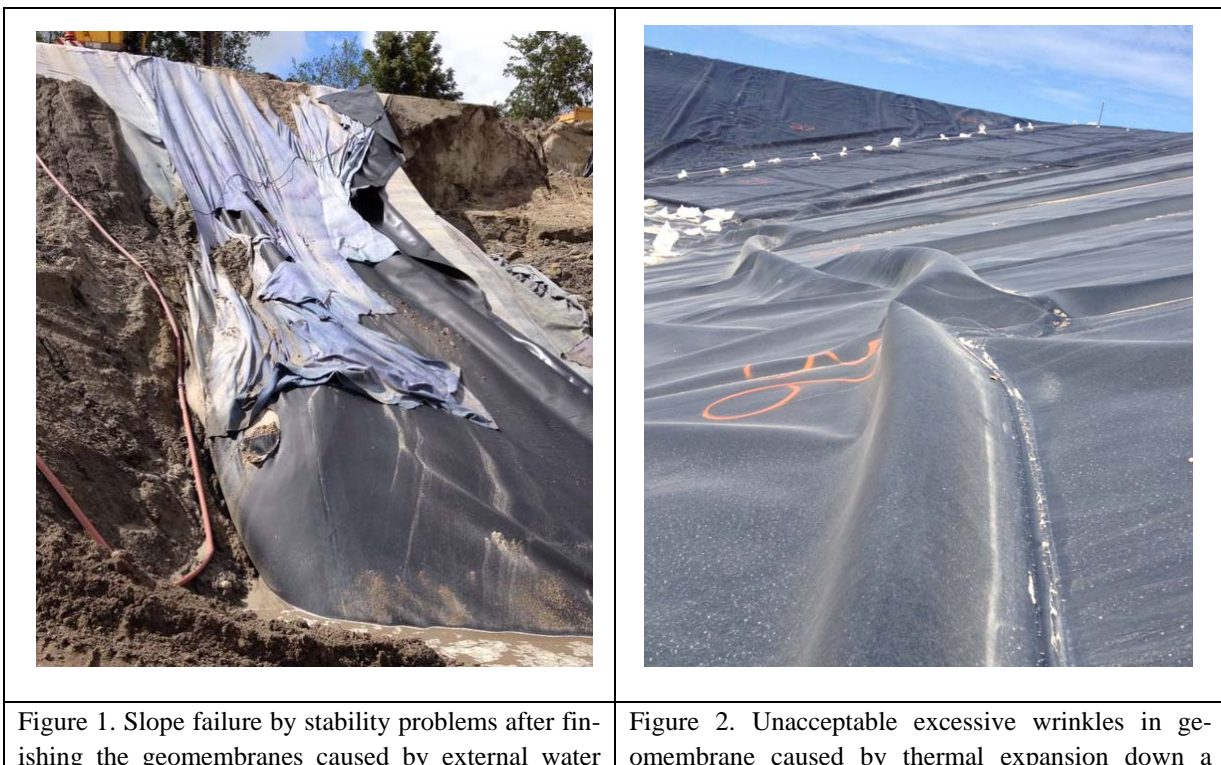
An example of severe damage is given in figure 1. A situation of unacceptable excessive wrinkles is given in figure 2. Covering these excessive wrinkles will result in sharp folds, likely to give durability problems on the long term, due to stress concentrations.

pressures versus insufficient backfill levels [Genap]	slope [Scheirs]
---	-----------------

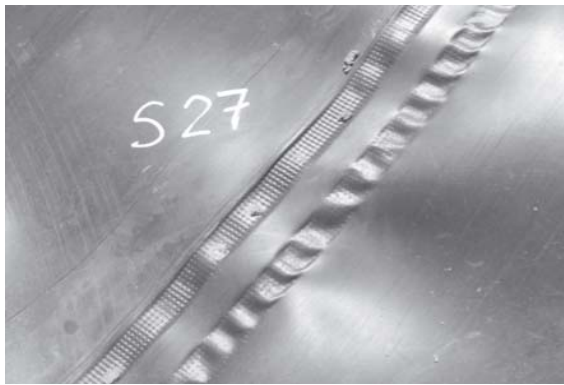
Figure 6. Example of poor nip roller tracking in a HDPE wedge weld [Scheirs]

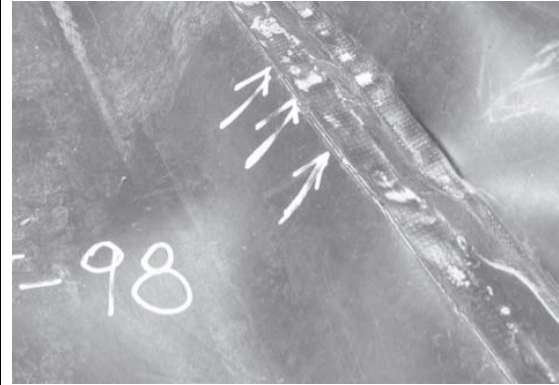
Figure 7. Example of overheating a HDPE Weld [Scheirs]

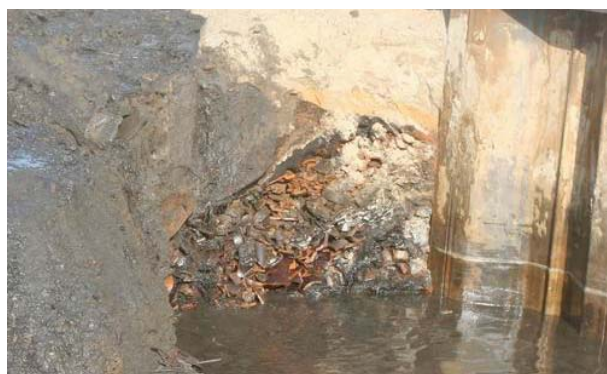
Figure 8. Presence of an un-expected dumpsite with ceramic material and environmental pollutions at a project site with a planned submerged geomembrane [Gerritsen].

Related to this issue many examples in projects are known, observing worse circumstances during the excavation or covering stage (see figure 8 and 9). In case these circumstances are neglected and no actions are taken, this can result in direct physical damage to the geomembrane.

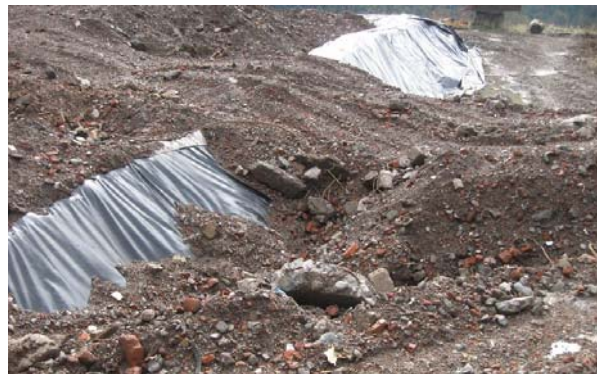
Figure 9. The presence of sharp/big stones without protective geotextiles will significantly increase the risk on damaging the geomembrane [Gerritsen].

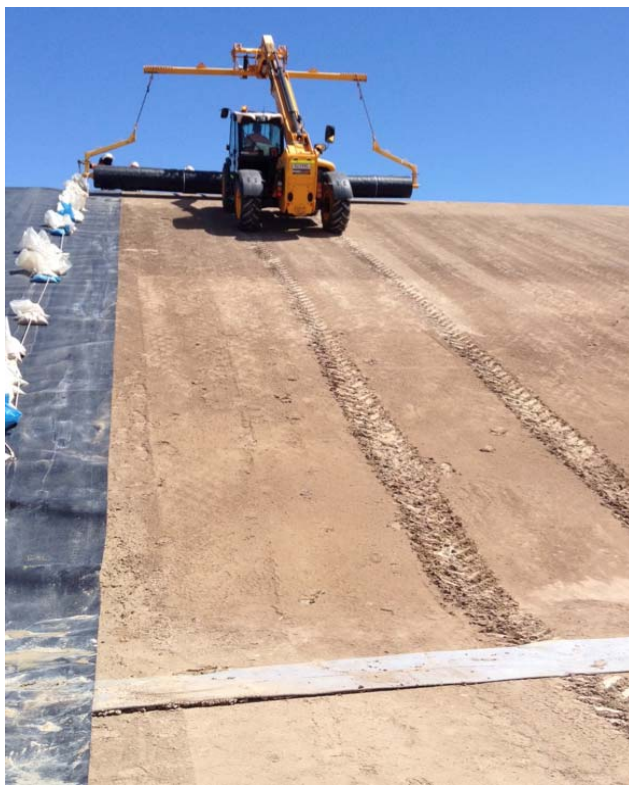
Figure 11. Unacceptable damage to sub grade and improper working method by construction equipment [Scheirs]

The subsoil on which the geomembrane will be installed needs to be clear from sharp subjects which may puncture through the geomembrane. In figure 10 to 12 several examples are given of unacceptable sub grades. The starting point for suitability of soil material adjacent the geomembrane shall be that the material is free of admixtures with sharp stones, desiccated sub grade, boulders, concrete blocks, tree roots, construction waste (wood, beams, steel rebar, nails, piles, drainage or sewage pipes, foundation materials etc.). In case of building in urban areas with a long history or reconstruction works it can be presumable the excavated soil and surface will not be clean enough. In case of admixtures the material can be mechanical sieved by on plant installation or sieving equipment (see figure 13). In case the sand material has a lot of fines (problem of reaching the required degree of compaction) the fines can be removed. The same extraction can be done by presence of too much coarse material (gravel/boulders).

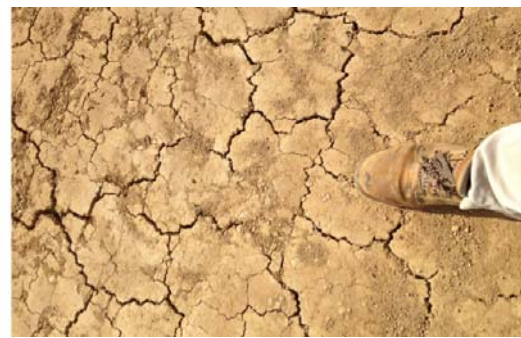
Figure 10. Unacceptable desiccation of clay sub grade [Scheirs]

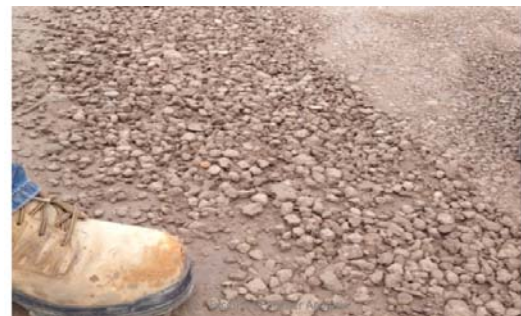
Figure 12. Unacceptable sub grade for direct (HDPE) geomembrane installation [Scheirs]

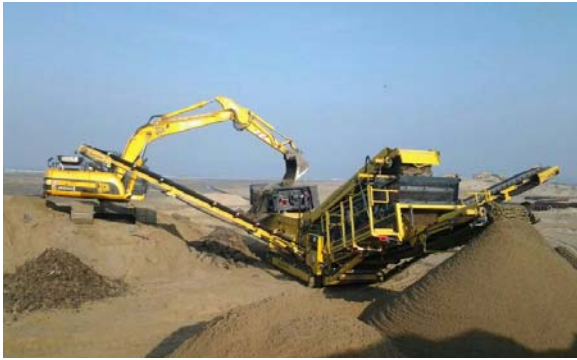
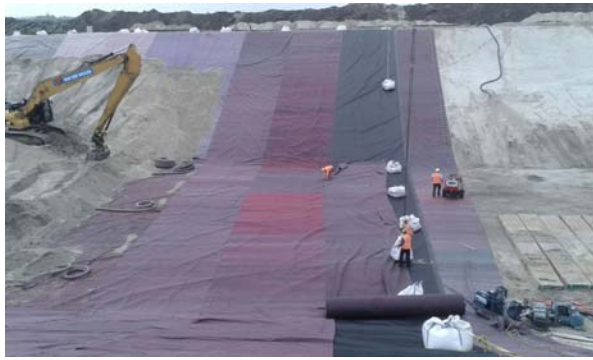
<p>Figure 13. Example of proper mechanical sieving equipment to extract rubbish/admixtures before re-using the material within a geomembranes [G.M. Damsteegt]</p>	<p>Figure 14. Example of proper installation using a protective non-woven geotextile at the subsoil and top-side of the geomembrane, working sequence with excavation works and installing method at large slopes [Genap]</p>

After placing a non-woven protective geotextile and a first layer of back fill contractors tend to use their internal transport to drive over this back fill. At least 50 centimetres should be taken into account as a minimum before driving on top of the geomembrane, but preferable a thickness of 100 centimetres to ensure enough load spreading from equipment (see figure 14).

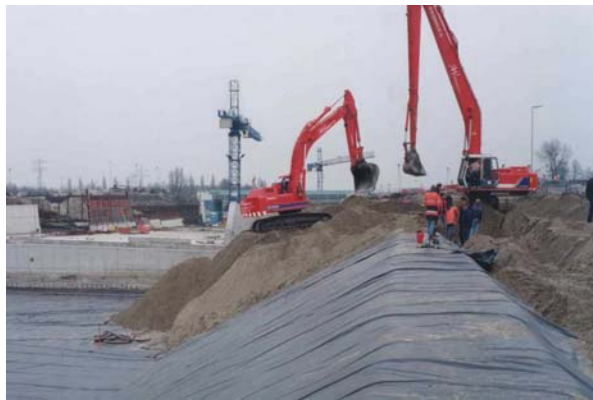
A photograph of a construction site. In the foreground, a grey geomembrane is being laid out on a prepared surface. Behind it, a large pile of brown soil is being backfilled. Two red excavators are visible, one of which is actively working on the soil. The background shows a clear sky and some industrial structures.	  A photograph showing a large-scale environmental remediation site. A wide, shallow body of water is visible, surrounded by dark, rocky terrain. In the center, a large, curved, light-colored structure, likely a geomembrane, is partially submerged and appears to be damaged or displaced by the water. The surrounding area is filled with dark rocks and debris.
<p>Figure 15. Risk to instability soil backfill and severe damage geomembrane, using a wrong backfill sequence at the geomembrane structure [Ref. Dutch directorate for public Works and Water Management]</p>	<p>Figure 16. Geomembrane whales due to uplifting water pressure below the geomembrane related to improper backfilling levels [Genap].</p>

The presence of groundwater is affecting in a prior case the stability of slopes and retaining structures. Groundwater can be seen as a ‘sneak murderer’ for building pits, so also in the construction of geomembranes. The conditions of groundwater are of major importance, and also the proper working of dewatering devices (deep wells, filters, etc.). In case the dewatering devices (pump generators) fail, a quick build up of water pressure can occur, this can cause severe problems to the stability of geomembrane construction. Also excessive rainfall can lead to problems by rapid increasing groundwater levels, exceeding the design water levels or overflow of the working area. Another failure mechanism can be leakage through retaining walls (sheet piles). In the Netherlands several cases are known of groundwater conditions which damaged the excavated slopes or already installed geomembrane structure during the construction process (see figure 15 and 16). These situations are unintentional.

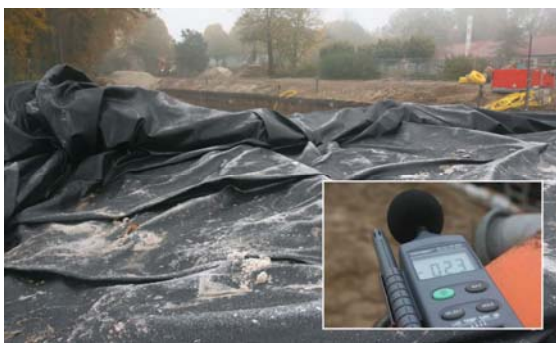
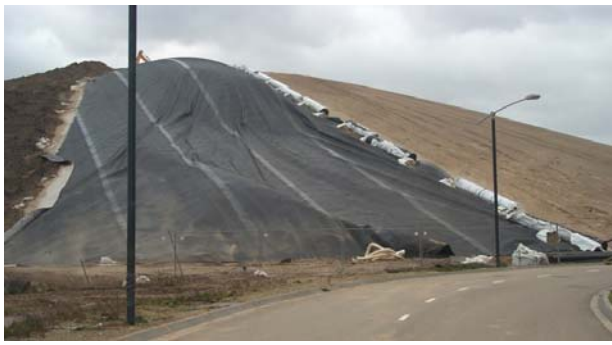
<p>Figure 17. Low temperature with frost during the unpacking and installation of a PVC-p geomembrane given delays around wintertime [Gerritsen].</p>	<p>Figure 18. Major effect of wind influence at an uncovered geomembrane field, causing intense safety risks for personnel and quality issues to the geomembrane [Gerritsen].</p>

Wind may influence the quality as well since a firm wind blow may blast away the uncovered geomembrane. The geomembrane should not be installed during high wind speed > 5 Bft and assure sufficient back fill after unrolling before final back fill is placed. In case of suddenly strong or increasing wind speed, this can cause intense safety risks for personnel and quality issues to the geomembrane (see figure 18).

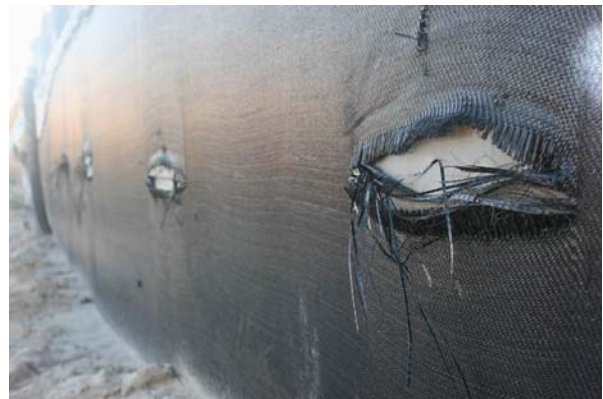
Figure 20. Mechanical damage of a woven protective geotextile by handling of heavy equipment, given a direct threat to the geomembranes behind [Gerritsen]

The geomembrane can also be harmed by actions of the personnel themselves, for example by smoking, wearing improper footwear or inclusions with sharp stones (see figure 22), falling tools like knives and scissors, effects of heat blowers, movement of a electric generator, or leaving waste. Another factor of damage can be the pulling to geomembrane sheets with strong forces (ropes, winches, big bags); in case the geomembrane is not exactly positioned in the right place. The geomembrane can be harmed by sharp edges of construction objects, like geonets (see figure 21), steel sheet piles or anchoring systems. Another cause is the impact of heavy equipment used on the construction site, causing mechanical damage by cranes, trucks, dozers (see figure 19 and 20).

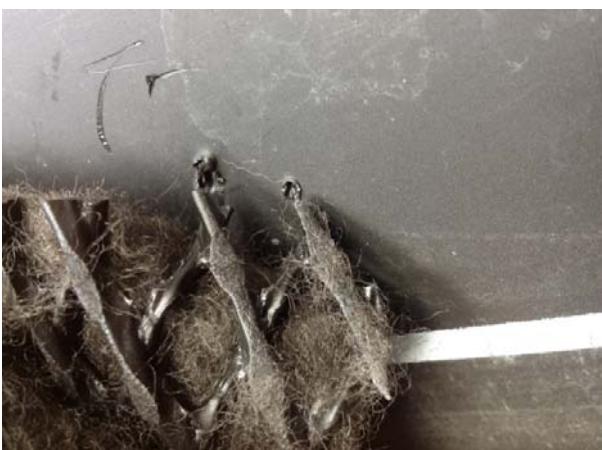
Figure 21. Sharp cut end of geonet causing puncture of geomembranes [Scheirs]

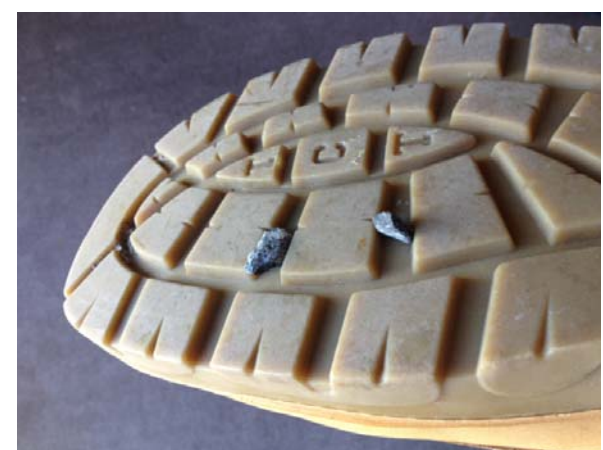
Figure 22. Stones in tread of work boots causing puncture of geomembranes [Scheirs]

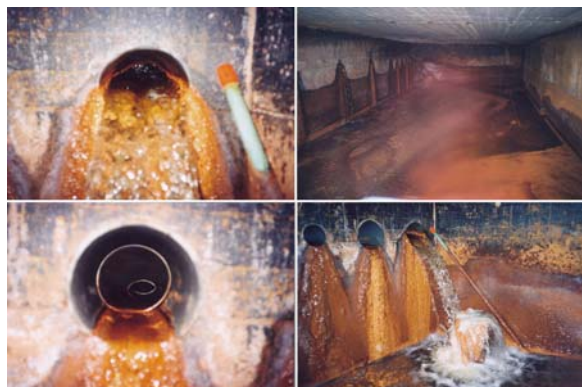
Figure 24. Inspection of a water collection cellar, observations of an increased influx (leakage) with external iron rich groundwater, blocking the total drainage system within a geomembrane construction [Municipality of Zwolle]

At most geomembrane systems drainage and sewage systems are installed to collect rain-fall water or leakage water. These systems are to be maintained and regular inspected. A learned-lesson is the case of a 15 year old geomembrane failure ‘IJssellaan Zwolle Netherlands’. Observations were made of an increased influx (leakage) with external iron rich groundwater, blocking the total drainage system within the geomembrane construction (see figure 24). As remedial measure the leakage was treated with injection measures, however this was finally increasing the leakage. Water on the road construction result in winter times in an uncontrollable and dangerous situation for traffic driving through the underpass. Finally the barrier was replaced by a traditional concrete construction in 1995.

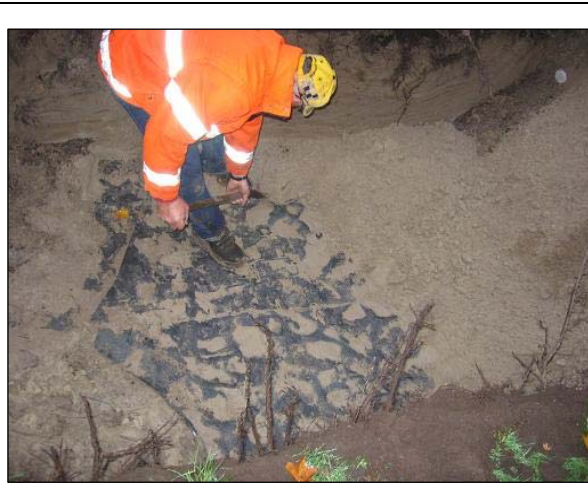
Figure 27. Investigation of 45 year old 0.4 mm geomembrane in trial pit, observing an irregular surface, wrinkles and cracks and water inflow [Witteveen+Bos / Kiwa, 2010]

The barrier system consisted of PVC-p (weakened) material, with a nominal thickness of 0.4 mm. In 2009 and 2010 investigations were carried out by several trial pits to obtain more information about the durability of the geomembrane system in place (see figure 27 and 28). Based on several trial pits and material tests the condition of the original 45 year old geomembrane was quite bad, knowing wrinkles, brittle cracks and water inflow. Based on tests and observations it was concluded the remaining lifetime of the geomembrane was ended.

Reasons for the loss of functionality of the geomembrane can be found in the source material (quality of the geomembrane), 0.40 mm small thickness and likely the construction way with wrinkles/sharp edges and irregularities in the adjacent backfill (stones). Another major reason can be found in an exposure to severe groundwater pollutions nearby. Next to the geomembrane was over a period of around 30 years a laundry factory located, causing a historic groundwater pollution of VOC. The chemical properties of VOC are having a higher volume weight than water, so pollutions of VOC are gradually descending to deeper aquifers. Around 2012 investigations turned out pollution depths of 10-25 m-surface, but from historic point of view the pollution was likely around and exposing the geomembrane decades before. Exposure to this kind of pollutions is causing an increased loss of plasticizers, which reduce the lifetime of geomembranes significantly. As the Client was planning to build a high speed public transport line, which should cross the geomembrane, it was strongly advised not to build new structures in or next the severe attacked geomembrane. In consultation with the Client (municipality of Breda) decisions were taken to replace the geomembrane over the full length of the road underpass, combined with the construction of two crossing viaducts. Based on a

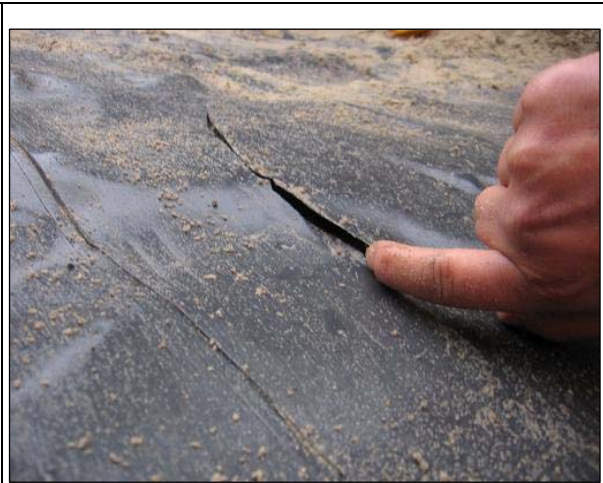
Figure 28. Close up brittle crack in the 45 year old 0.4 mm geomembrane, causing water inflow [Witteveen+Bos / Kiwa, 2010]
