10 Sources of Microplastics from Geosynthetics and Suggested Mitigation Strategies

www.excelplas.com

August 2022

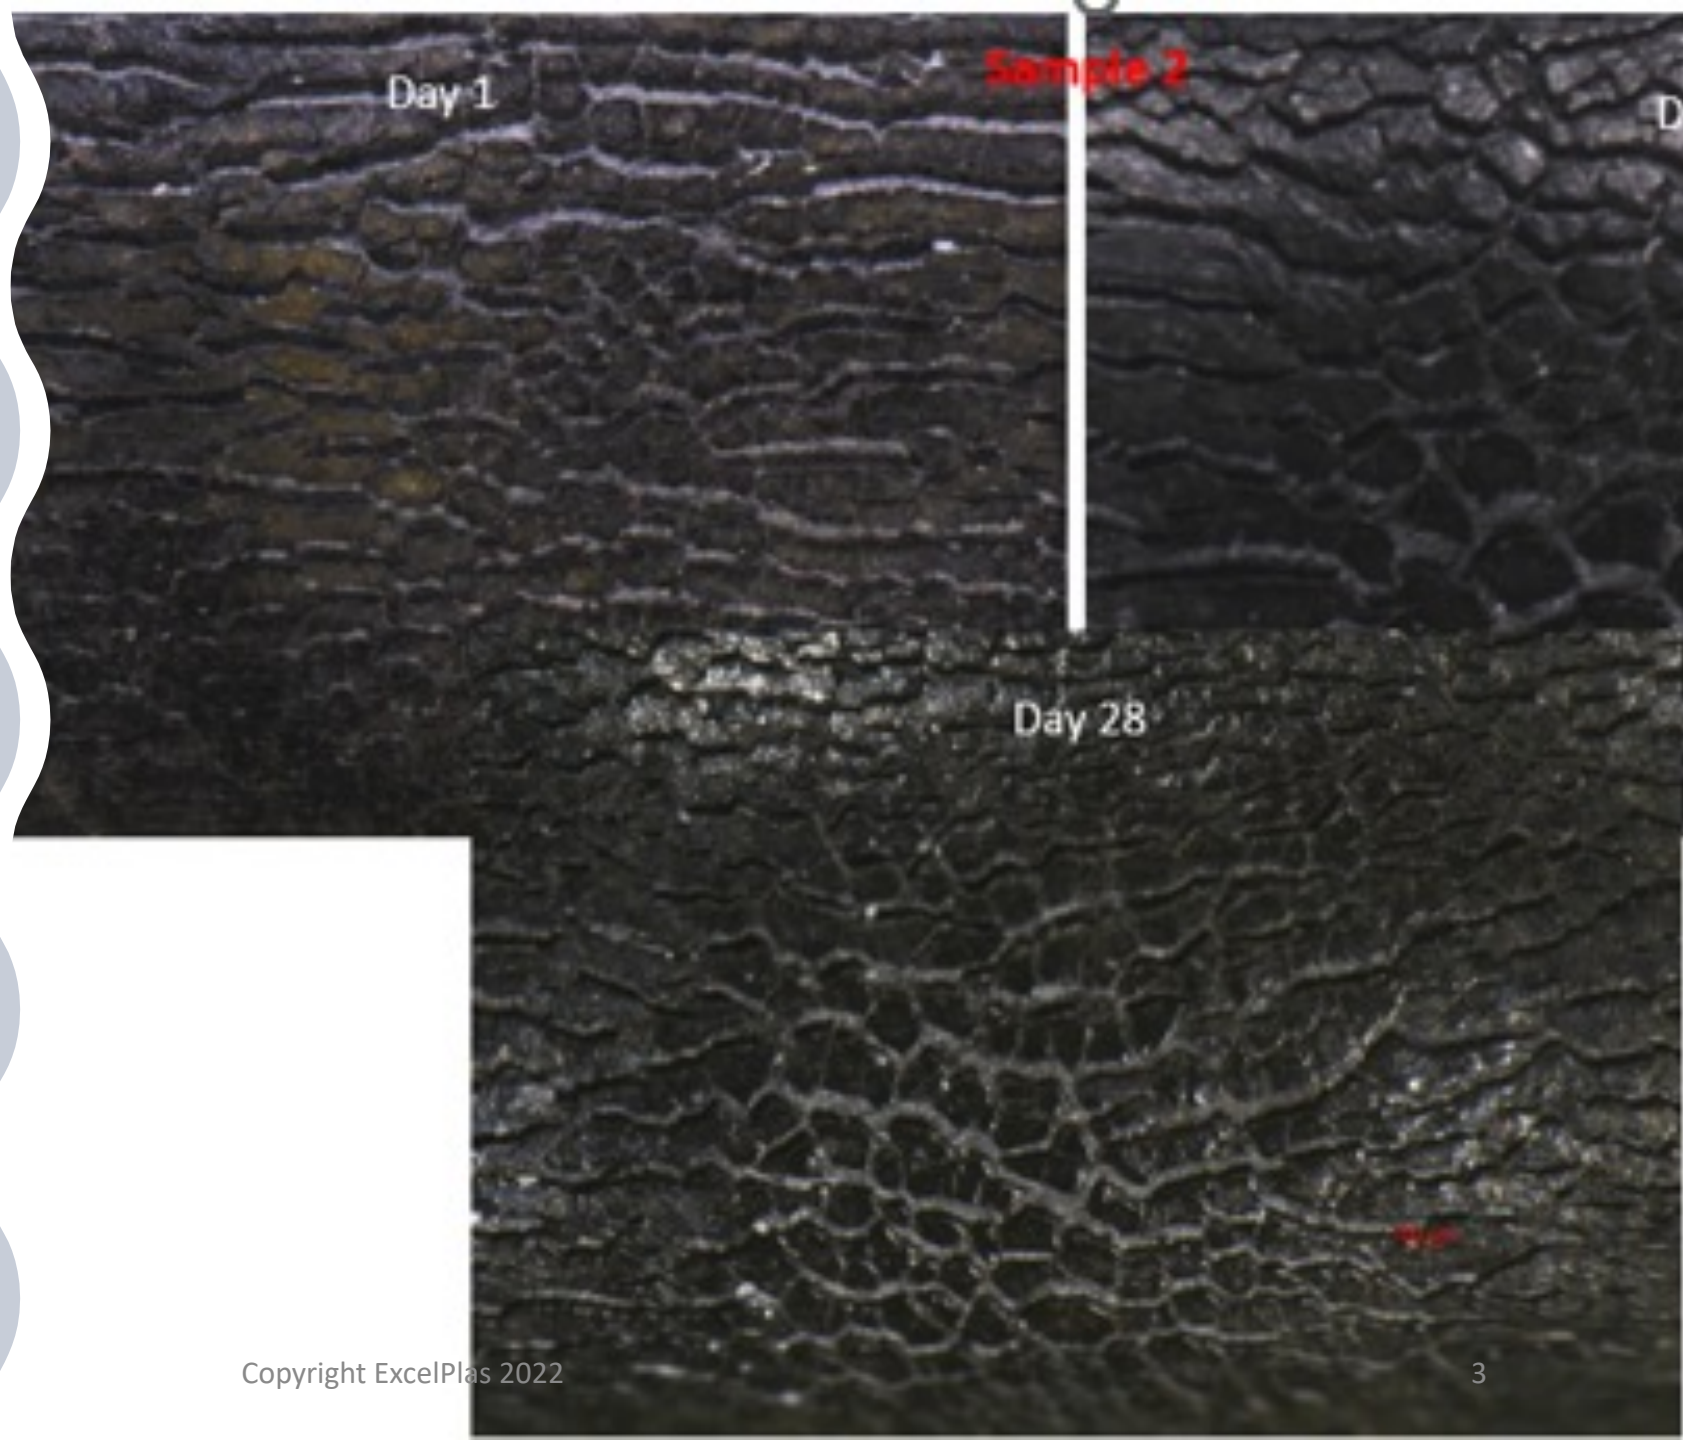
Chlorine Oxidation of PE Liners

Mitigation: ensure high levels of
protective stabilizers against
chlorine oxidation

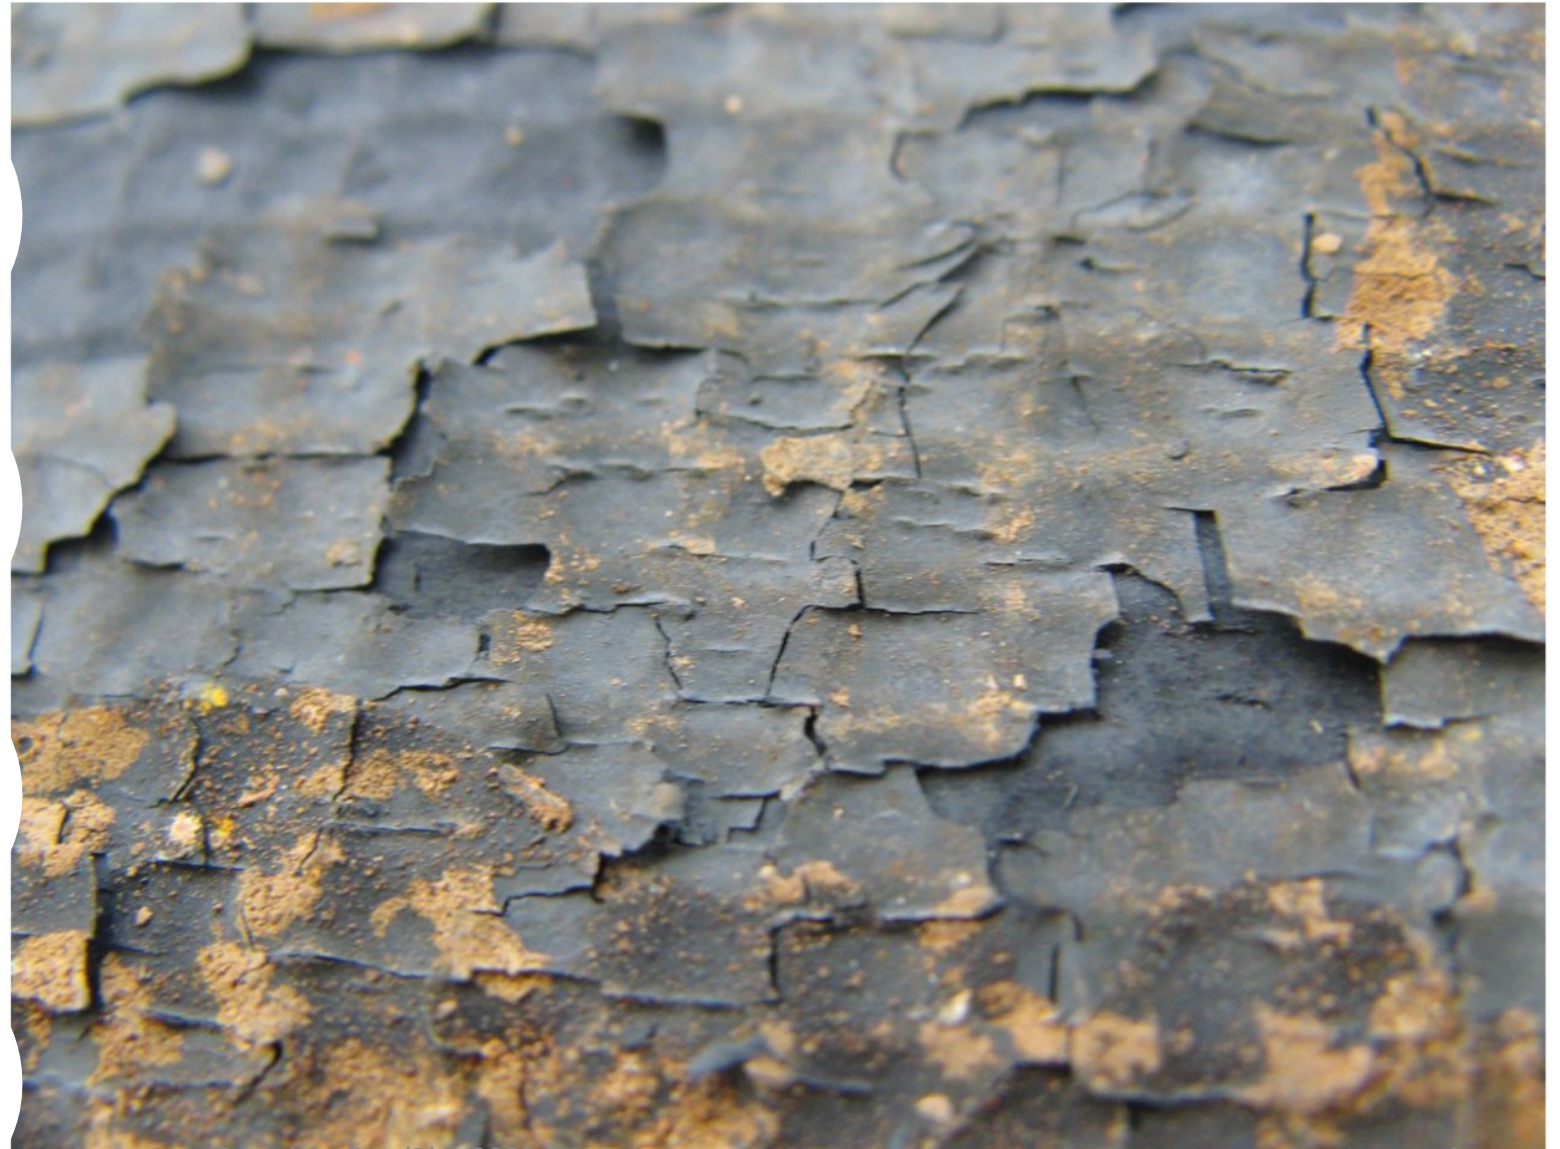
Chloramine Attack on fPP

Chloramine
Exposure
of
Polypropylene
Liners (tea-leaf
delamination)

Mitigation: do not use fPP or
RPP for chloramine applications

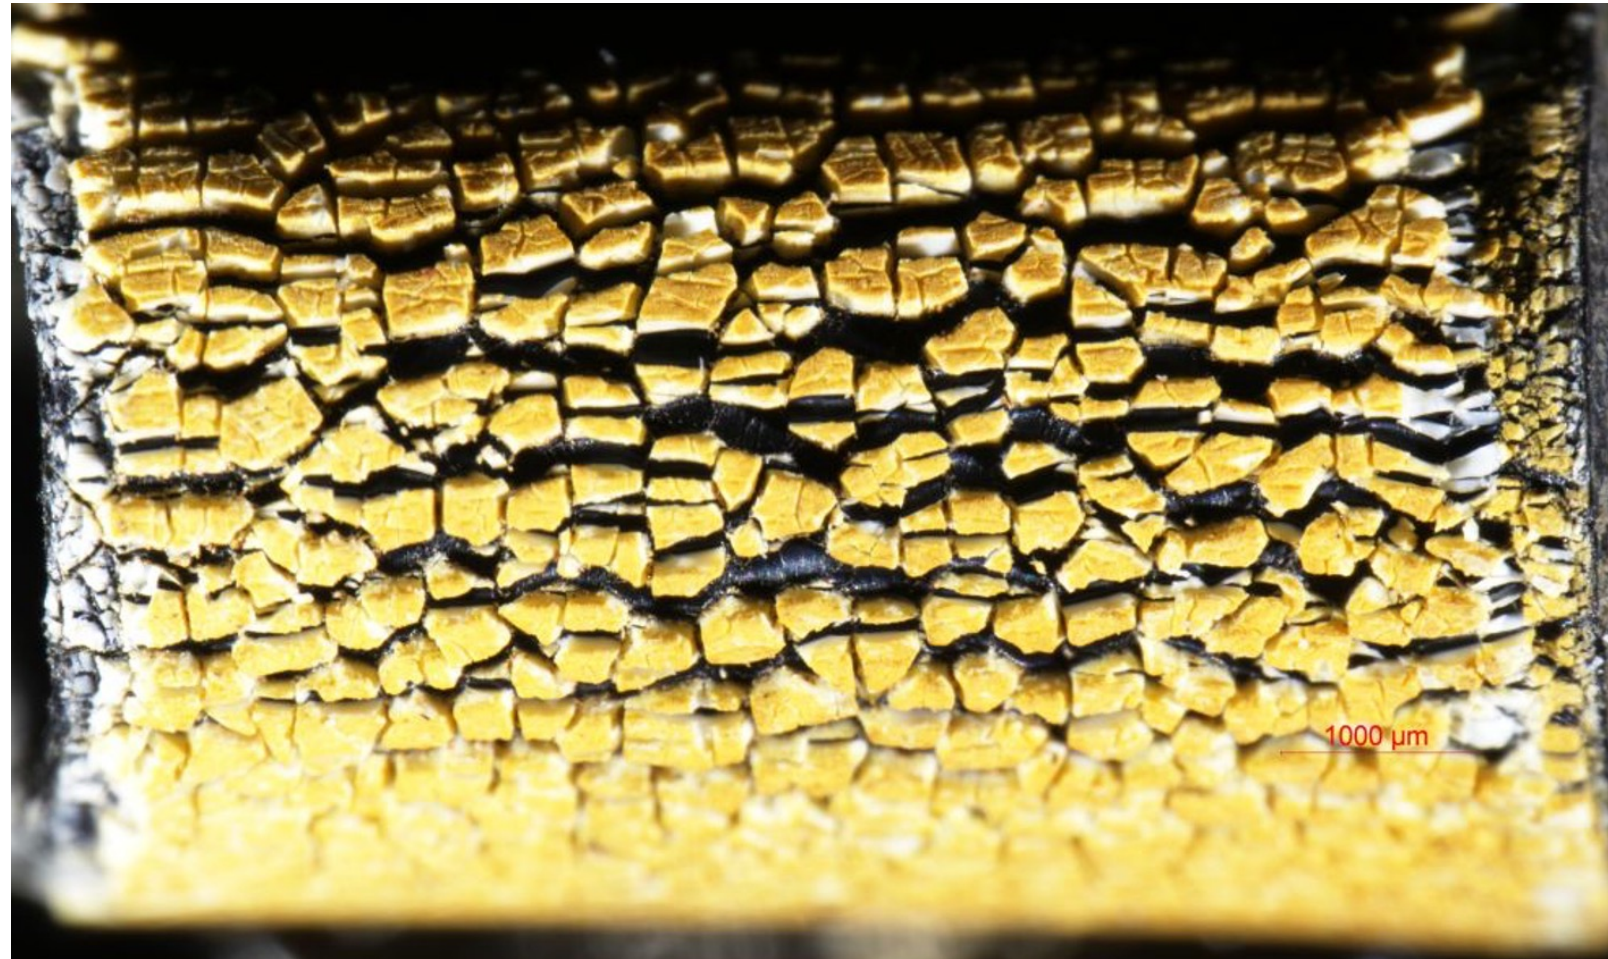
UV Exposure of White HDPE Liners

Mitigation: ensure white layer of HDPE geomembrane is properly stabilized and contains metal deactivator additives

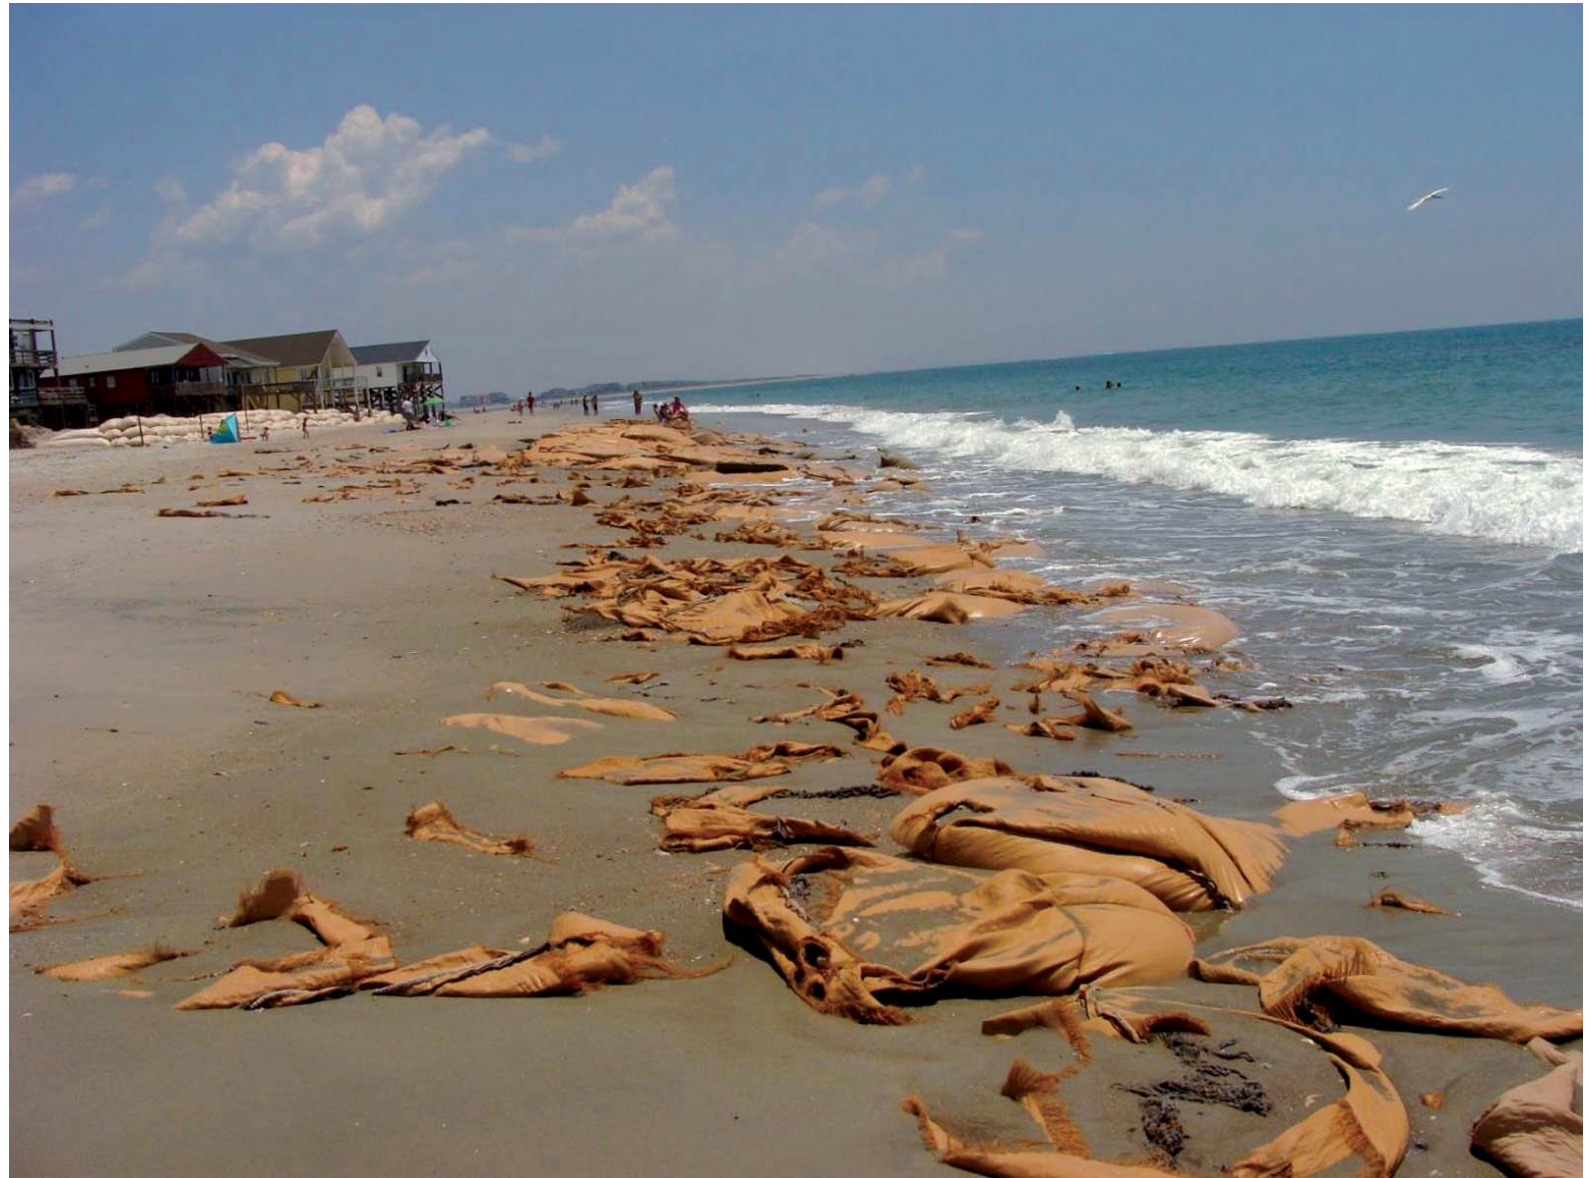
Abrasion of Geotextiles in the Marine Environment

Mitigation: ensure use of high-quality Geotextile Sand Containers (GSC) such as Elcorock™/GeoRock™.

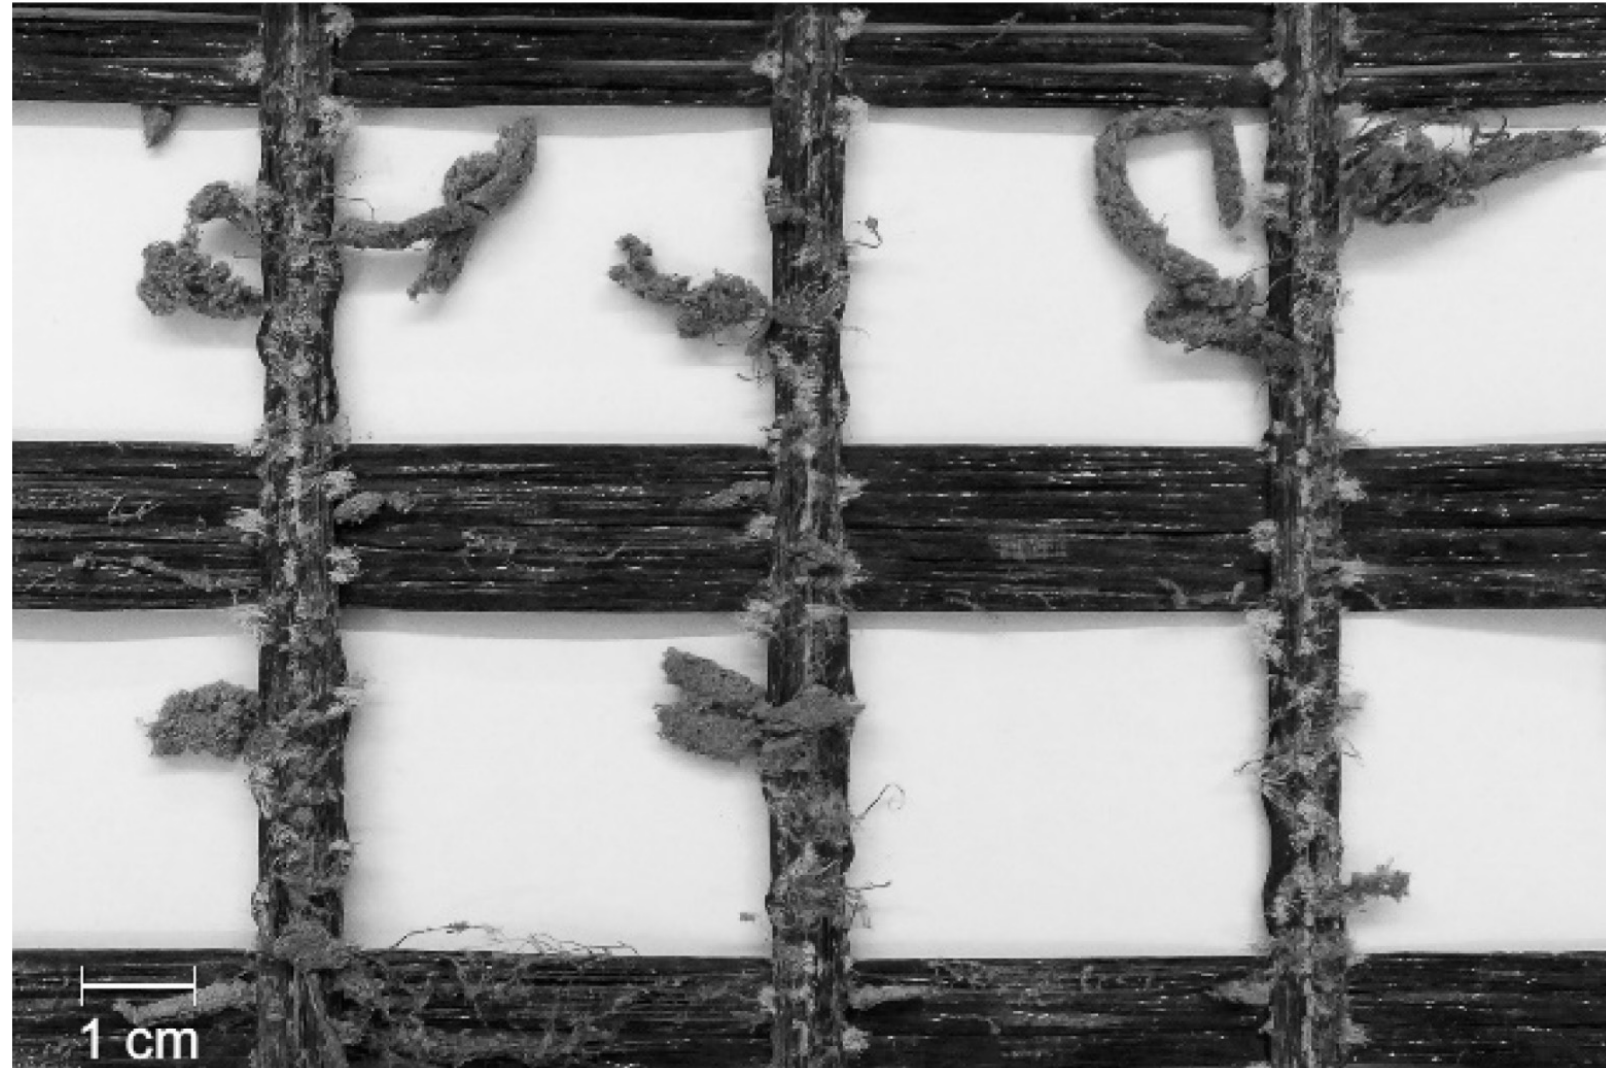
Fretting of Geogrids

Mitigation: ensure design prevent excessive fretting and rubbing.

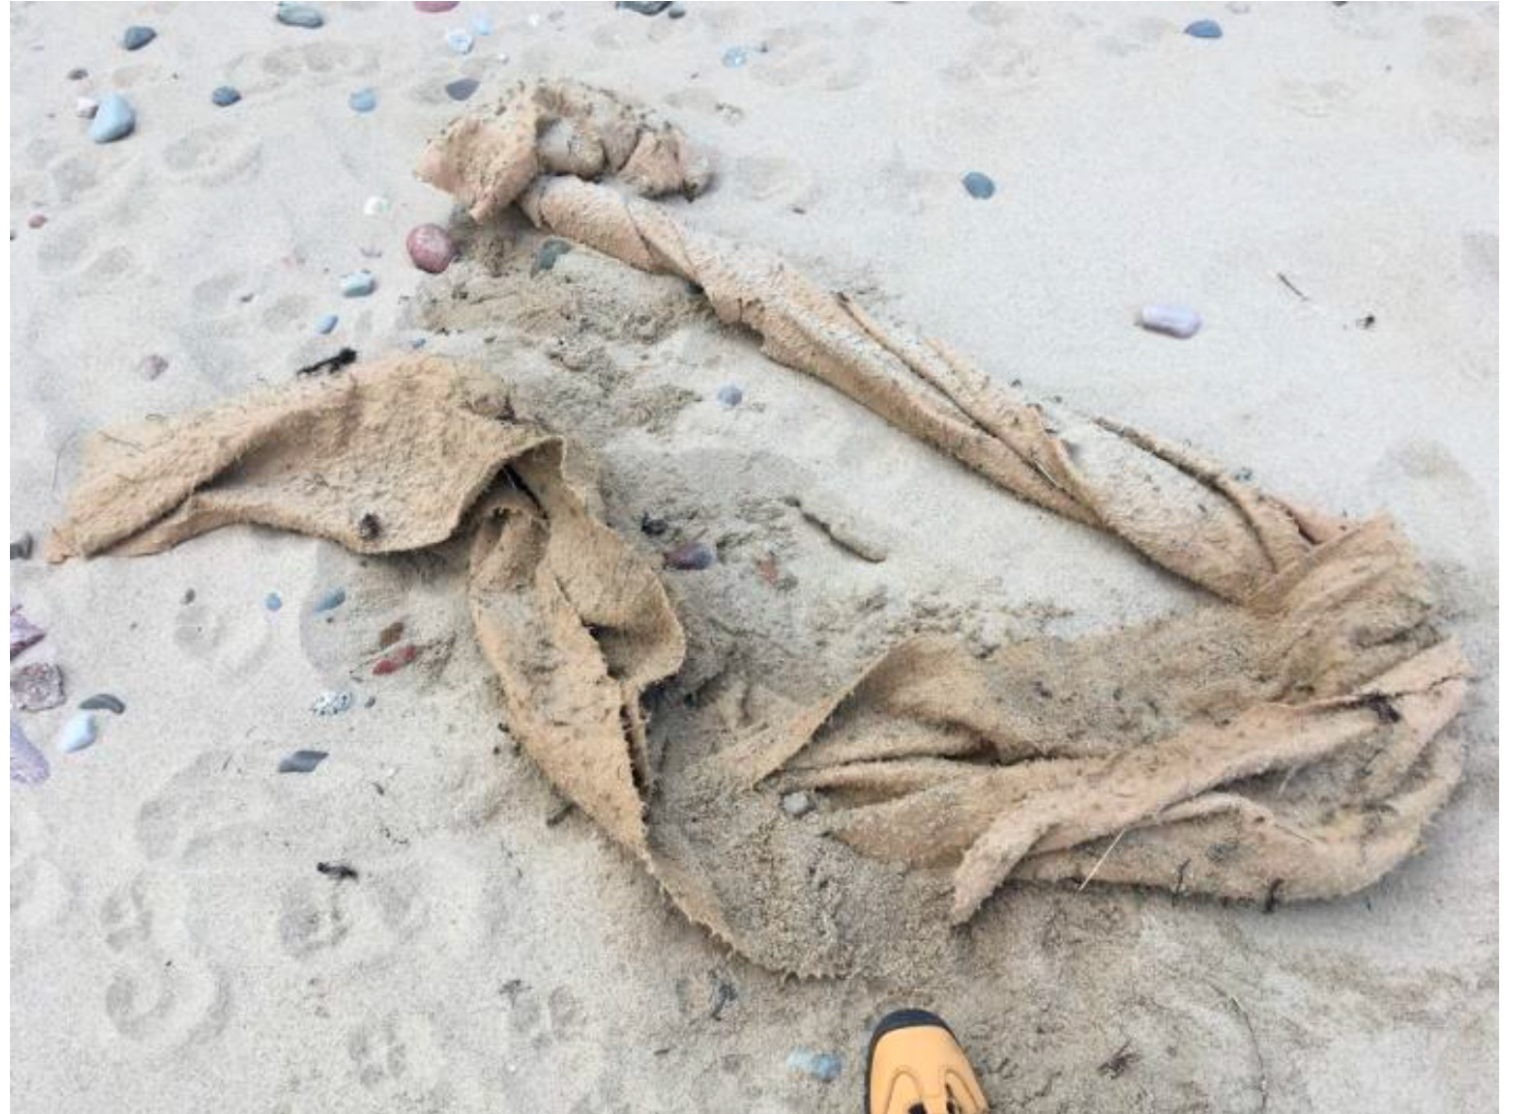
Shearing and Puncturing of Geotextiles by Sediment Grains

Mitigation: ensure design prevents excessive shearing and puncturing.

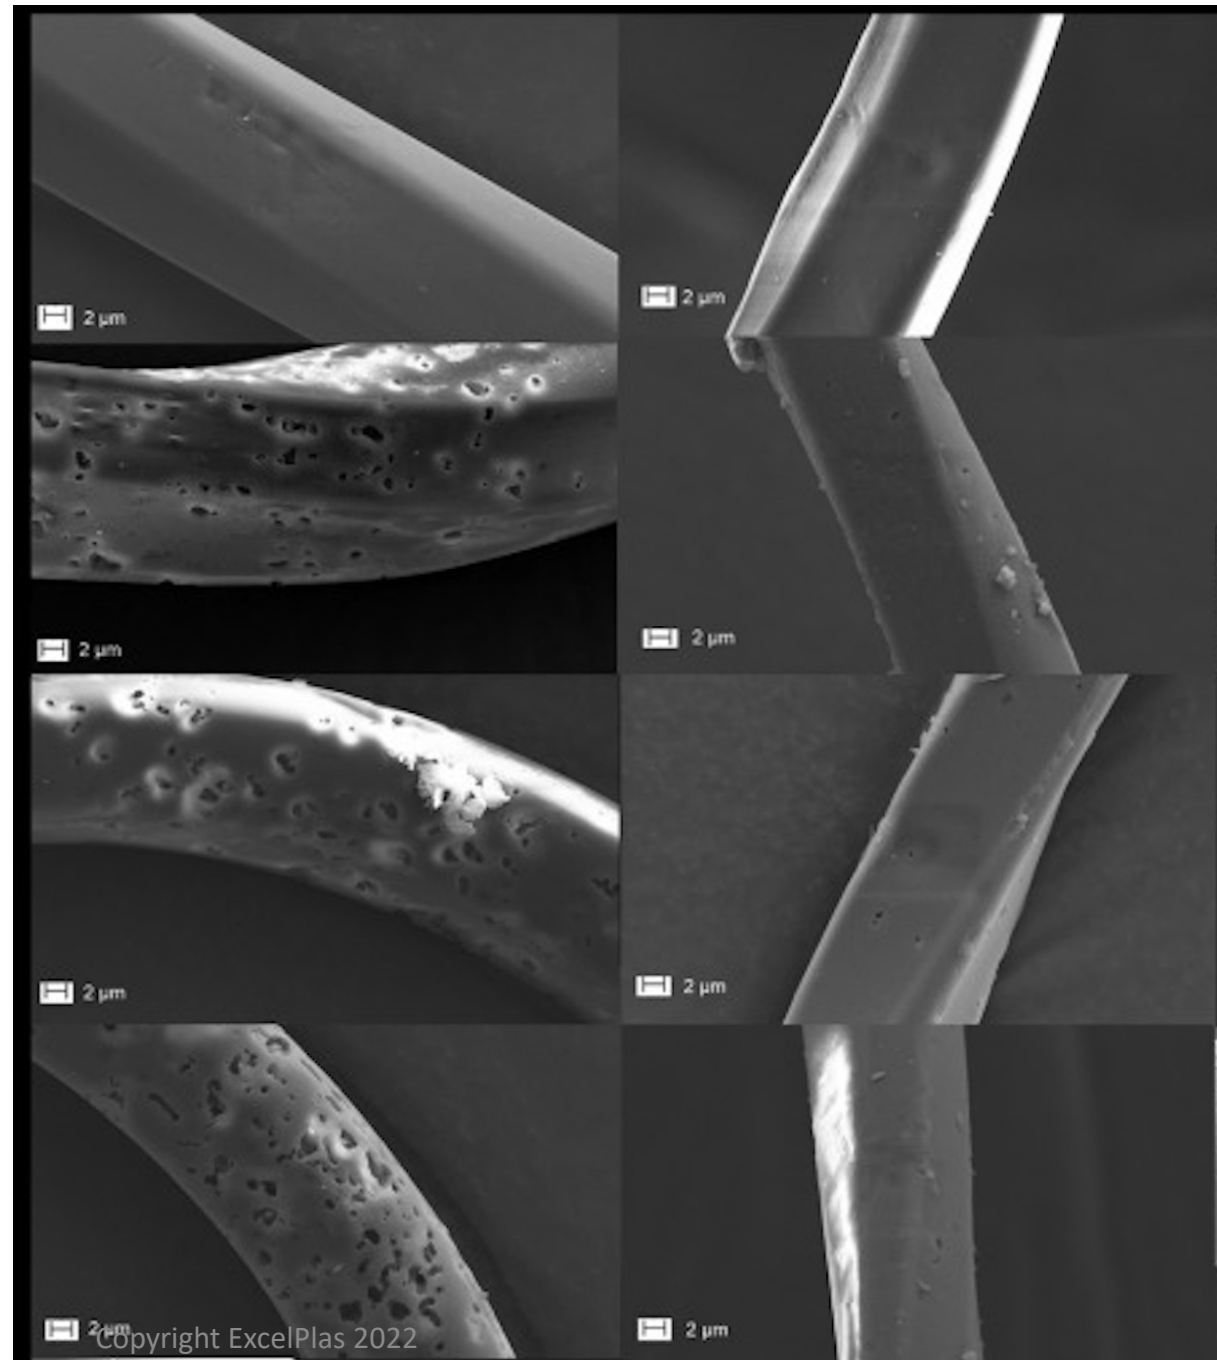
Alkaline Hydrolysis of Polyester Geotextiles

Mitigation: ensure low
carboxylic acid numbers and
avoid high pH contact

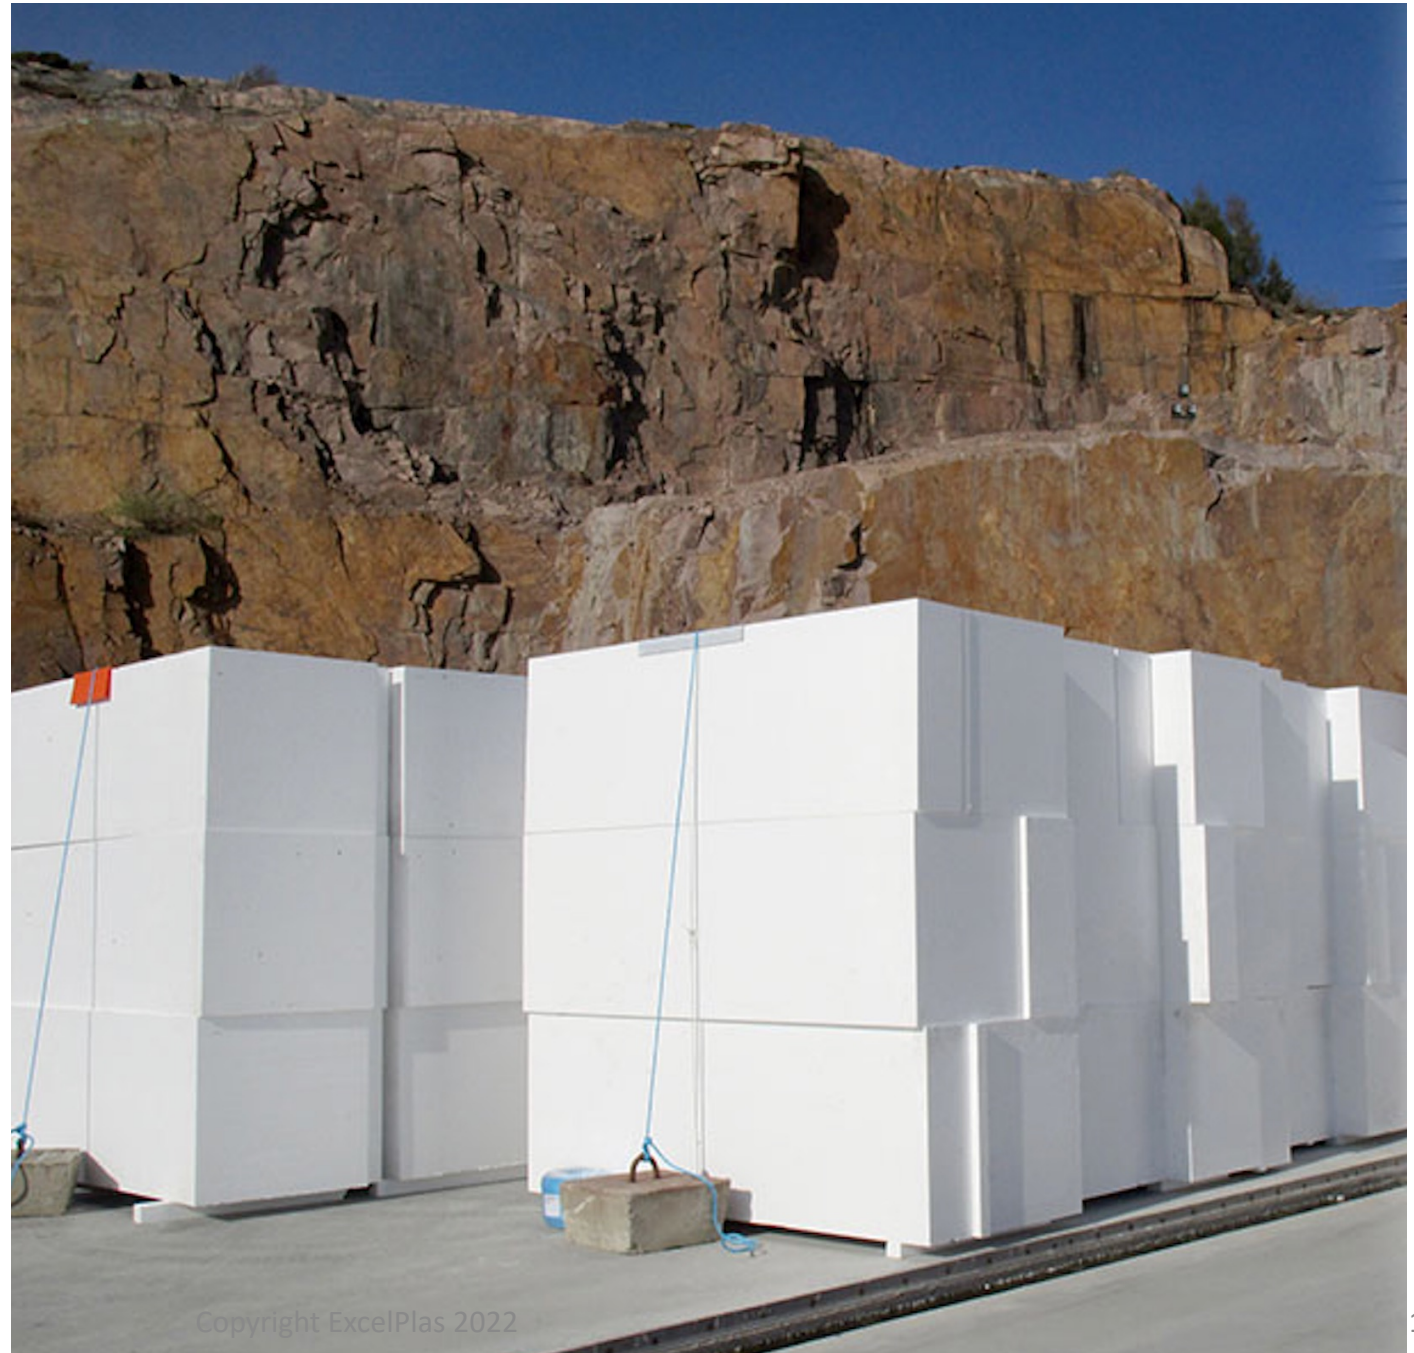
Attrition and Comminution of EPS Geofoam and Dissolution by Fugitive Fuels

Mitigation: wrap geofoam with
protective liner

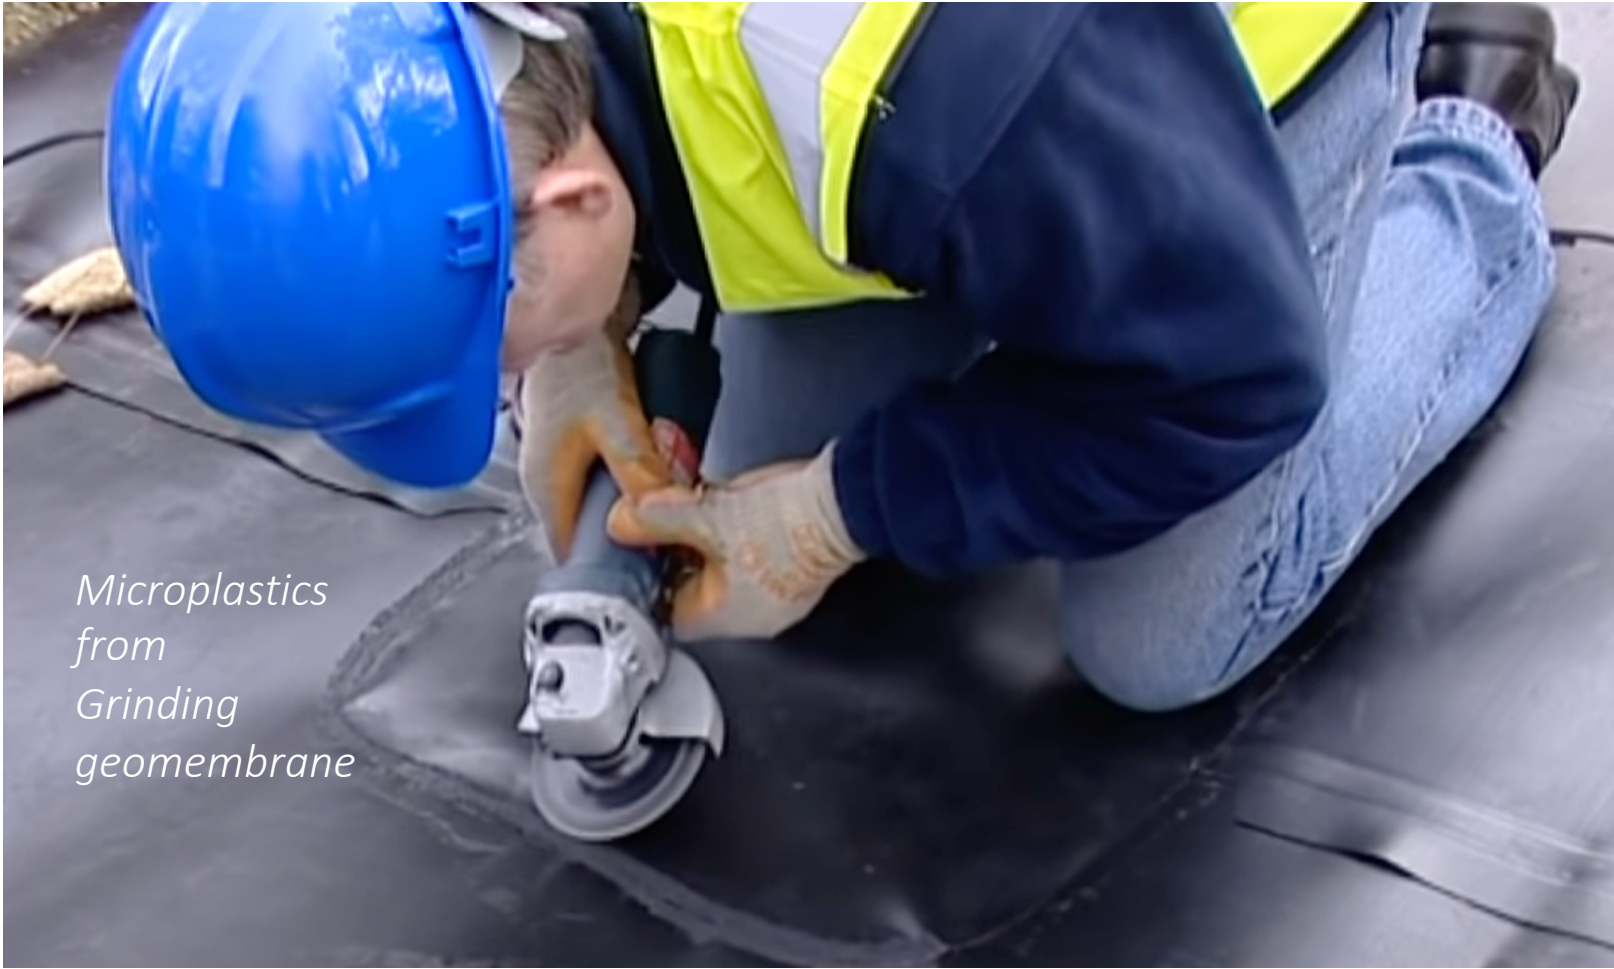
Disc Grinding of Geomembrane Prior to Extrusion Welding

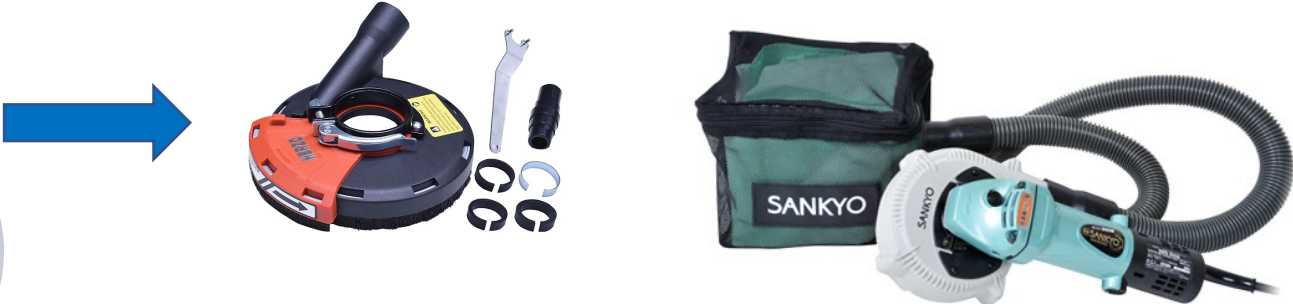
Mitigation: Geomembrane installers need to use suction shrouds to capture grinding dust
