# Installation damage of geosynthetics and consequences for the design

Margarida Fernandes de Pinho Lopes

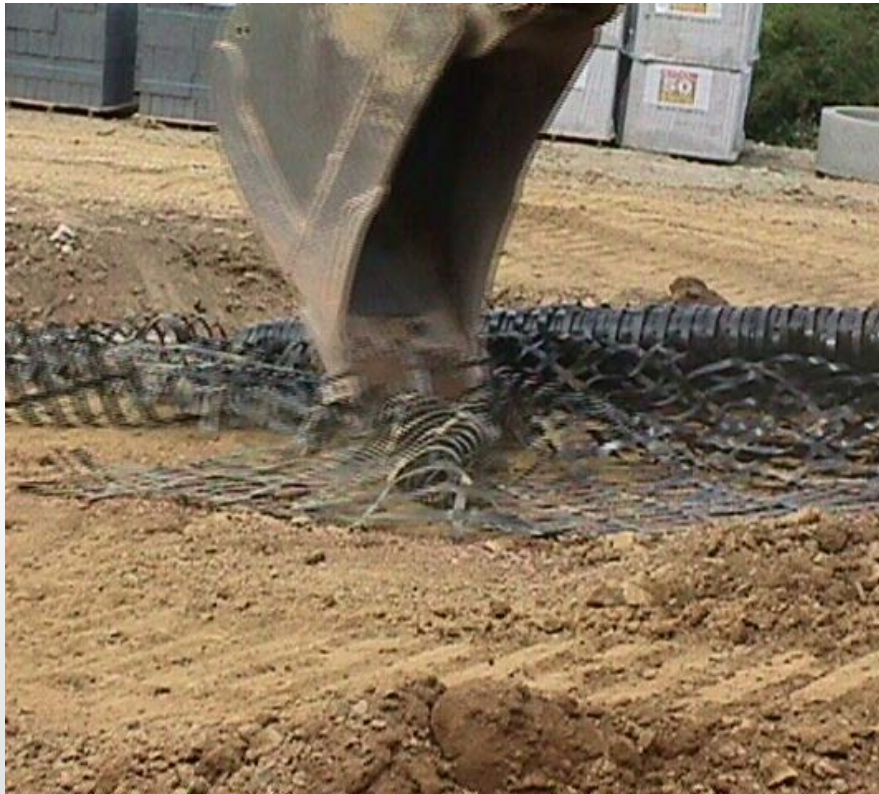
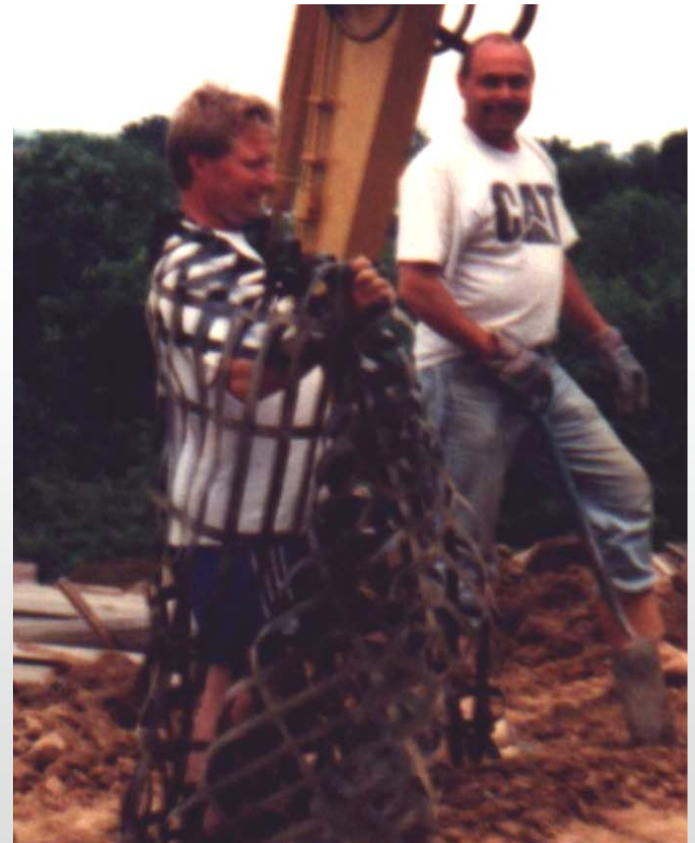
# Handling and placing the geosynthetics

- Handling and placing the geosynthetics
- Placing and compacting fill materials

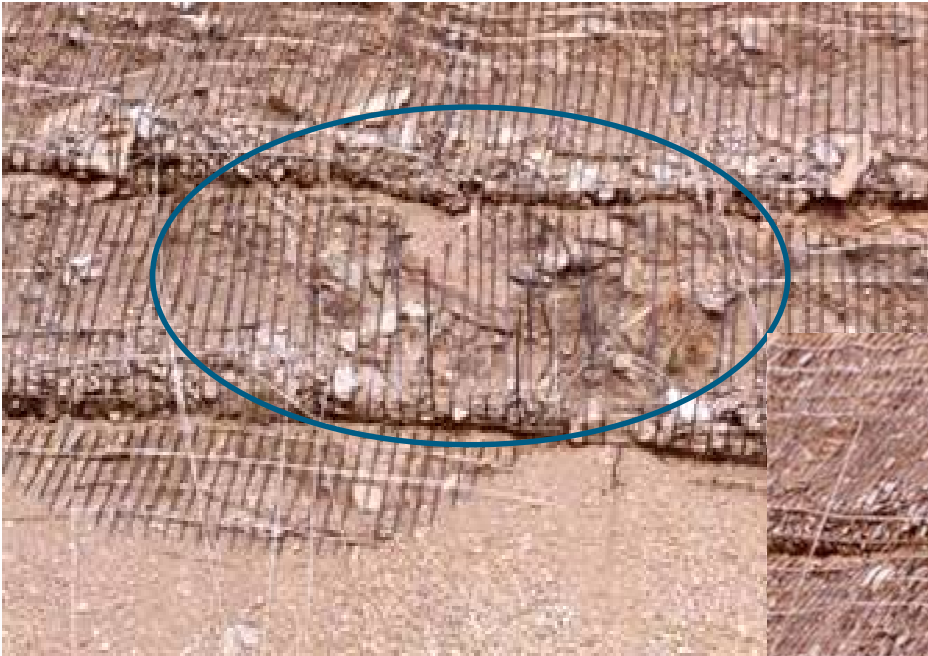
Local defects

- Abrasion
- Puncturing
- Fibre cutting
- Thickness reduction
- Cuts and holes
- Total disintegration

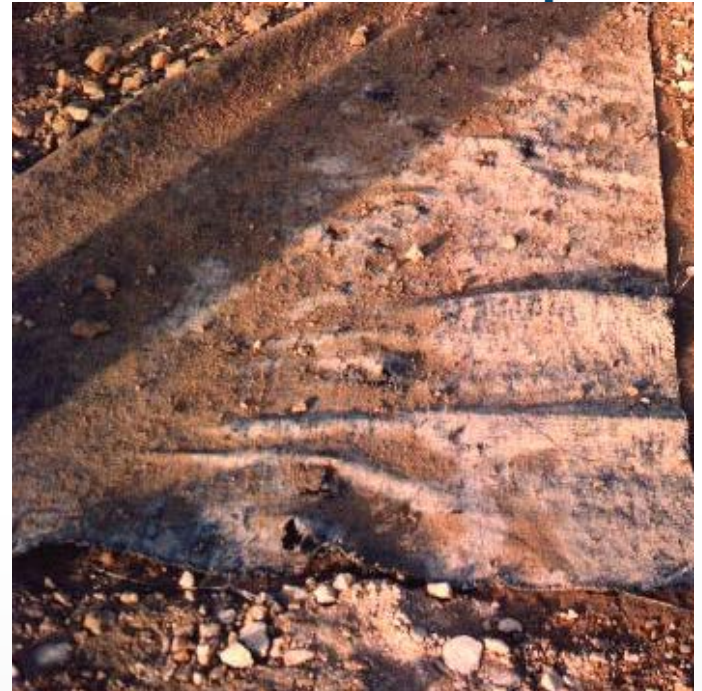
# Visual inspections

- Typical observations
  - Accumulation of dust and dirt
  - Local defects
- Classifications
  - Number and size of openings
  - Very subjective / operator dependent

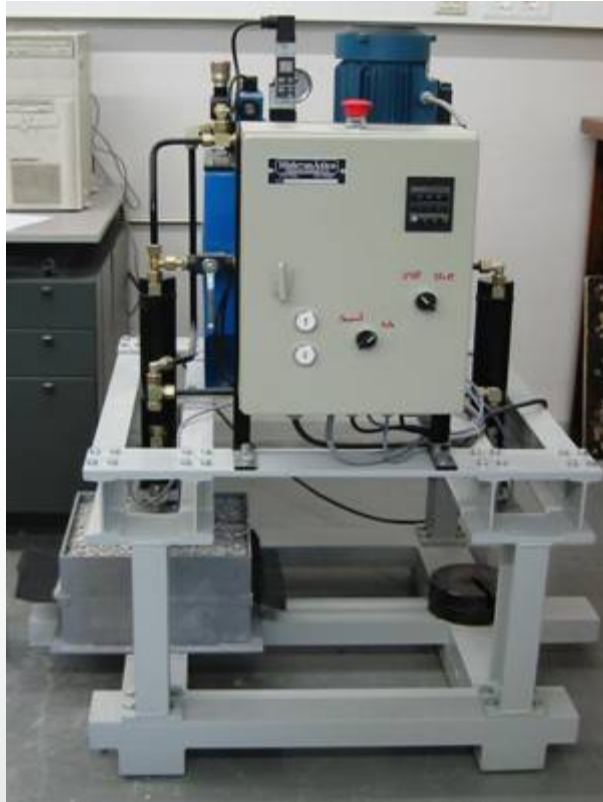
# Laboratory simulations

Container:

- 300 x 300 mm<sup>2</sup>
- 150 mm high

Aggregate:

- Sintered aluminium oxide
- 5 mm to 10 mm

ENV ISO 10722-1:1998

Stress range: 5 – 900 kPa

EN ISO 10722:2007

Stress range: 5 – 500 kPa

Cyclic loading:  
Frequency of 1 Hz; 200 loading cycles
