Pilot Project and Field Study: Data and Quality-Based Geomembrane Field Seaming Evaluation for CCR Projects

Evan Andrews, P.E.¹; and Kenneth R. Daly, P.E.²

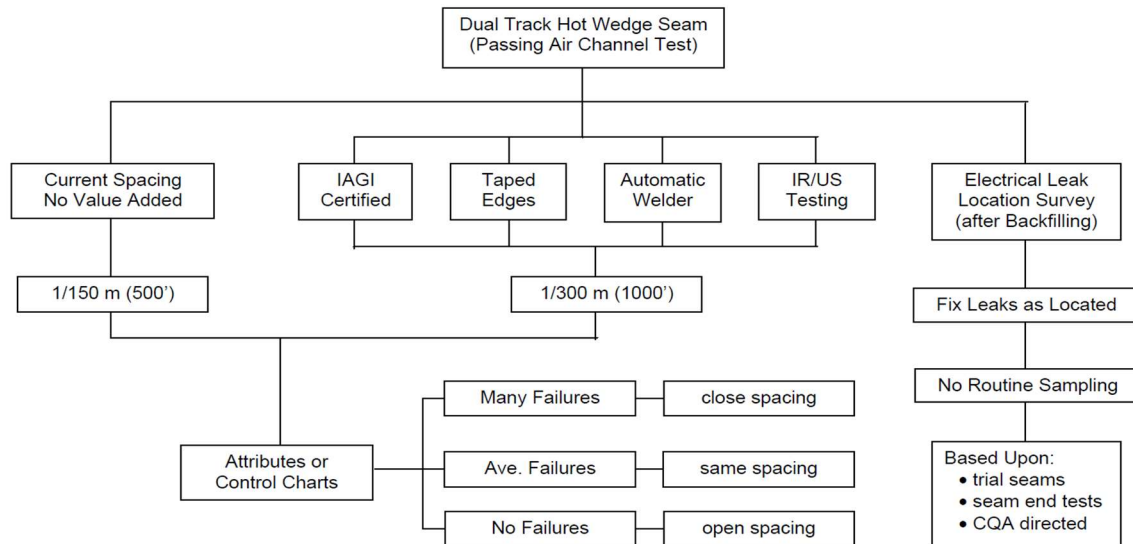
Figure 1: Suggested Strategy for Destructive Test Sampling (from *GRI White Paper #3* by Koerner & Koerner, 2003).

GRI has attempted several times to question why, with better products, manufacturing technology, installation methods, and equipment that we appear to be stuck with this prescribed destructive sampling and testing standard that replaces a superior double-track fusion weld with an inferior extrusion welded patch. GRI White Paper #3 published in 2003 documents the industry advancements since 1987 and advocates for a minimum frequency of one destructive test per 1,000 ft (305 m) of seam and then adjusting the frequency using a table of attributes or control charts (GM 14 and GM 20, respectively, were developed specifically to address these methods) to open the testing frequency for good performance and close the testing frequency for poor performance. They argued that by including new (for 2003) methods such as requiring certified welding technicians, taped geomembrane edges to limit seam contamination, automated welders and infrared or ultrasonic testing, then the control chart could be used, as illustrated in Figure 1. However, they also infer that by adding ELL surveying, no routine destructive sampling should be needed (Koerner & Koerner, 2003).

The authors of this paper had the opportunity to put GRI White Paper #3 into practice and aim for destructive testing only as the data indicates a need (very similar to the 1980s concept of CQA testing through judgement) by requiring certified welding technicians, taped geomembrane

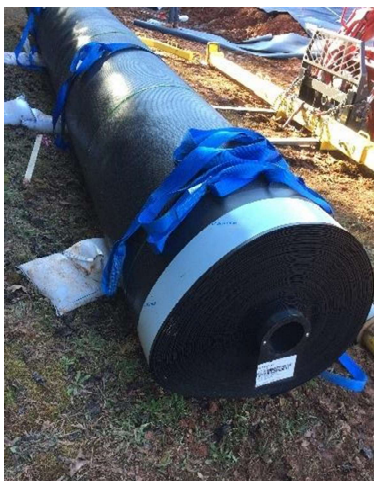
Figure 2: Geomembrane with taped edge.

1. Requiring International Association of Geomembrane Installers (IAGI) certifications for welding technicians and installation companies;
2. Requiring taped geomembrane edges to limit seam contamination;

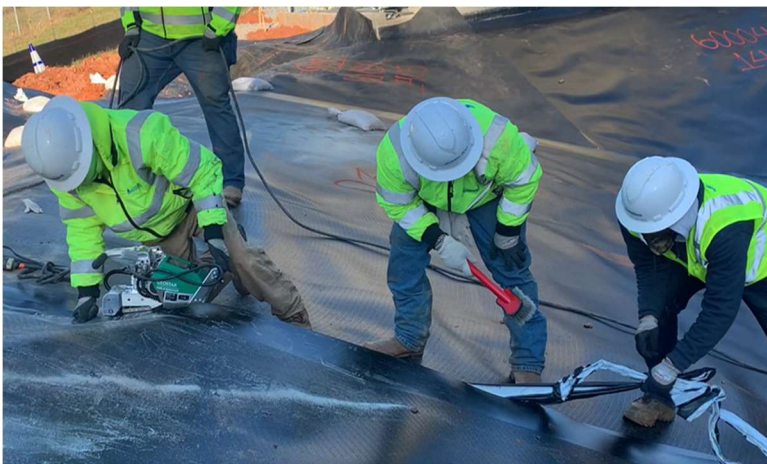
Figure 3: Geomembrane seaming in progress – tape removal (right) ahead of seaming (left).

The owner contracted Sequoia Services, LLC (Sequoia), of Greensboro, North Carolina as the general contractor. Sequoia subcontracted CCS of Statesville, North Carolina to install geosynthetics. The liner system was installed over the course of one week in early December 2020 and consisted of approximately 0.2 acres (0.08 hectare) of secondary geomembrane overlain by 0.2 acres (0.08 hectare) of primary geomembrane. Agru America produced the 60 mil (1.5 mm) double-sided textured HDPE geomembrane with smooth edges for seaming. The geomembrane was fabricated with a 6 inch (15.2 cm) wide film (tape) adhered to the geomembrane smooth edge as shown in Figure 2. Tape was applied on the top edge of one side of the roll alternating to the bottom edge on the opposite side of the roll so that top and bottom edges matched up when the geomembrane was deployed. Welding technicians removed the tape immediately ahead of the welding machine thereby exposing fresh and clean geomembrane surfaces for seaming as shown in Figure 3.

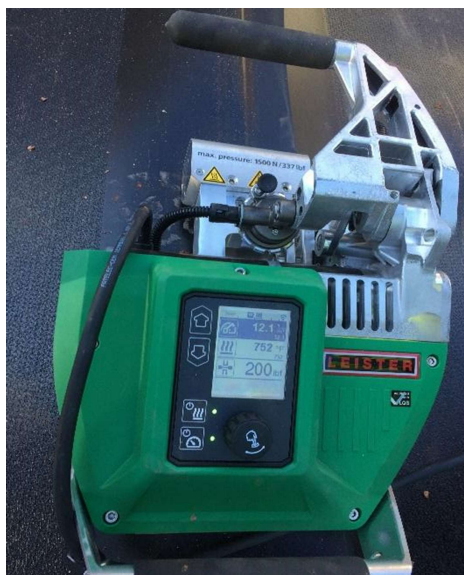
Figure 4: Data Acquisition Welding machine with visual display showing speed, temperature, and pressure.

CCS seamed approximately 520 lineal ft (158 m) of double-track fusion seam on the primary geomembrane and approximately 550 lineal ft (168 m) on the secondary geomembrane. The welding machine with its visual display is shown in Figure 4. In addition to the machine display, the geosynthetic installer CQC personnel monitored seaming using a tablet PC (connected to the welding machine by Wi-Fi) as shown in Figure 5.

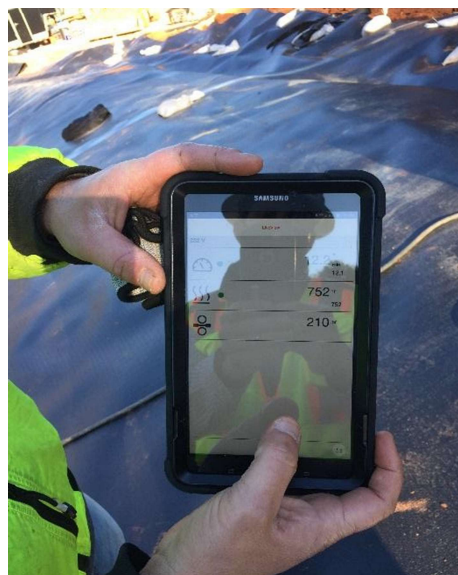
Figure 5: Tablet PC connected to the Data Acquisition Welding machine displaying seaming parameters.

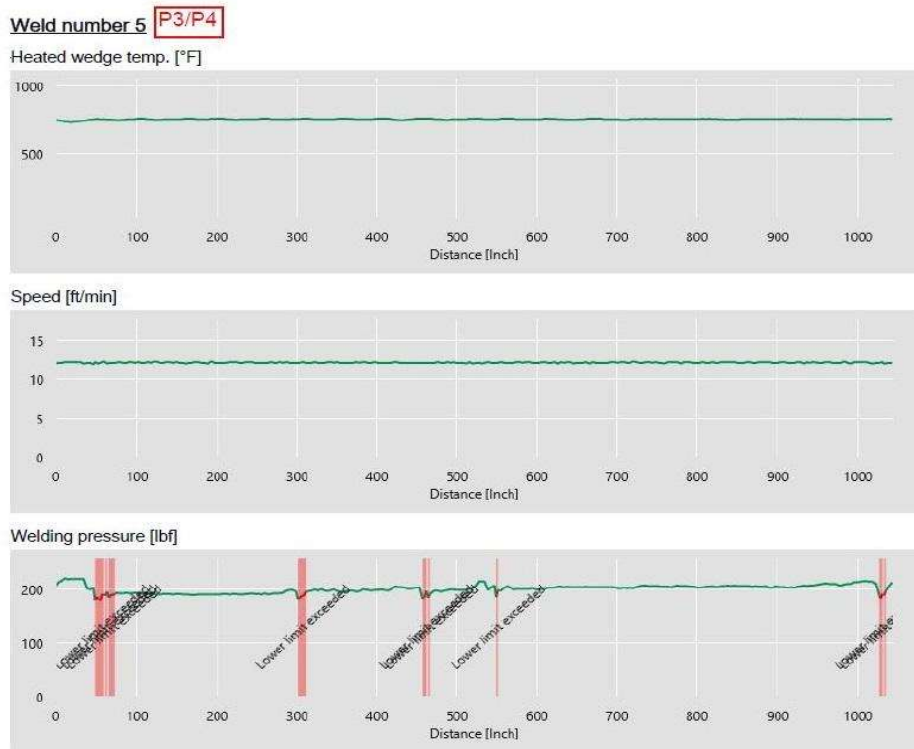
Figure 8: Data Acquisition Welding Report – Graphical Report showing the temperature, speed, and pressure plotted versus the data measurement position (distance).

- Graphical Report: One page showing the temperature, speed, and pressure plotted versus the data measurement position (distance) and color coded to visually identify out of tolerance seaming parameters (Figure 8).
