CC CC8™ and CC13™ Bulk & Batched Rolls

G Glenridding, Ullswater, Cumbria

i Re-lining of an existing channel on top of a tailings dam, using Type II & Type III GCCMs to prevent severe flooding & storm damage.

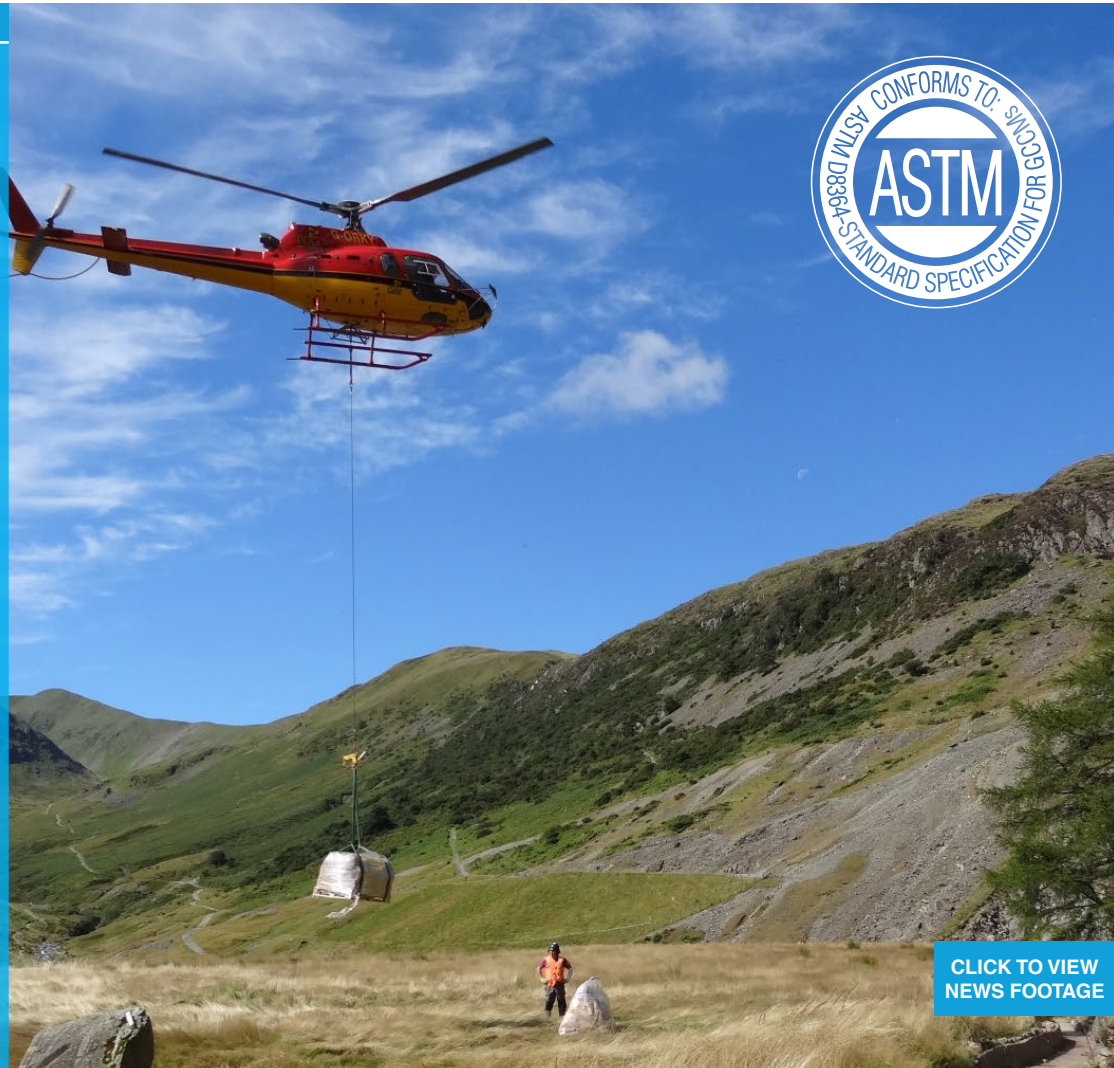
Batch & Bulk Rolls of Type I & Type II Concrete Canvas® being delivered via a commercial helicopter

The mine site is on a steep hillside 2 miles up a remote track, presenting a number of logistical issues in regards to delivery. With no possibility of off-loading on site, the project manager organised delivery of palletised material by HIAB wagon to a point 500m away, with pallets then being flown into position by commercial helicopter. The rolls of CC8™ were batched to specific lengths to accommodate the different profile the channel takes along its 200 metre length. Concrete Canvas Ltd ensured that the hand-portable batch rolls were all labelled correctly and palletised to the customers' requirements into loads that each weighed less than 950kg, allowing them to be subsequently lifted and accurately positioned by helicopter. Getting the logistics correct was key to enabling a rapid delivery and the success of the project. With no wheeled or tracked machinery able to access the site, correctly positioning the pallets by helicopter meant the volunteer Army workforce was then able to focus on the installation of CC in the channel rather than waste time moving materials by hand.

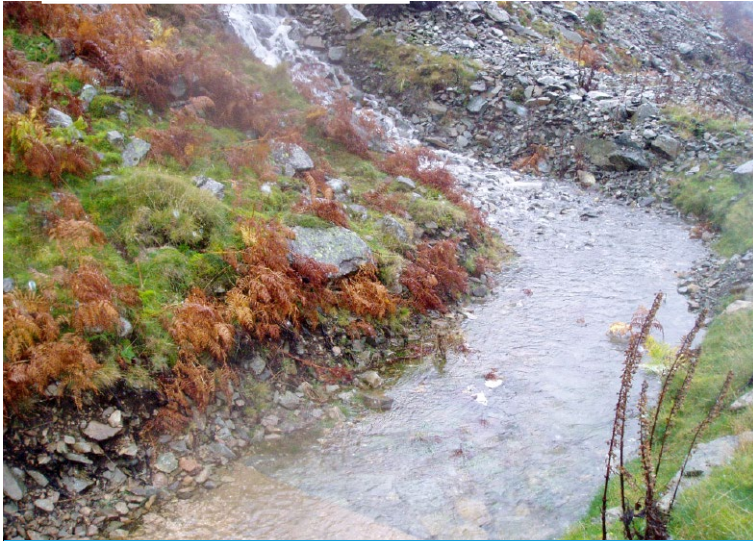
The channel prior to remediation

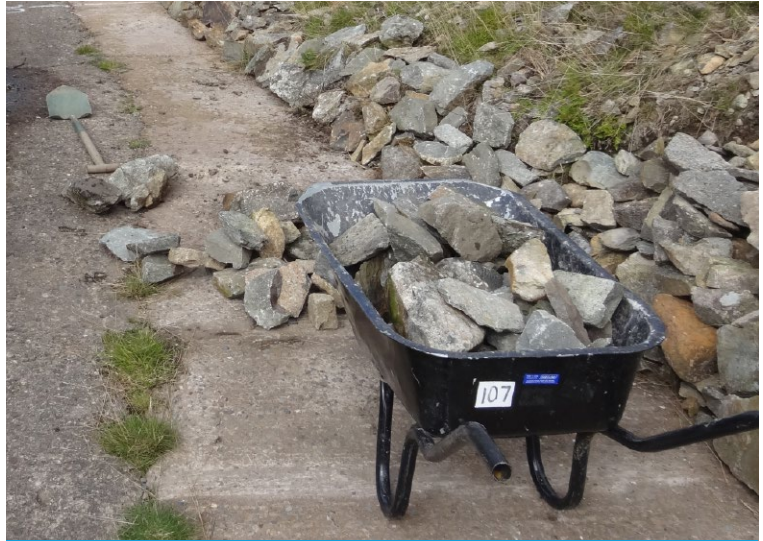
Large stones and debris were cleared to be re-used after CC installation

Removal of some of the dry stone walls and overburden on one side of the channel took place prior to installation. The CC was trimmed using knives, and anchored to the ground using steel pegs and heavy rocks. The overlaps were jointed using stainless steel screws at 20cm centres. An army issue portable temporary 10,000 litre reservoir was used for hydration. In total, 837m² of CC8™ & 128m² of CC13™ was installed for this project.

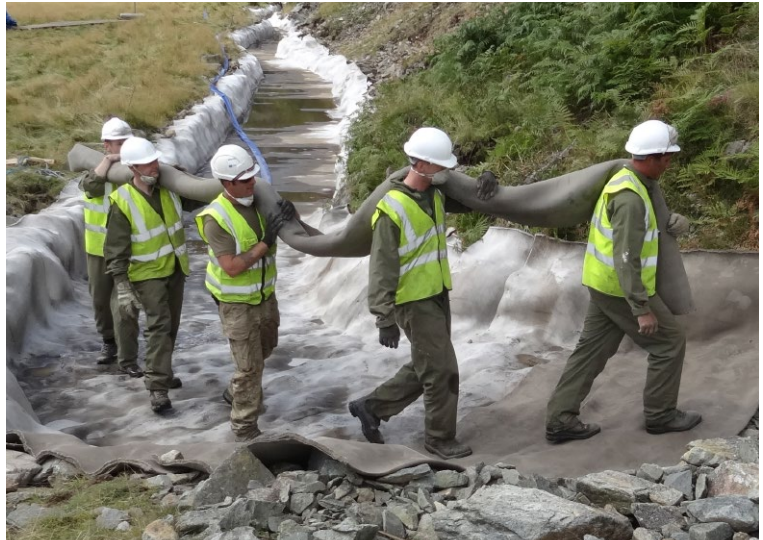
The site was extremely difficult to access, all work was carried out by hand

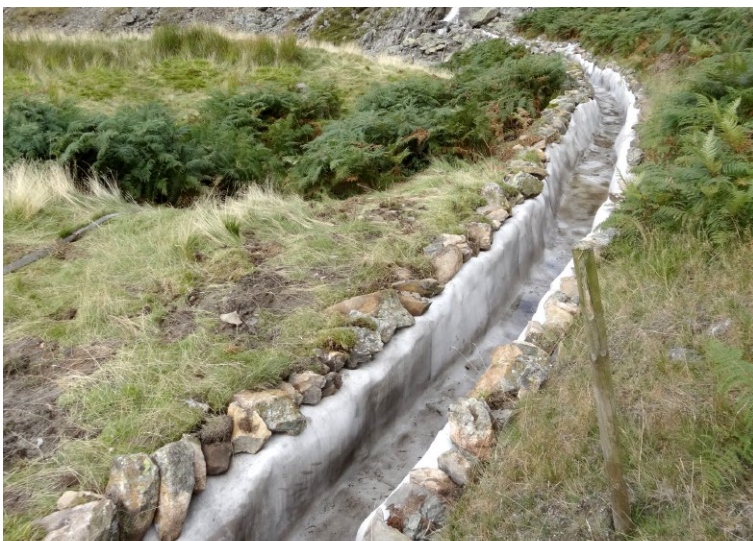
The completed lined channel at Glenridding, Ullswater

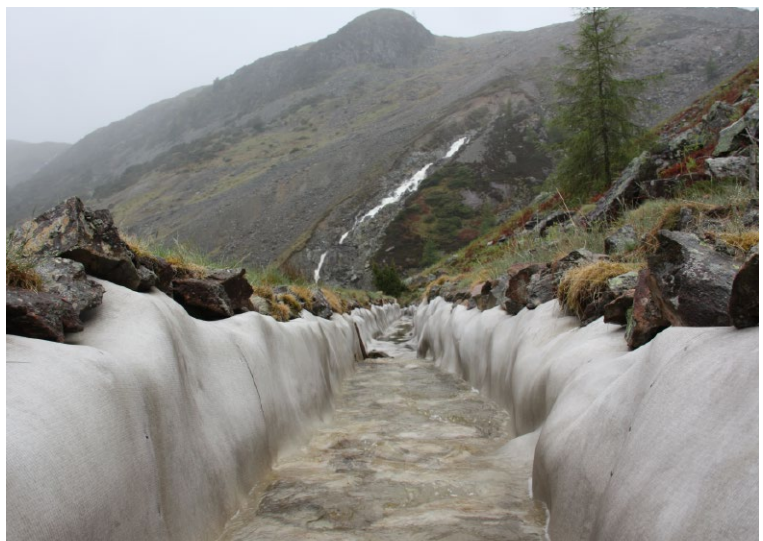
Two years later - May 2017 - the channel at Glenridding

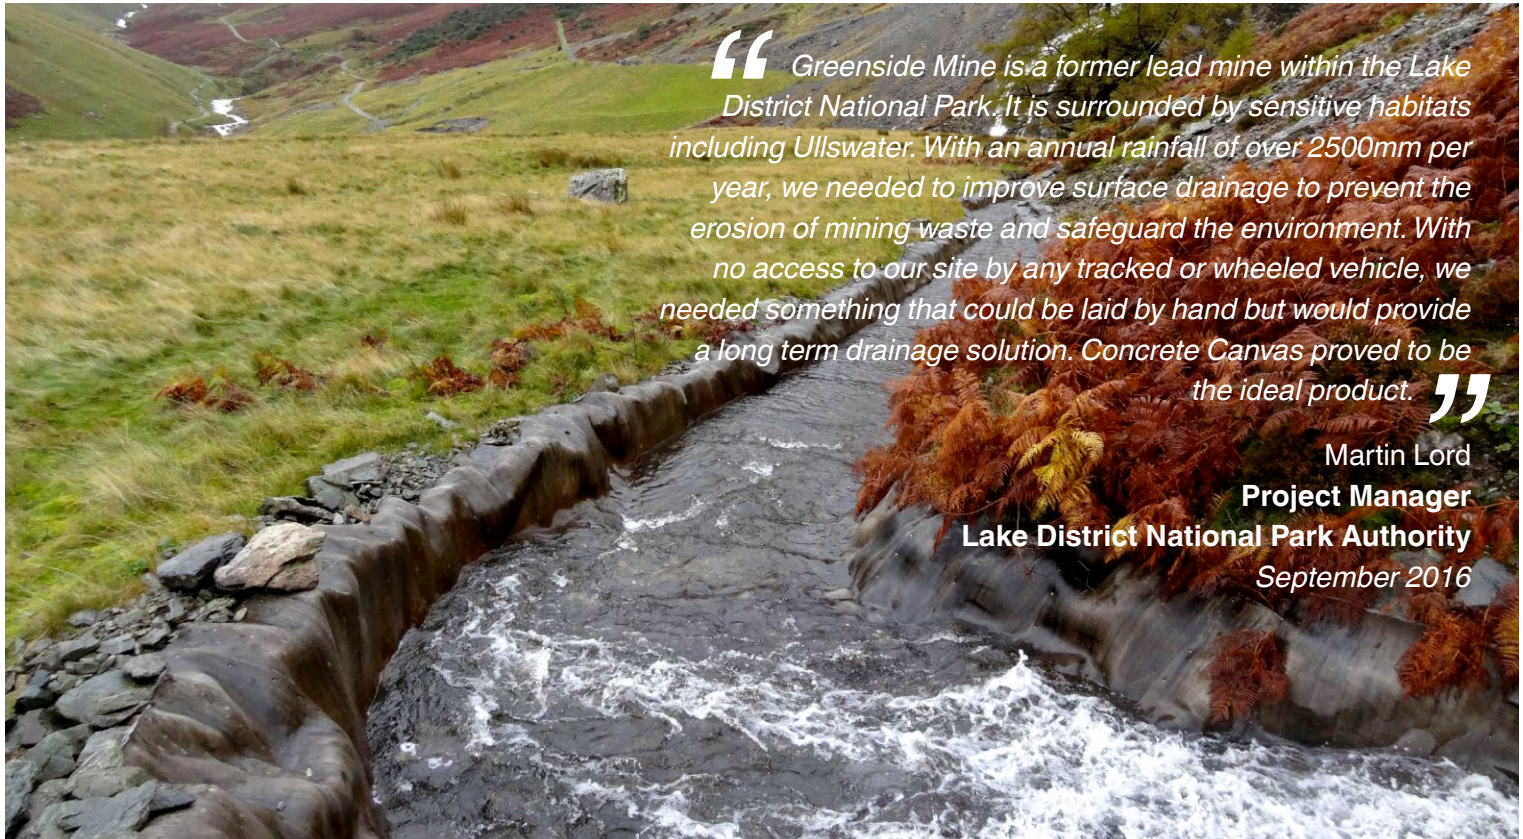
The installation five years later - October 2021 - CC is BBA certified with durability in excess of 120 years when used in erosion control applications.

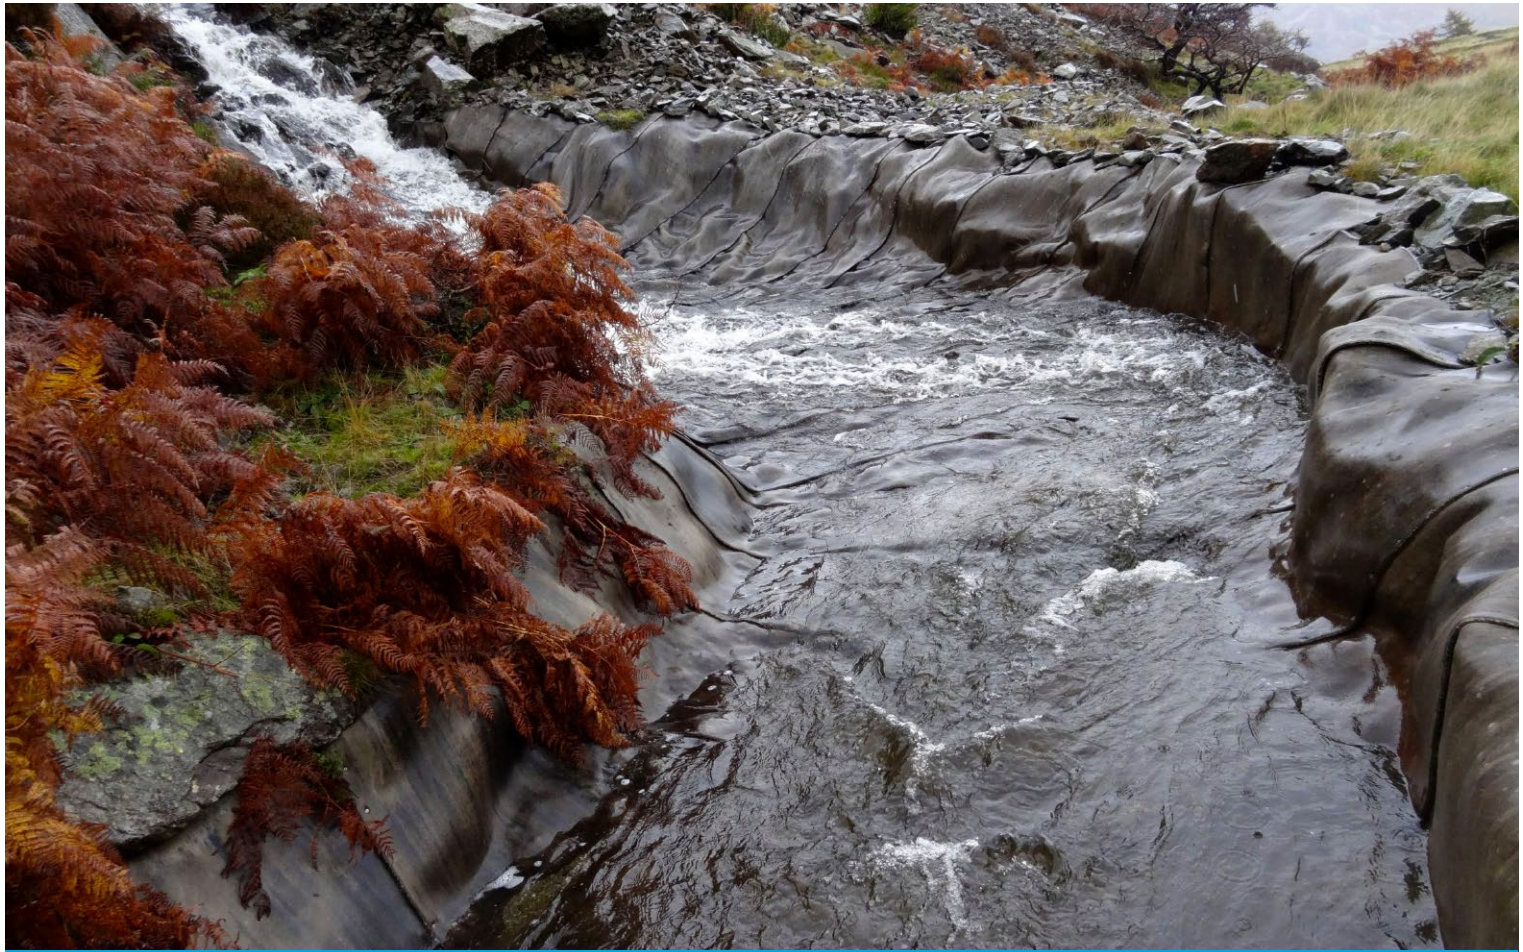
The installation five years later - with an average rainfall of over 2500mm per year, 400mm fell in just six days at the end of October 2021.

“The concrete canvas is still working as effectively as when it was installed. We’ve had about half a dozen really heavy rainfall events since it went in and on every occasion the runoff from the hillside above the tailings dam has been intercepted and safely conveyed directly into the beck without causing any erosion of mine material. At the end of October 2021 the site received 400mm of rainfall in six days, the wettest week since Storm Desmond in December 2015. The Concrete Canvas performed exactly as it needed to and there was no erosion of any mine material.”
