BITUMINOUS GEOMEMBRANES EXHIBIT OUTSTANDING TOLERANCE TO DAMAGE

COLETANCHE®

Puncture by Aggregate test

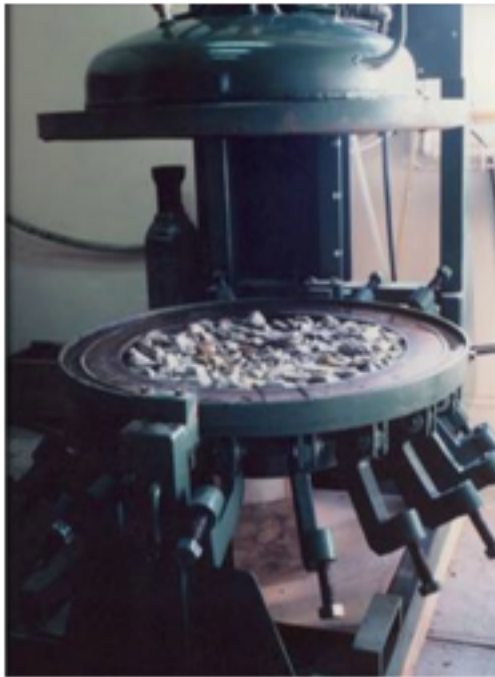
**Puncture Test:
Aggregate size 20-40 mm**

COLETANCHE PUNCTURE BY AGGREGATE (NFP 84510)

Puncture by Aggregate (Aggregate 20/40)

20 - 35 kN /
4496 -
7868 lbs

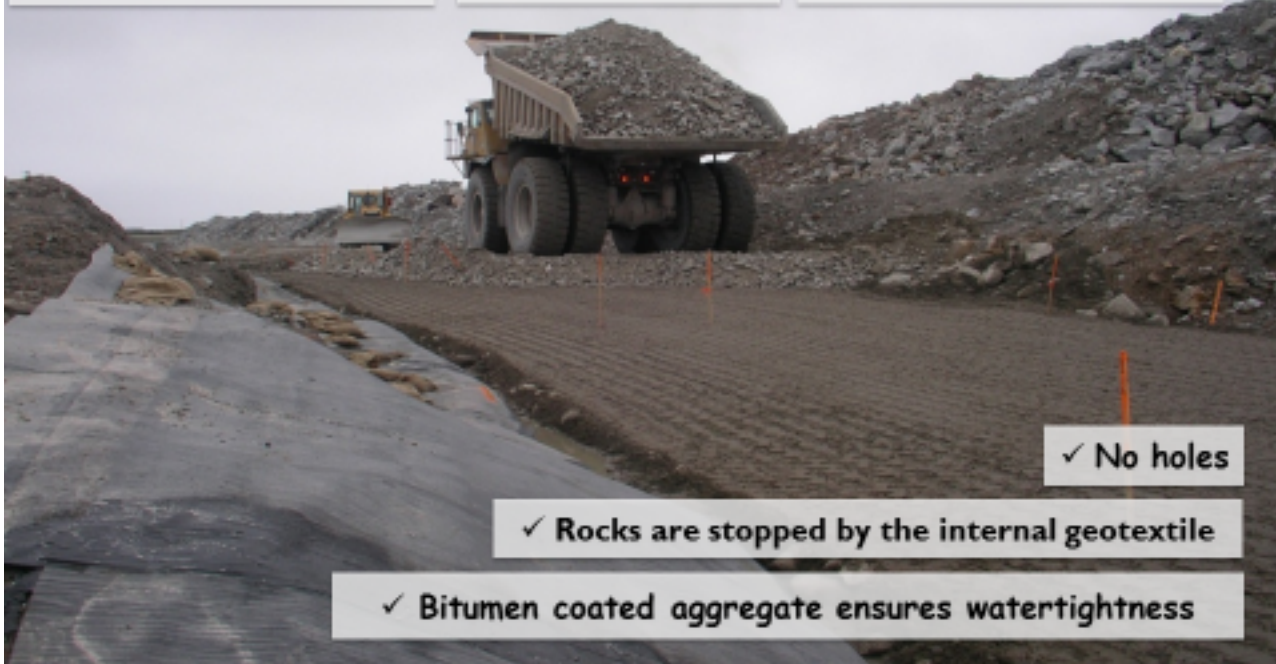
Rio Tinto
Diavik Diamond mine
Canada

✓ No holes

✓ Rocks are stopped by the internal geotextile

✓ Bitumen coated aggregate ensures watertightness

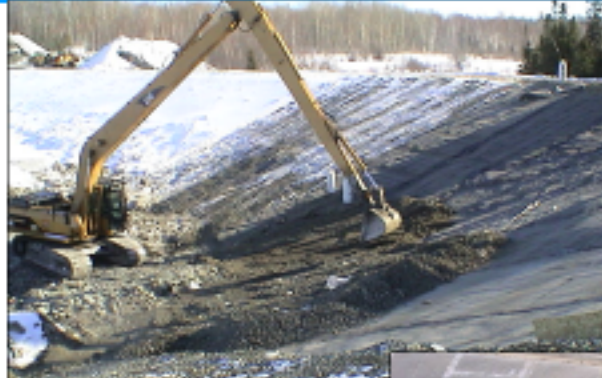
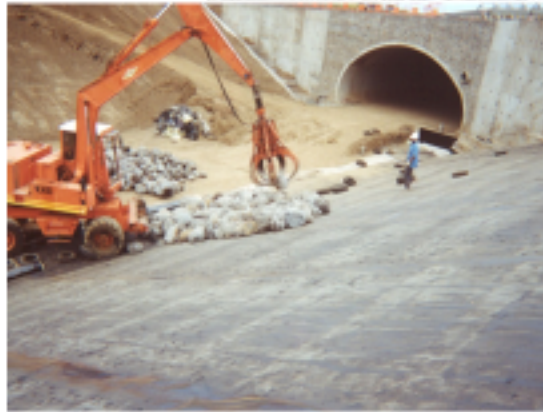
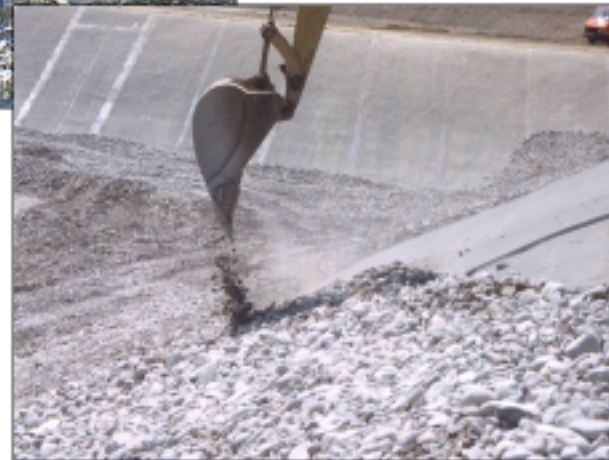
Cover Options

Natural cover options including soil or rocks
