Case study

Evaluation of exhumed HDPE geomembranes used as a liner in Brazilian shrimp farming ponds

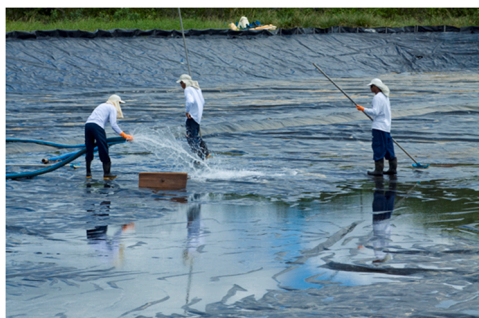
Fig. 1. Shrimp farming pond representing the CAM and CAM1 samples.

covered with an agricultural plastic film. Figs. 1 and 2 show, respectively, the shrimp farming pond representing the CAM and CAM1 samples and the shrimp farming pond representing the CAM2 sample. Table 1 presents the salinized water parameters used for shrimp cultivation.

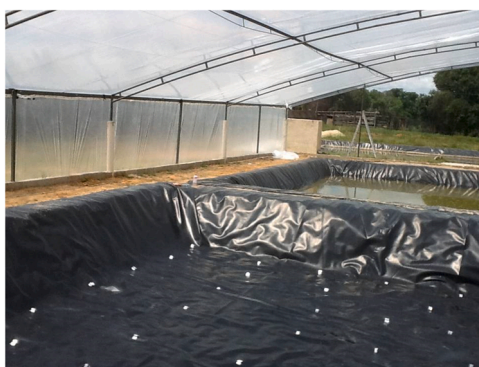
Fig. 2. Shrimp farming pond representing the CAM2 sample.
