Analyzing the consequences of improper storage and preservation techniques on geomembrane integrity

Y.D. Ntow, J. Sampah- Adjei, D. Johnson, J. Cobbinah, E.M. Melomey
Constromart Investments Ltd, Accra, Ghana

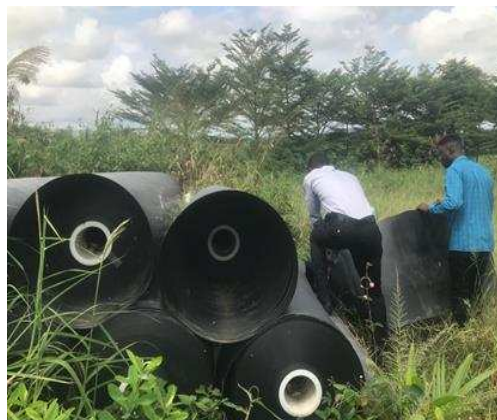
Figure 1. Rolls of HDPE Geomembranes in the study area

The research was conducted on 2mm thick HDPE geomembrane rolls that had been stored at a site located in Accra, Ghana with geographical coordinates of 5° 40' 0" North, 0° 22' 0" West. The research focused on the impact of improper storage and preservation practices on the integrity of high-density polyethylene (HDPE) geomembranes.

The selected HDPE geomembrane rolls with smooth surfaces were divided into two experimental groups for the research: one labelled as "high exposure" and referred to as Sample A, and the other categorized as "medium exposure" and designated as Sample B. The group labelled "high exposure" experienced direct exposure to the prevailing environmental conditions at the study site, while the medium-exposed group was subjected to less or no direct exposure to the prevailing environmental conditions as shown in Figure 1. Over ten years, the geomembrane rolls were subjected to a range of environmental stressors, including temperature variations, UV light exposure, moisture exposure, and other pertinent factors such as microbial growth and abrasion or physical damage.
