SPE-216663-MS

Applications & Challenges of the Non-Metallic Material for Hydrocarbon Piping

W. S. Saeed, A. S. Al Mehairi, A. M. Alnaqbi, and S. O. Al Blooshi, Abu Dhabi National Oil Company, ADNOC Offshore

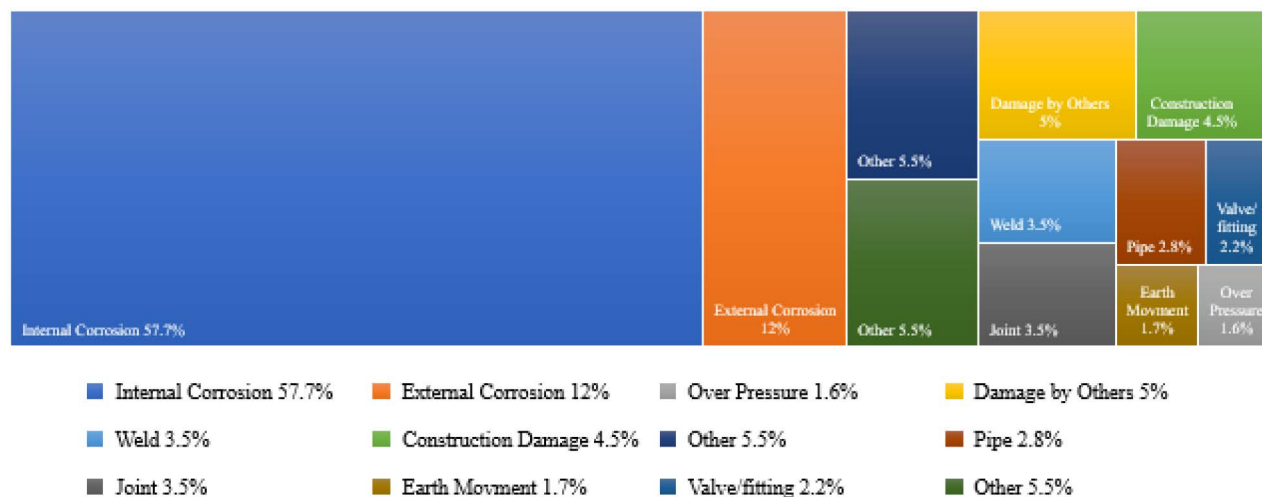
Figure 1—Alberta, Canada Production Pipeline Failure Data for 1980–2005. Source: Adapted from Utilities Board (ERCB) 91-G Report

According to the below graph, it is clear that internal and external corrosion were the primary culprits behind pipeline failures in Alberta, Canada, between 1980 to 2005.

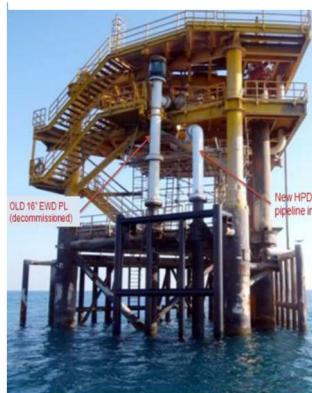
Figure 5—New HDPE pipeline in service (Right)

The operating pressure for the required pipeline is 350 psig, and an internal diameter of 400mm (16") to replace the existing pipeline. As per the HDPE manufacturer, the design pressure of 350 psig would result in a pipeline design of 560mm (22") outside diameter and 80mm wall thickness (Size to Diameter Ratio (SDR) equal 7). The pipeline manufacturer confirmed that this size and thickness combination was unprecedented in the whole Middle East and very difficult from the manufacturing point of view. However, the technical support from the local raw material supplier made it possible to produce this challenging pipeline configuration.

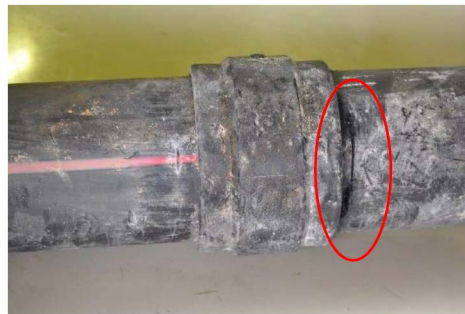
Figure 8—Pipe rupture near coupler welding joint

A more recent failure was reported as a pipe rupture, and the preliminary analysis indicated that the pipe material does not comply with the required standard ISO-4427. Moreover, it was found that the pipe producer added foreign material to the resin used to produce the pipe, which made it deviate from the ISO-4427 requirement.

From the analysis conducted, it has been determined that the main reasons for the frequent failures are non-compliance with the required standards of the materials used, poor workmanship and installation quality, without any documentation of welding or joining parameters, and an inadequate design and layout configuration. Additionally, it was found that there was no stress analysis performed on the network as part of the initial design process. It is crucial to address these issues to prevent further failures and ensure the safety and reliability of the system.
