PROJECT SPOTLIGHT

ARMORING OF MINE TAILINGS POND, ARIZONA

Tailings Pond Containment

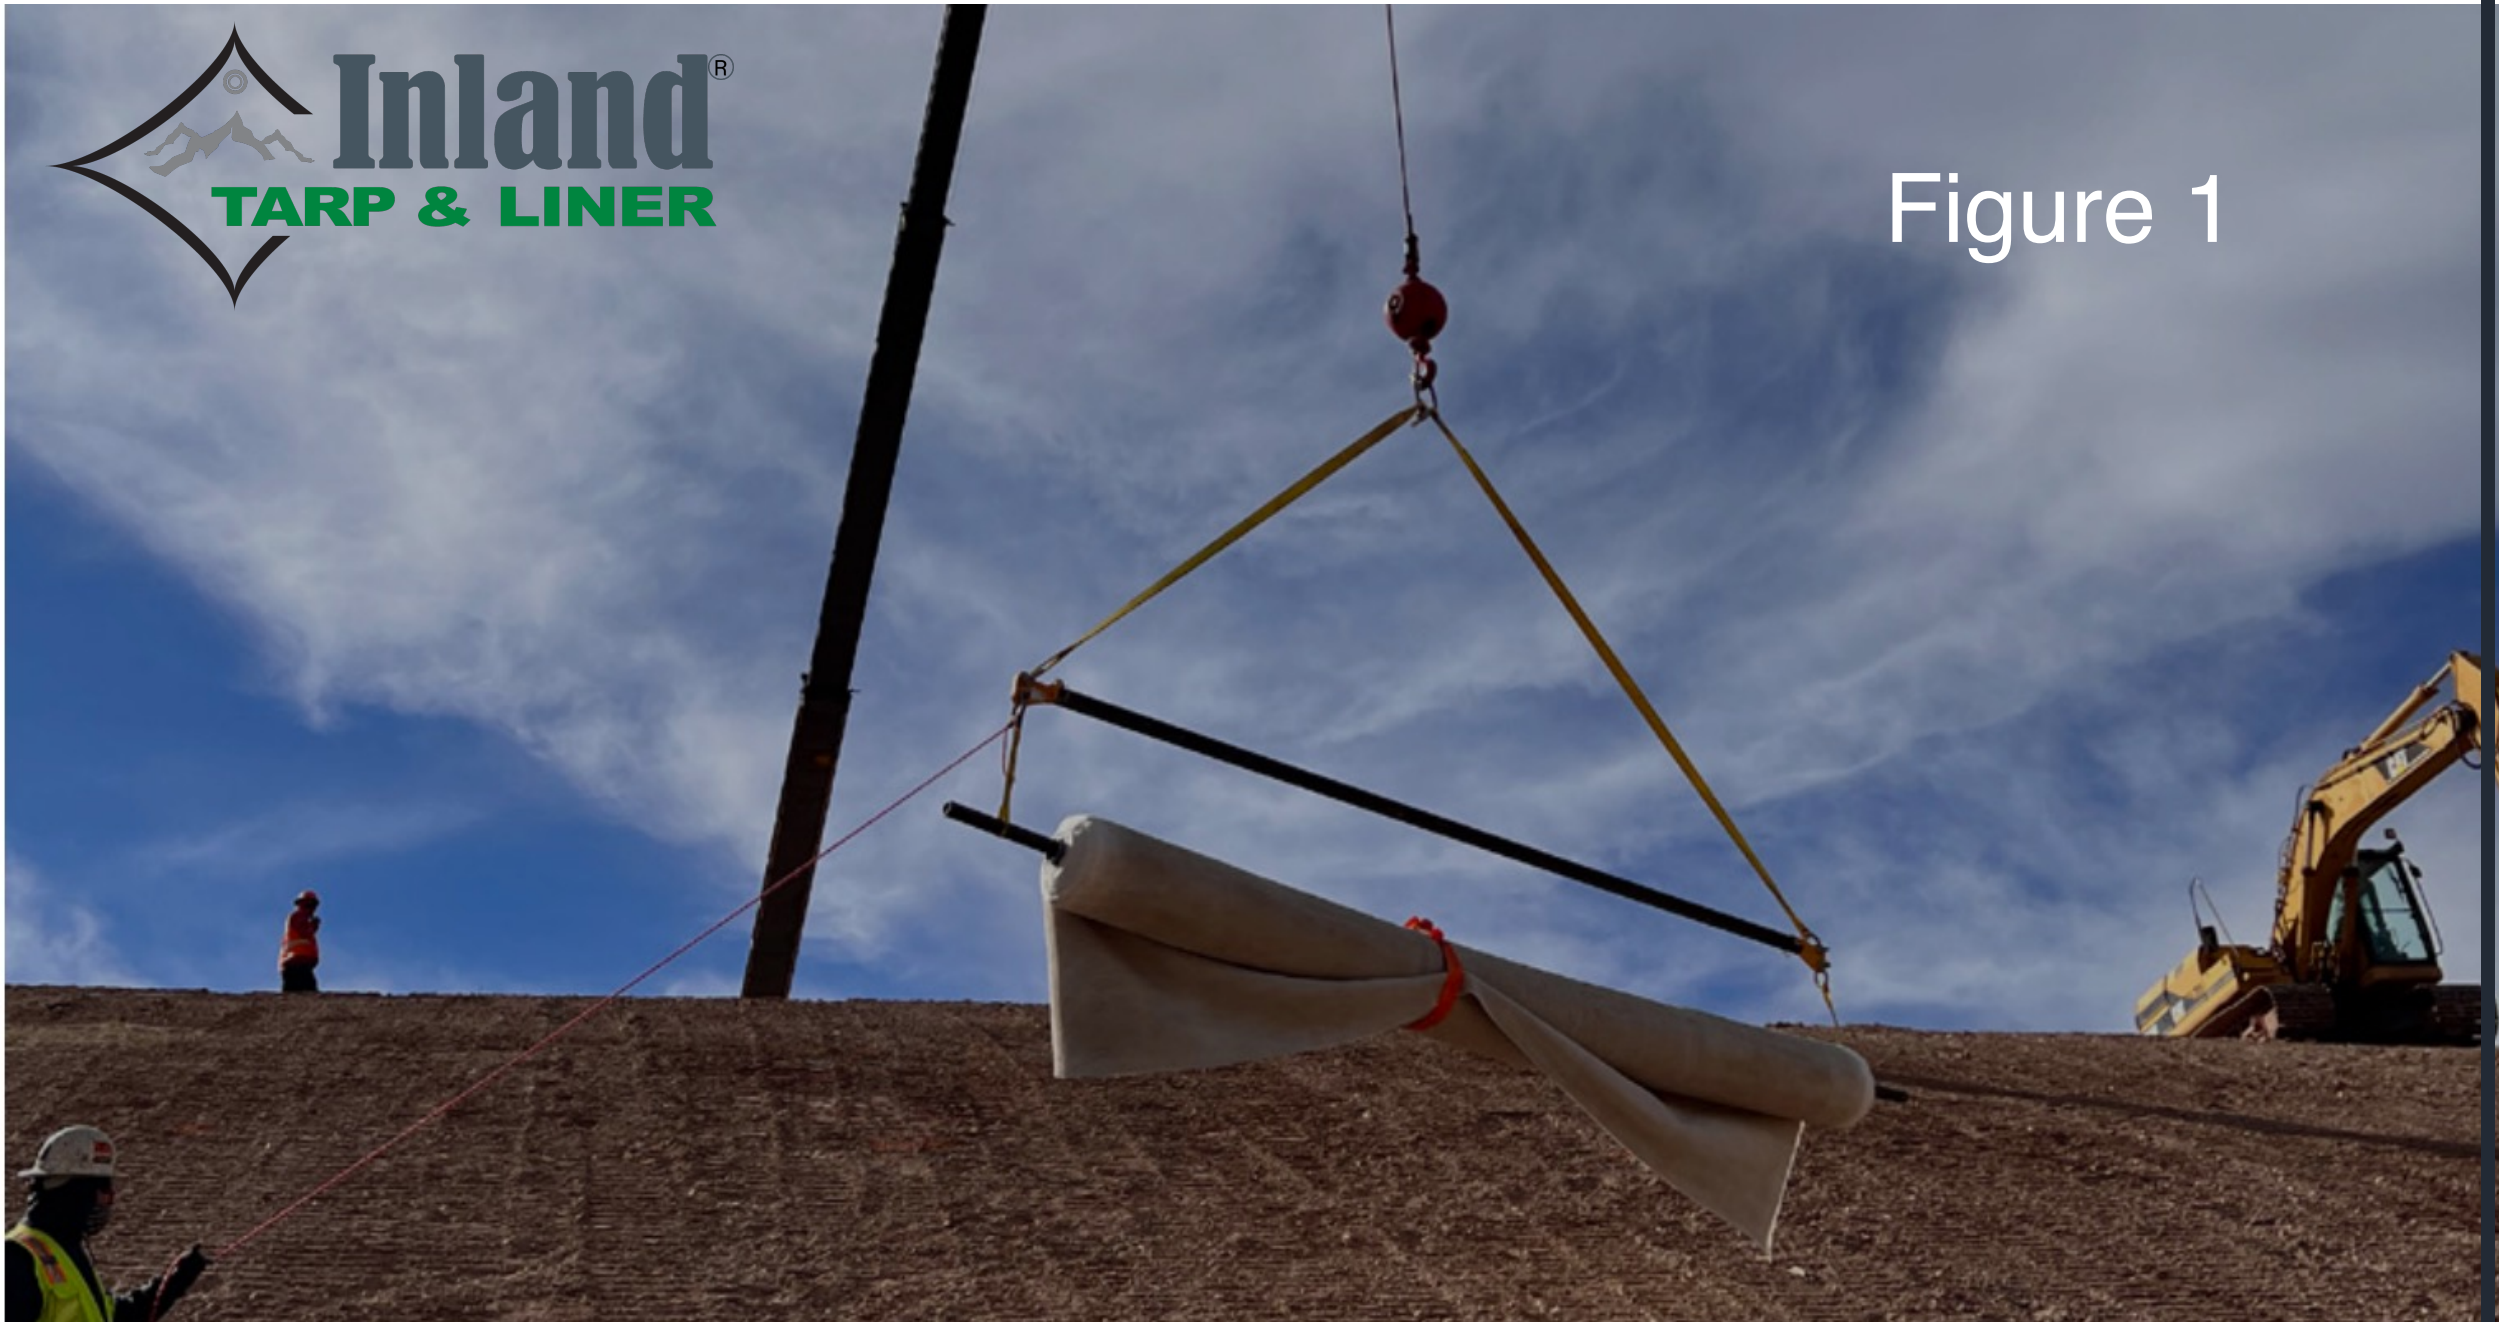
Figure 1

Because an RCR is a relatively simple product with a less labor-intensive installation process than traditional concrete slabs, it requires minimal fabrication to transform the face of an earthen berm into an armored slope. In this application, unrolling the RCR from behind the berm (see **Figure 1**), utilizing an anchor trench at the top of the slope (see **Figure 2**), and overlapping each panel by six inches, meant the crew could seam the prefabricated panels of RCR using thermal fusion welding (see **Figure 3**). It was estimated that use of prefabricated RCRs saved weeks of labor and significant cost compared to other armoring methods considered. The steep slope angle (see **Figure 3**) made using RCR a feasible and effective solution for armoring the slope. **Figure 4** shows the finished berm slope with more than 120,000 ft² of RCR installed safely on the berm face.

Despite thorough pre-planning, large-scale construction sites can be challenged by surprise events, and this site was no exception. Initial challenges included a crane that was unable to be staged in the optimal position for installation of the RCR rolls. Though there was an acceptable secondary position (see **Figure 1**), the correct equipment was not immediately available to transition to the second position. Repositioning the crane, as well as identifying and locating additional equipment, all contributed to further delays that worked against a narrow RCR installation window.
