CORROSION UNDER INSULATION IN OIL AND GAS PLANTS: CASE STUDIES IN A JAPANESE FIELD

T. Toyoda^{1,*}, K. Watanabe², Y. Kushima³, T. Sunaba¹

ABSTRACT

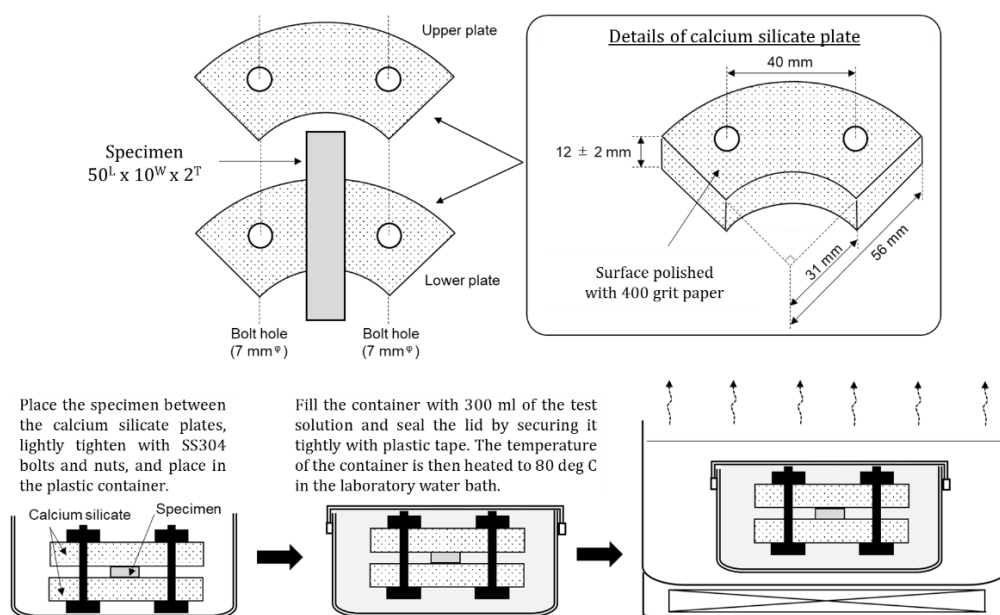
FIGURE 4: SCHEMATIC DIAGRAMS OF THE IMMERSION TEST PROCEDURE

The immersion test was performed with only a part of the specimen covered with calcium silicate plates as a simulated CUI condition to confirm the susceptibility to crevice corrosion. Each carbon steel specimen was sandwiched between two pieces of calcium silicate plate and immersed in 300 mL of the test solution pre-added sodium nitrite in a polypropylene container. Each closed container was engaged in a laboratory water bath warmed to 80 °C. After the 7-day test period, the mass loss of each specimen was measured, and the surfaces of post-test specimens were observed. The test conditions are shown in Table 1, and the schematic diagram of the test procedure is shown in Figure 4. Sodium nitrite was pre-added to the test solution before starting the immersion test. After the immersion test, the pH of each solution was measured with a pH meter to examine the corrosiveness to exposed areas under the test environment, and the pitting depth was measured with a laser scanning microscope to estimate the pitting corrosion rate per year.

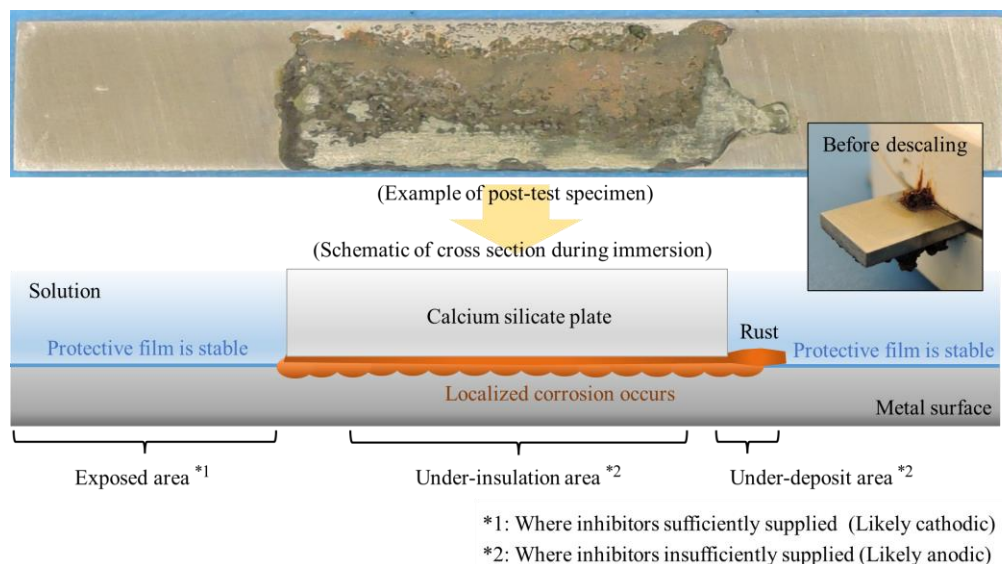
FIGURE 6: THE SCHEMATIC DIAGRAM OF THE ESTIMATED MECHANISM OF LOCALIZED CORROSION

The possible mechanism for the induction of localized corrosion under the test conditions with the addition of the corrosion inhibitor, NaNO₂, is shown in Figure 6. A protective film formed by dense corrosion products is established in areas where the corrosion inhibitor functions effectively, acting as a cathode. However, the protective film is not maintained in areas where the corrosion inhibitor's function is insufficient, resulting in anodic behaviour. In other words, forming a corrosion cell with a fixed anode leads to concentrated metal loss due to localized corrosion. Areas prone to insufficient supply of the corrosion inhibitor include the crevice portion under the insulation or the deposit. Localized corrosion was observed in the under-deposit regions in specimens with deposits on the exposed area. While adding NaNO₂ can slow down corrosion progression in areas where their effects are practical, there is a concern that they may promote corrosion in areas where their effects are not working effectively (e.g., under insulation materials).
