Preliminary Survey Report for Jagersfontein

Orthophotos, Topographic Surveys (DEM),
and Reconstructed Surfaces Produced
from Archive Satellite Imagery

First: January 20th, 2023

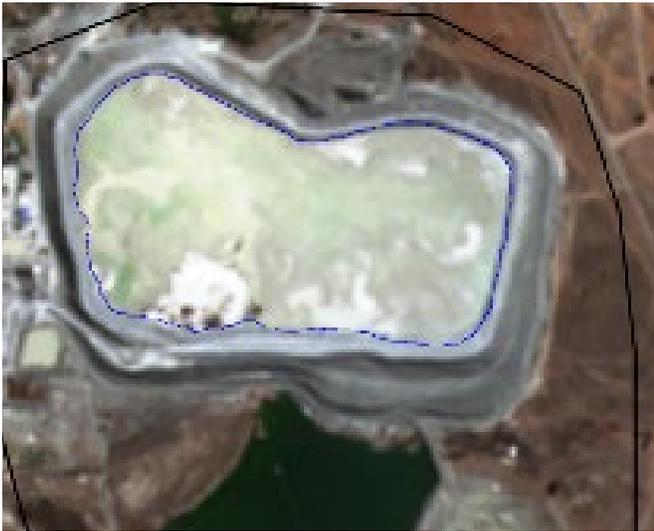
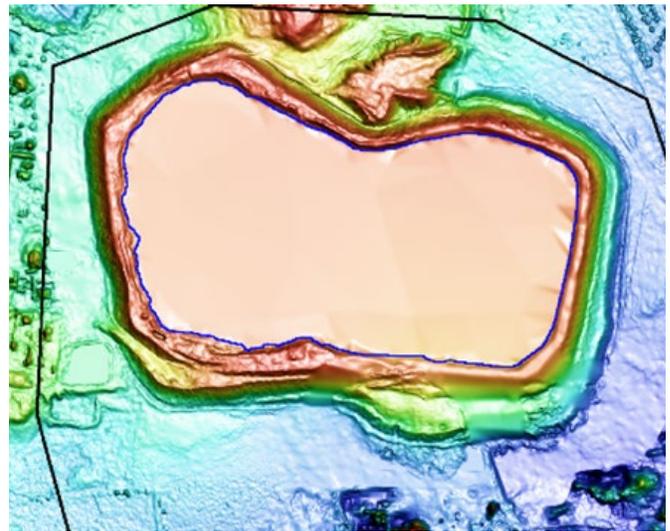
Figure 4: Sentinel 2A satellite image for September 6th with topographic surface

upstream slope could be determined to re-construct the damaged embankment structure. The September 6th 2022 Sentinel 2A imagery (Fig. 4) was then used to establish the eastings and northings of the tailings footprint within the TSF prior to failure. The elevation of that boundary can then be determined wherever it contacted the re-constructed upstream dyke wall.

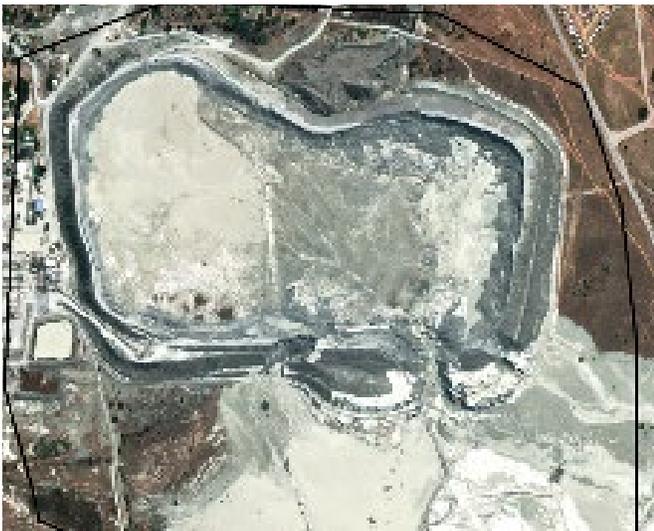
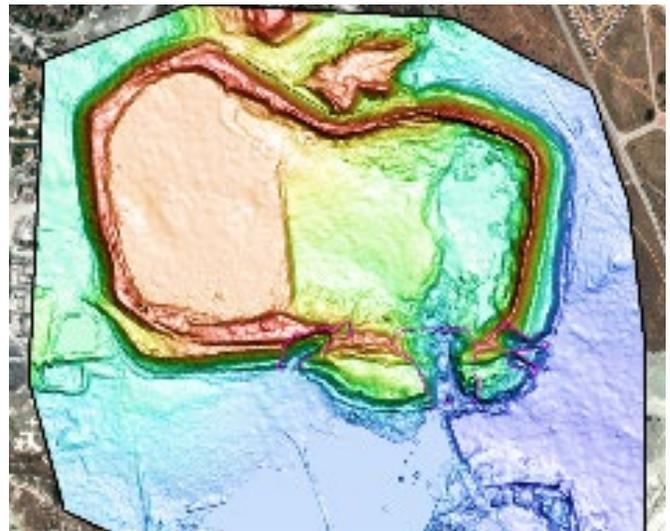
Figure 5: WV-2 satellite image for September 16th/24th with topographic surface

By applying PhotoSat’s reconstruction process to the post-failure survey (Fig. 5) and Sentinel 2A imagery from September 6th 2022, a pre-failure surface was generated.

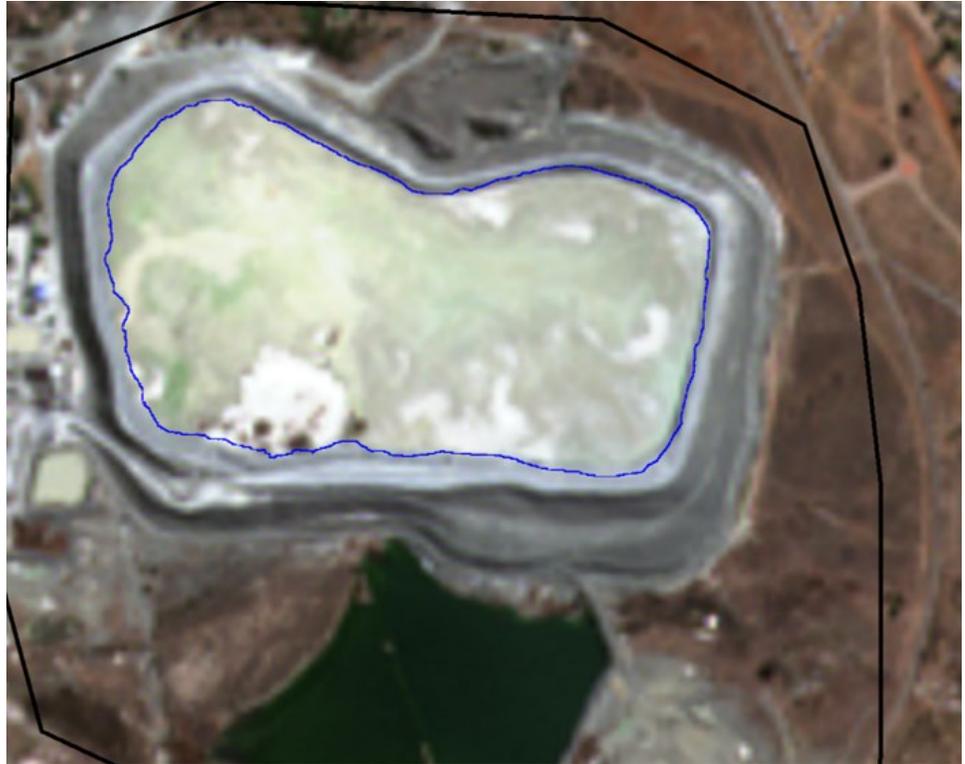
Figure 12: Sentinel 2A satellite image from September 6th 2022

This orthophoto (Fig. 12) shows the Jagersfontein TSF in 2022.

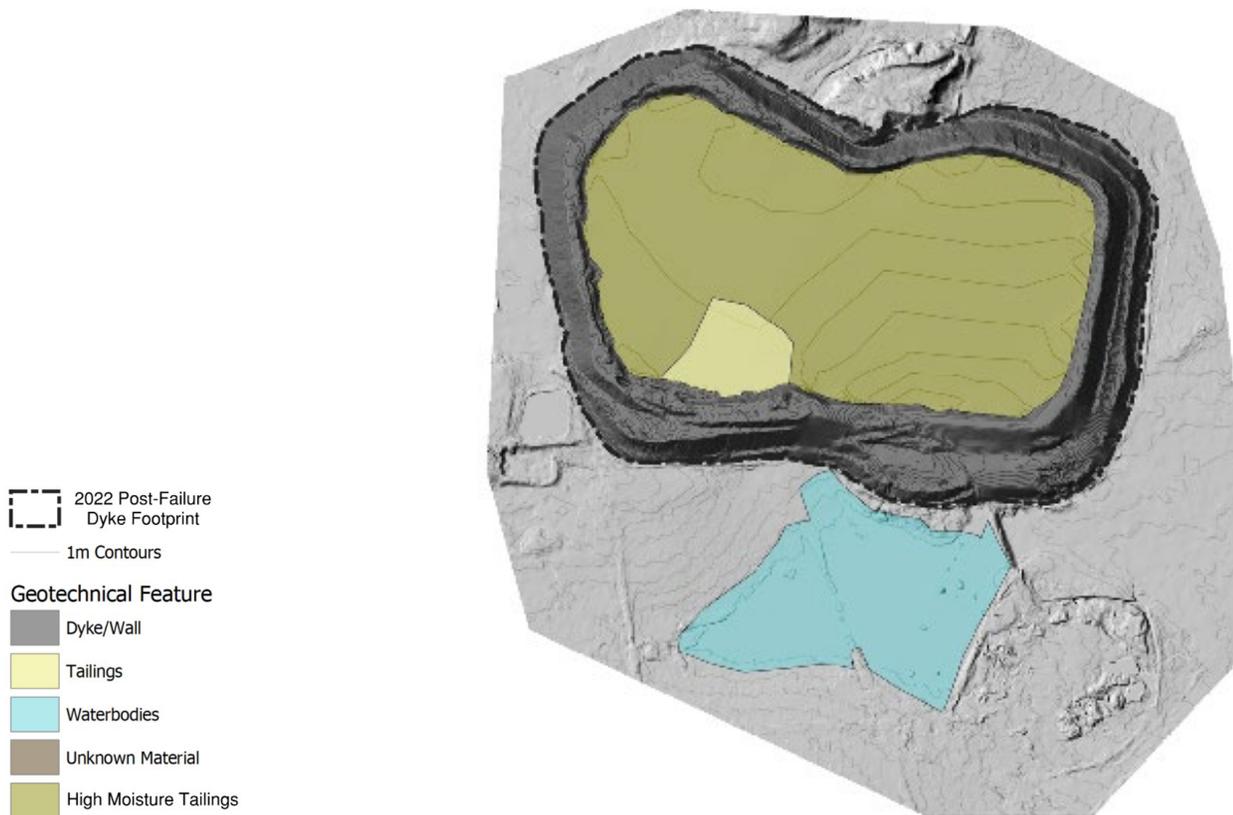
Figure 13: Component map for September 6th 2022

Shown below (Fig. 13) is a 3D topographic surface with segregated components with 1m contours and footprint of the 2022 TSF overlaid. Areas of high moisture tailings were determined using spectral analysis cross-referenced with optical observations.

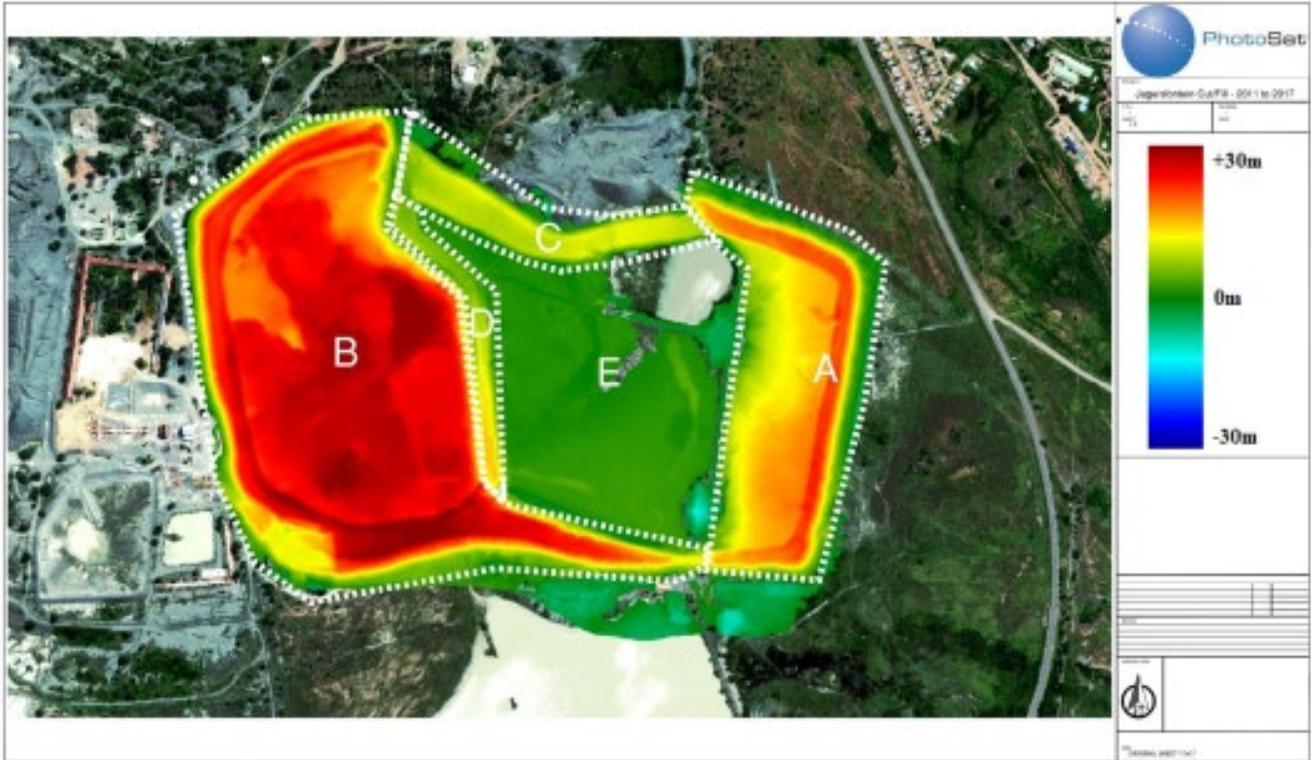
Figure 28: Cut and fill map from 2011 to 2017 surface

2022 pre-failure, and post-failure surfaces. The total and zone segregated cut and fill volumes can be found in the Table 2 to Table 5. The maps display changes greater than 50 cm. The volumes are accurate to within +/- 10%.

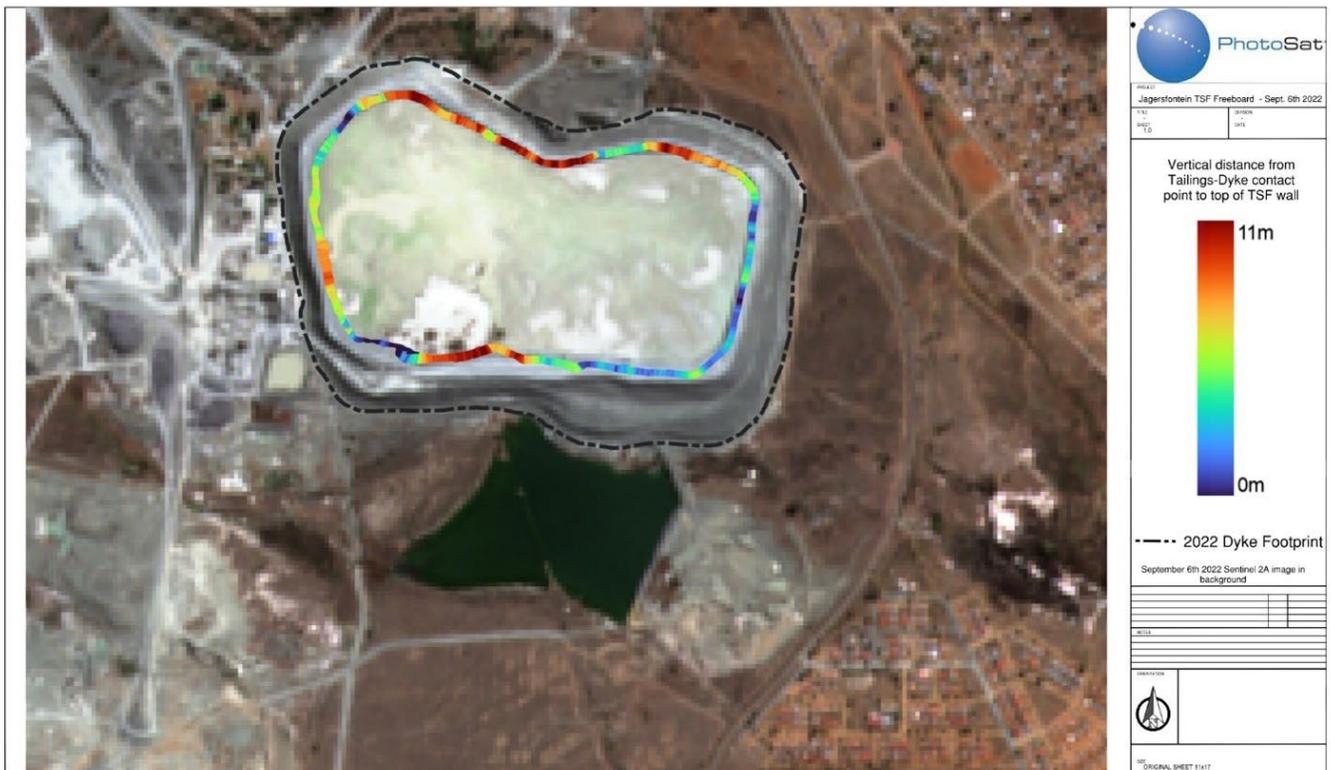
Figure 40: TSF operational freeboard map for 2022

that location is the operational freeboard. (Fig. 37) The maps below (Fig. 38 to Fig. 40) display the distance by color, where warmer the color corresponds to greater freeboard distance. In some areas of the TSF, the wall was not visible. In those areas, freeboard was not measured.

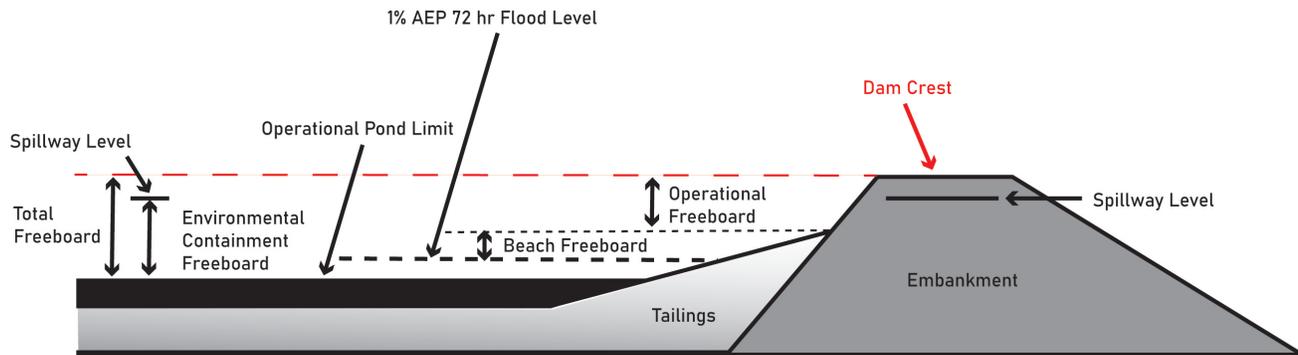
Figure 41: Diagram of dam crest

The dyke wall height (Fig. 41) along the upstream crest was measured for 2011 and 2017 using topographic surfaces. The dyke wall height was measured for 2022 using the reconstructed surface.

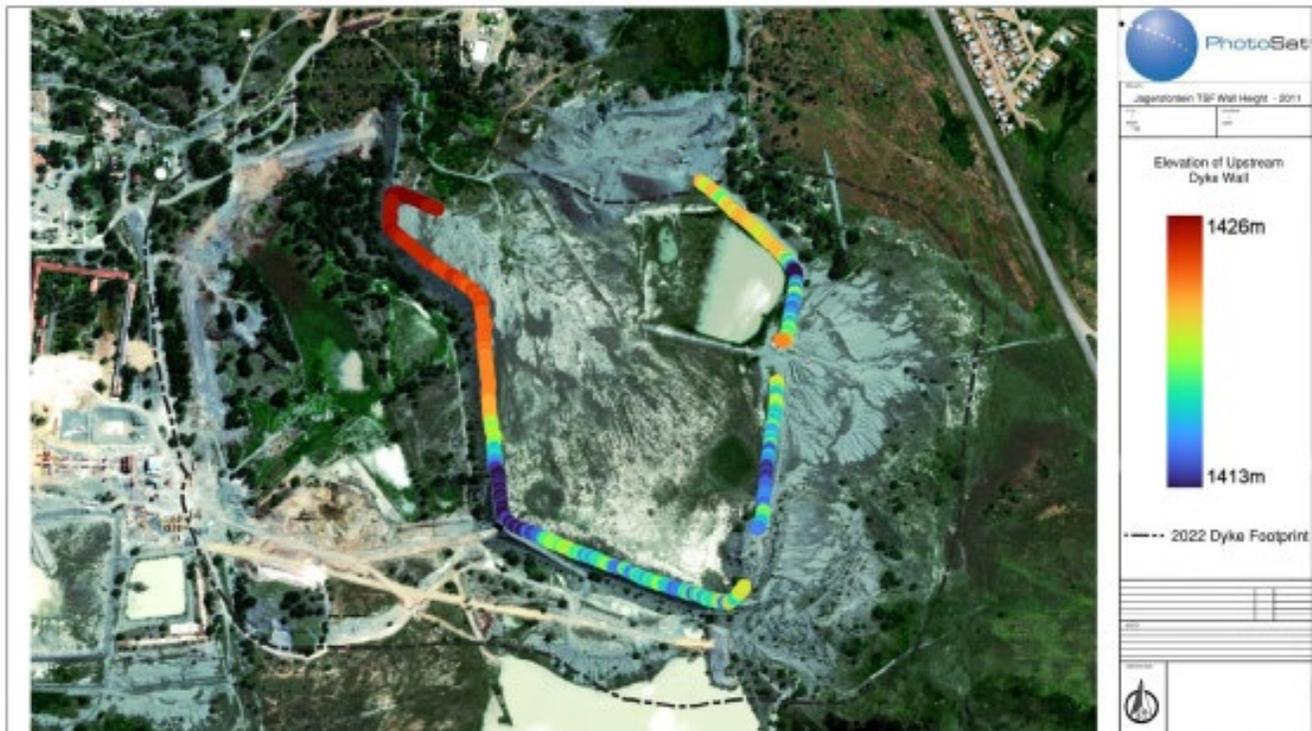
Figure 42: TSF upstream wall height for 2011

Shown below (Fig. 42 to Fig. 44) is the range in the wall height along the entire TSF, with warmer colors indicating higher elevations.
