# CORROSION PROTECTION LININGS FOR THE STRATEGIC TUNNEL ENHANCEMENT PROGRAM, ABU DHABI

T. Krause <sup>1\*</sup>, S. Orakzai <sup>2</sup>, R. Marshall <sup>3</sup>, J. Sickling <sup>4</sup>

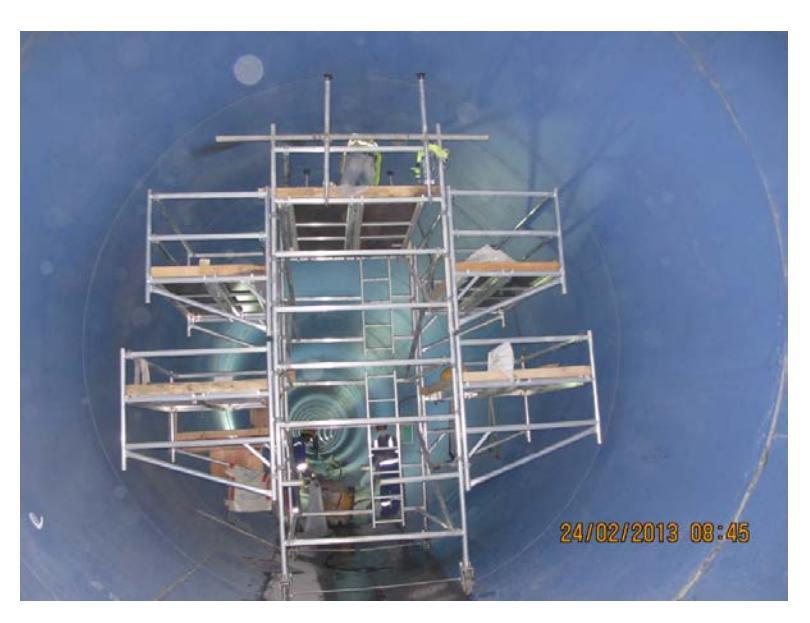
After completion of the works and prior to issue of the Taking Over Certificate (TOC), final inspections using gantries (to access tunnel shoulders and crown) and sounding rods were carried out at each CPL section to check the concrete integrity behind the liner. Sounding tests were carried out (refer to Figure 6) using hollow testing rods. Knocking with the test rods was carried out on the entire HDPE covered CPL arch, longitudinally and transversely. The method was effective in detecting where concrete segregation / honeycombing / voiding had occurred that had not already been identified by visual inspection.

a – Sounding Rod **Figure 6. Sounding Tests**

b - Gantry Used for 360° Sounding
