# **SUBACUATIC REPAIRS OF A HDPE LINER SYSTEM BY USING AN ASPHALTIC BASE GEOSYNTHETIC MATERIAL AT “EL VALLE –BOINAS” MINE, ASTURIAS, SPAIN**

Authors: Castro Tejerina S.; Sánchez Arrótegui K.; Lázaro J.  
Position & company: Project Manager; Project Engineer; Area Responsible  
Golder Associates Global Ibérica S.L.U & Axter S.A.  
E-mail: SCTejerina@golder.com; KSanchez@golder.com;  
jlazaro@axter.es

## **Abstract**

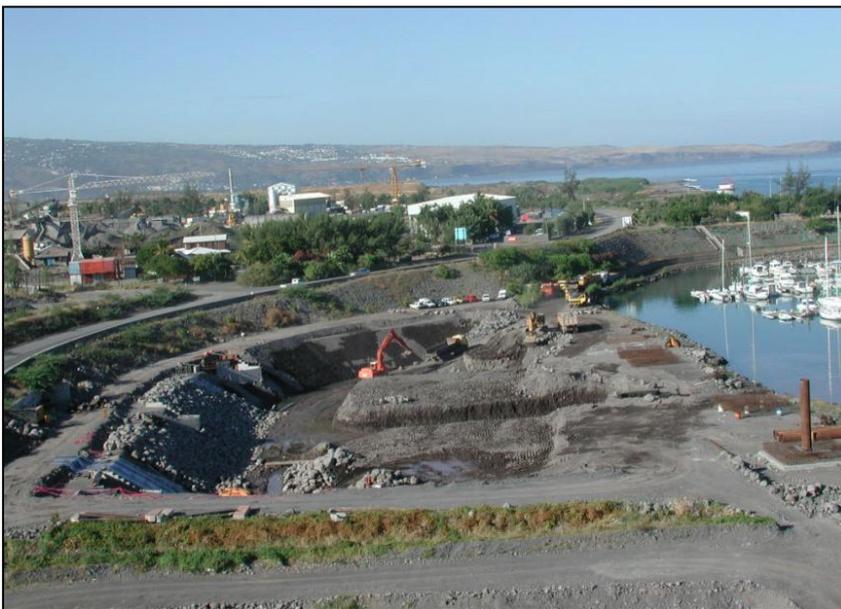
Job: Reunion Island

The geomembrane was place on slopes below a rock wall to separate the sea water from the phreatic water level. It was decisive for the Project the fact that was possible to weld underneath the water, adding that density higher than 1 the geomembrane to submerge under water. (Job Antiquity 14 years).
