Natural aging mechanism of buried polyethylene pipelines during long-term service

Ying-Chun Chen ^a, Yan-Feng Li ^a, Yan Xi ^{a,*}, Qiang Li ^b, Qi Lu ^a, Jie Yang ^a^a Beijing University of Technology, Beijing, 100124, China^b Xinjiang Inspection Institute of Special Equipment, Urumqi, 830011, China

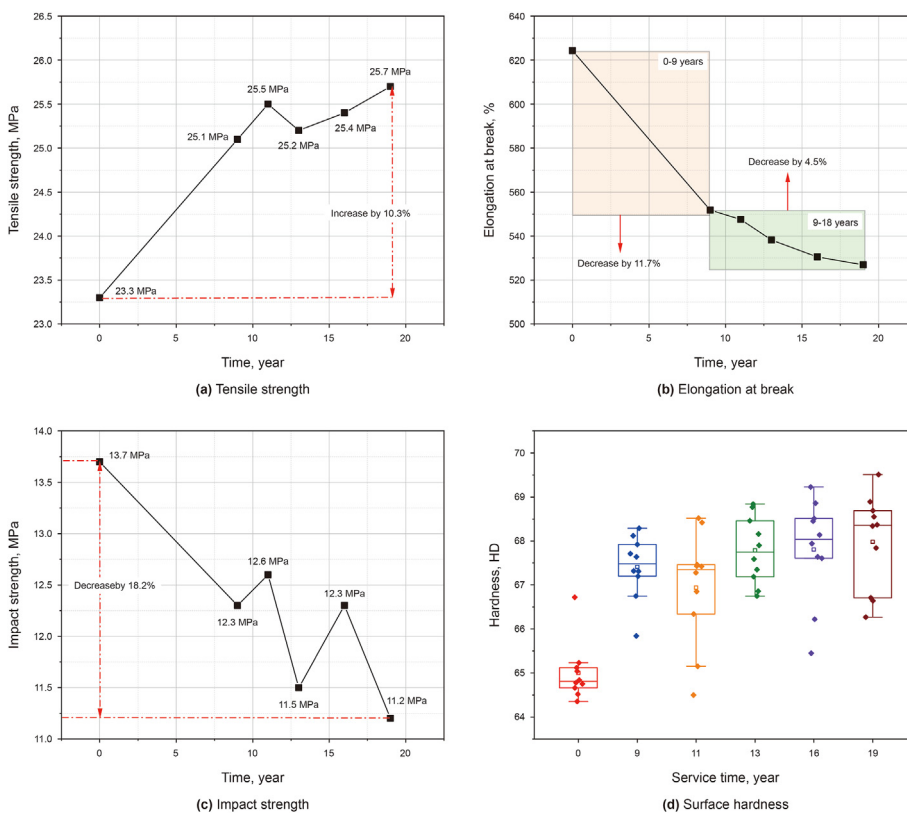
Fig. 4. Mechanical properties of pipelines with different service times.

According to the tensile test results in Section 3.1, the mechanical properties decrease significantly with the increase in service time. Both the tensile strength and elongation at the break of

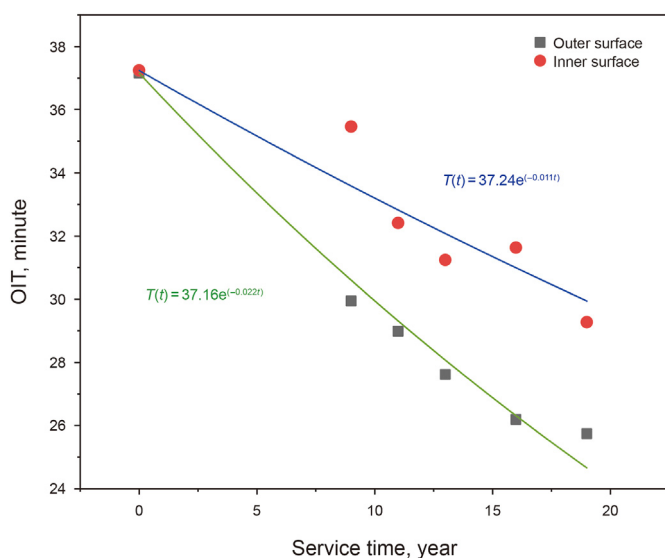
As shown in Fig. 6, the attenuation equation of the outer surface is as follows:

Fig. 6. OIT of polyethylene pipelines with different service times.

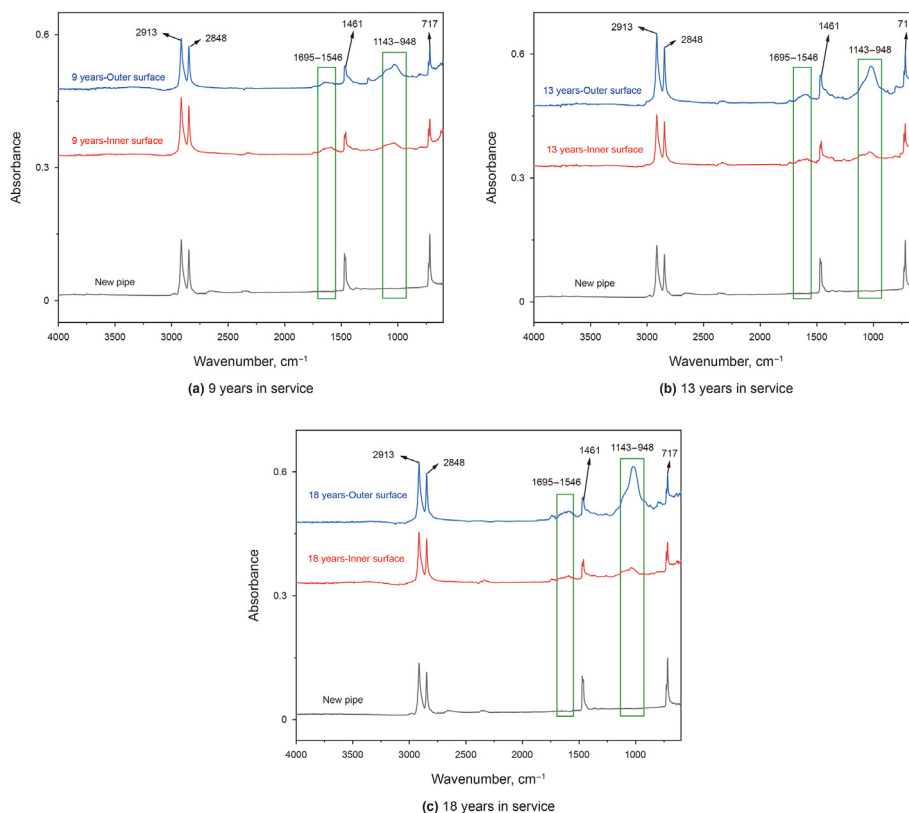
Fig. 7 shows the infrared spectrum absorbance diagram of the inner and outer surfaces of polyethylene pipelines with the same service time. As shown in Fig. 7(a–c), each absorbance curve shows the methylene absorption peak of polyethylene at the four-wave positions of 2913 cm^{-1} , 2848 cm^{-1} , 1461 cm^{-1} , and 717 cm^{-1} . Besides, an absorption peak appears at $1143\text{--}948 \text{ cm}^{-1}$. It matches the stretching vibration of the oxidation functional group. It can be considered that there are alcohols, phenols, hydrocarbons, and other aging products on the pipeline surface after service. In addition, another absorption peak appears at $1695\text{--}1546 \text{ cm}^{-1}$

after service. This matched the telescopic vibration of C=O and C=C. It shows that the pipeline surface has aging products of esters, carboxylic acids, aldehydes, and ketones.

Fig. 7. Infrared spectral absorbance of inner and outer surfaces of polyethylene pipelines.

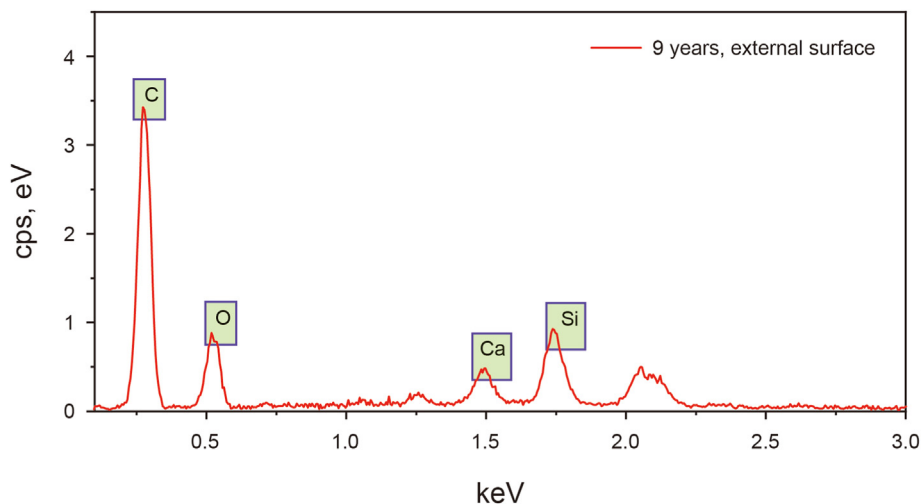
Fig. 8. Energy spectrum of the outer surface of 9 years serviced pipeline.

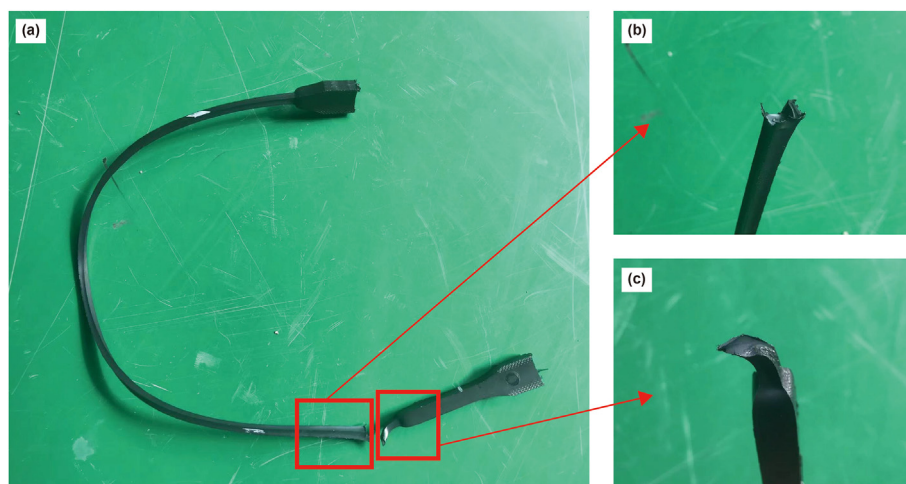
the tensile sample decreased. To explore the mechanism of pipeline aging on its mechanical properties, the microstructure of the fracture surface was observed by SEM. Fig. 14 shows the sample photos after the tensile test. It is seen in Fig. 14 (b) and (c) that the fracture surface of the extended sample part is concave, and the fracture surface of the short sample part is a protruding surface.

Fig. 14. Tensile fracture surfaces of polyethylene pipeline sample; (a) Fractured sample profile, (b) fracture surface of the extended sample part, and (c) fracture surface of the short sample part.

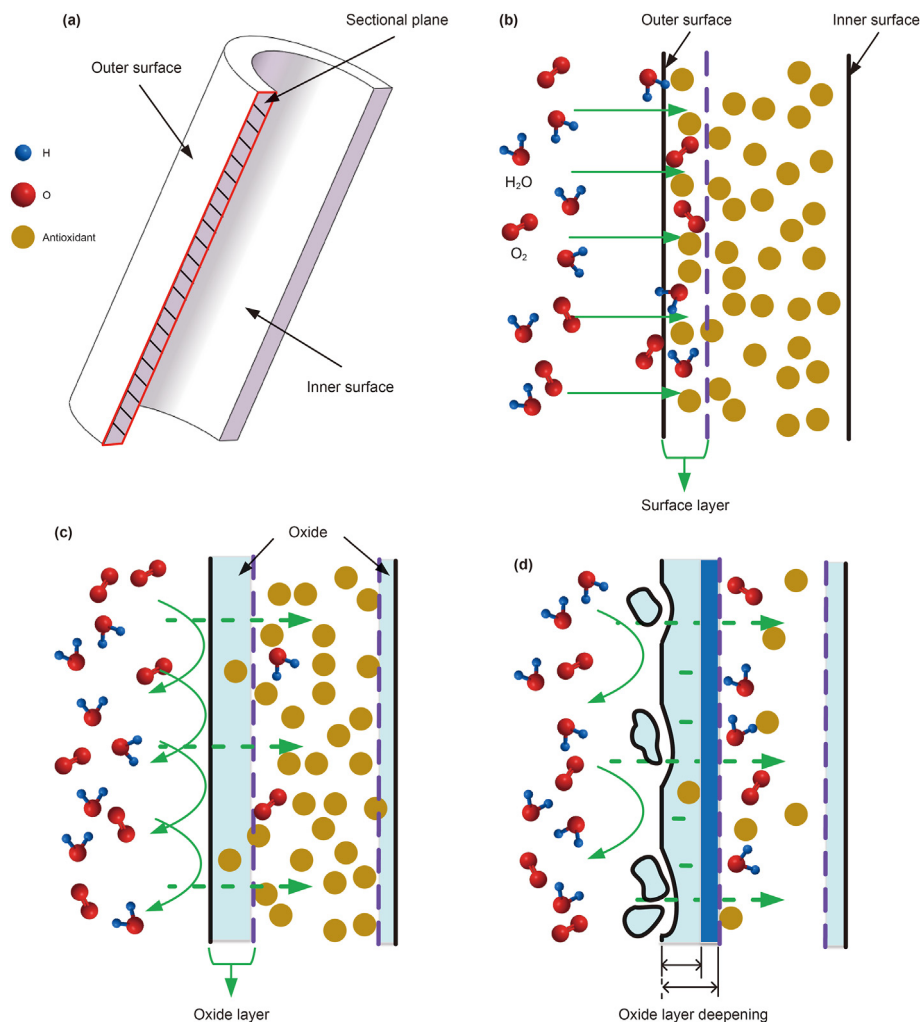
Fig. 18 shows the schematic diagram of the buried pipeline's aging process. Fig. 18 (a) shows the sectional diagram of buried pipelines. The outer surface is in contact with the soil environment, and the inner surface is in contact with the transported natural gas.

As shown in Fig. 18 (b), the pipeline is in the early aging period within 0–9 years in service. Most buried pipelines contain anti-aging additives, which are mainly composed of antioxidants. Because the soil contains a lot of water molecules and oxygen, the antioxidants in the surface layer are consumed first in the early aging period. During the consumption of the surface antioxidants,

It is seen in Fig. 18 (c) that the pipeline is in the slow aging period within 9–13 years in service. An oxide layer formed on the pipeline's outer surface due to the accumulation of oxide products. It has a certain isolation effect on oxides in the external environment, which slows down the consumption rate of the antioxidants and the pipe matrix. Similarly, there is an aging product layer on the inner surface.

As shown in Fig. 18 (d), the pipeline was in the significant aging period within 13–18 years in service. After long-term service, the oxide layer on the surface gradually becomes loose and falls off. Large areas of potholes and depressions appear on the outer surface, as shown in Fig. 12 (e) and (f). The detached oxide layer made the oxide in the environment easier to react with the internal matrix. In the cycle, the pipeline's performance decreased significantly.

Fig. 18. Schematic diagram of buried pipelines aging process; (a) sectional diagram of the pipeline, (b) early aging period, (c) slow aging period, and (d) significant aging period.

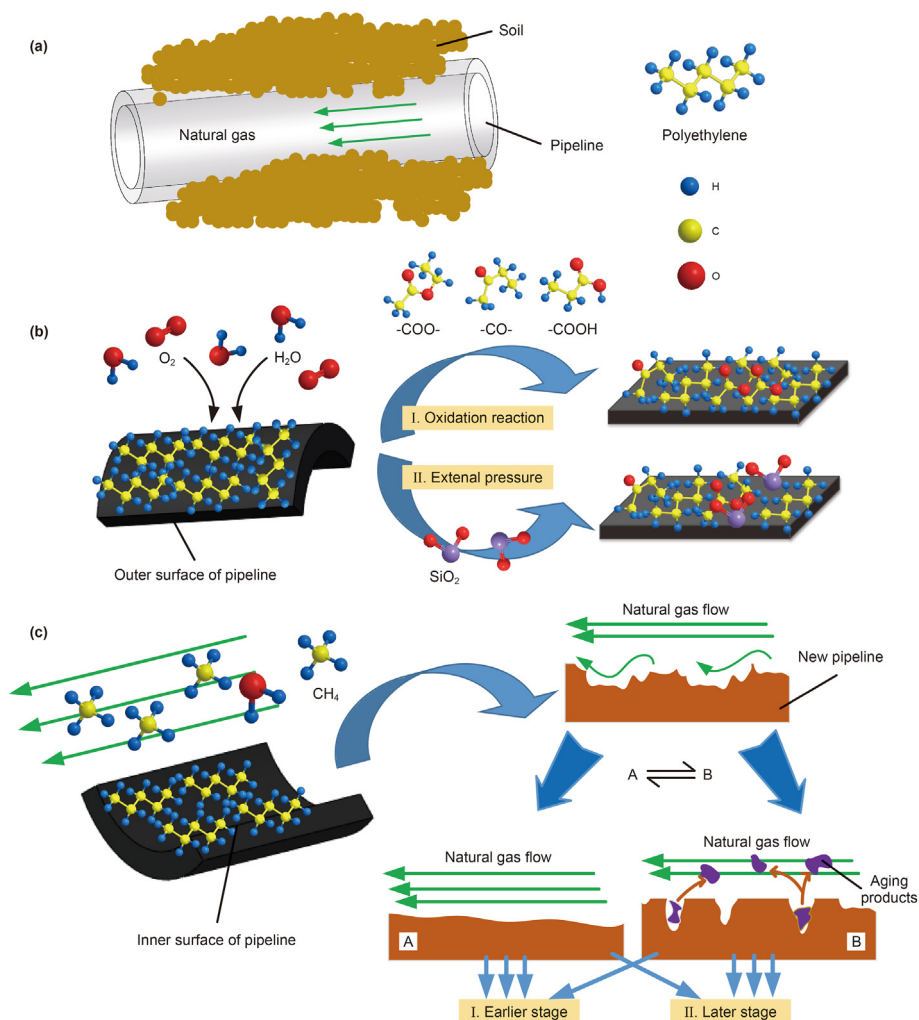
The aging mechanism of the inner and outer surfaces of polyethylene pipelines after long-term service is shown in Fig. 19. The service condition is shown in Fig. 19 (a). The polyethylene pipeline is surrounded by soil, and the transportation pressure of the natural gas inside the pipeline can reach 0.4–0.7 MPa. The aging mechanism of the outer and inner surfaces is shown in Fig. 19 (b) and (c), respectively.

As shown in Fig. 19 (b), the outer surface of the pipeline is in direct contact with the environment. Because the soil contains a lot of water and oxygen, the outer surface is prone to oxidation reactions that age the pipeline. Oxidation generates carbonyl,

Fig. 19 (c) shows the aging mechanism of the inner surface of the pipeline. The main component of natural gas transported by pipeline is CH_4 which accounts for 94%. Natural gas contains only a small amount of oxygen-containing substances such as H_2O and CO_2 , so it is difficult to have an oxidation reaction with the inner surface. Thus, the aging conditions of the inner and outer surfaces are quite different. The outer surface has obvious aging since 9 years, and the aging is severe at 16 and 18 years. However, obvious aging of the inner surface occurs only at 16 and 18 years.

Fig. 19. Aging mechanism of the outer and inner surfaces of the polyethylene pipelines; (a) Service environment, (b) outer surface and (c) inner surface of the pipeline.
