In the Wake of the Mount Polley Mine Tailings Breach

Tailings Dam Design, Innovation, and Practice Changes

By Harvey N. McLeod, P.Eng., P.Geo.

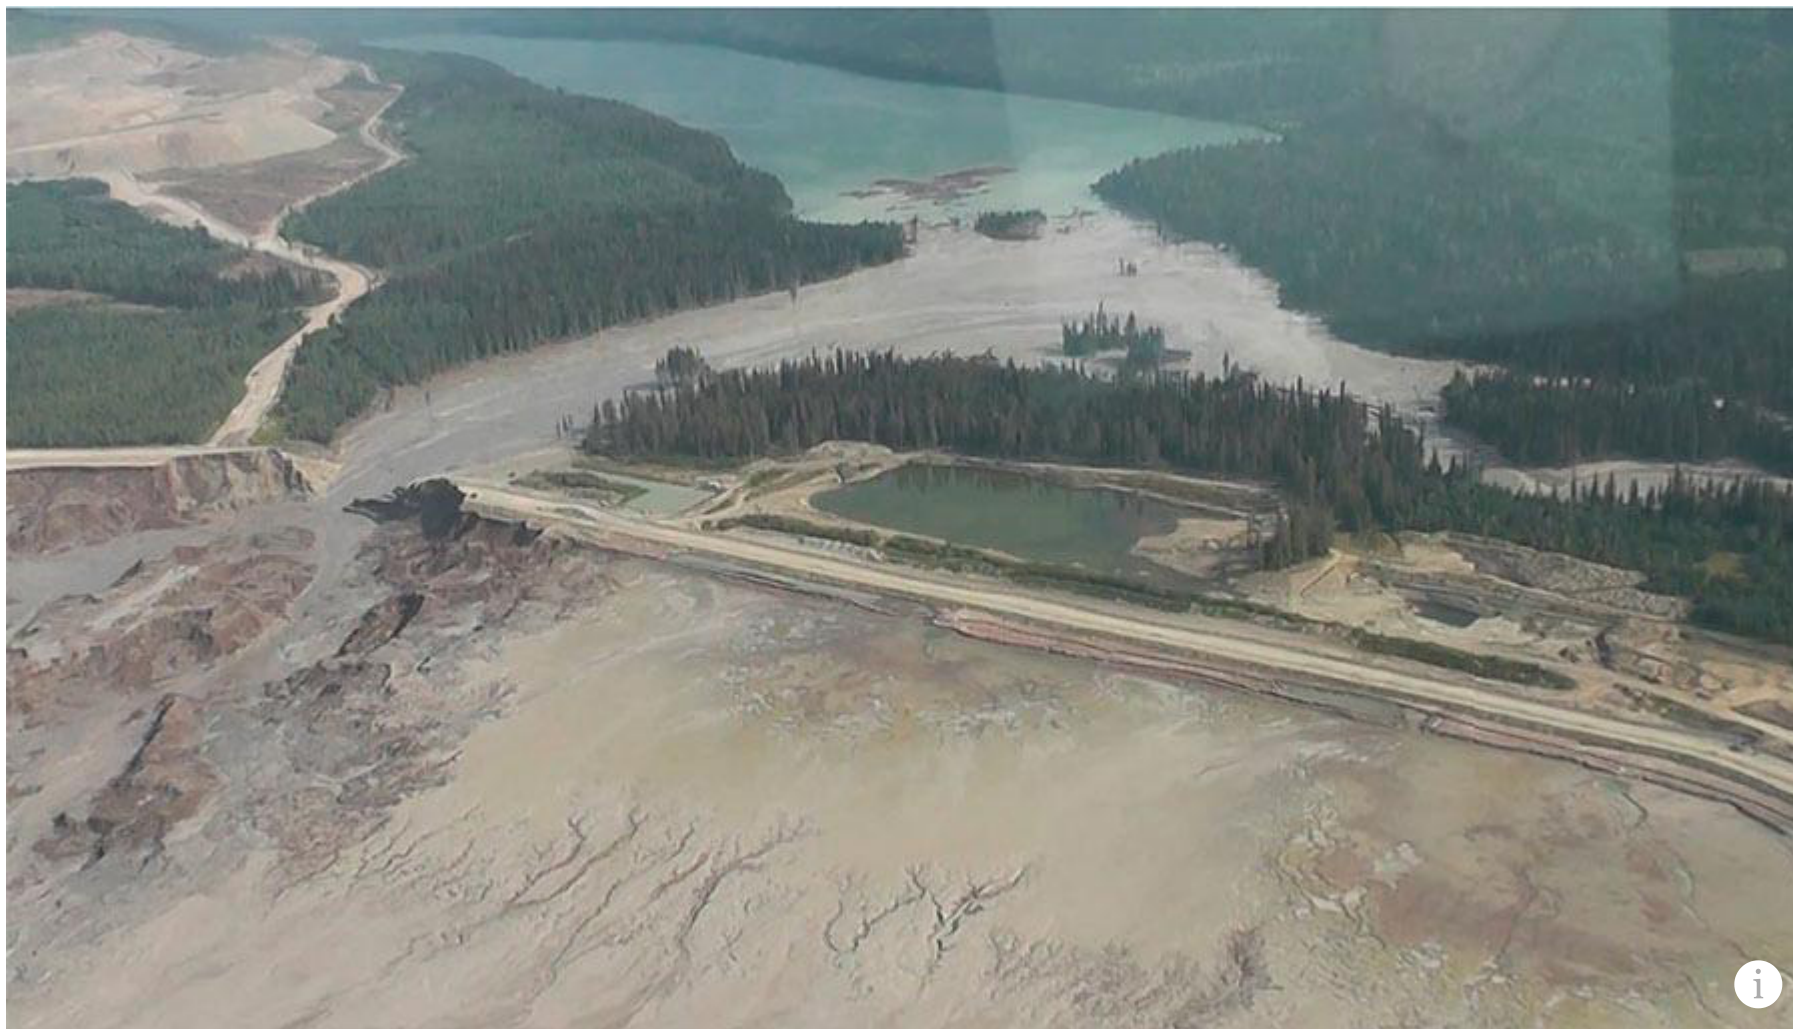
The Mt. Polley dam failed because of an unidentified glacial clay layer that caused the dam to "slump" (i.e., the dam crest dropped approximately 3-5 m as depicted in Figure 1). This slumping allowed the impounded water to flow over the crest of the dam, initially very slowly. However, within approximately ½ hours, the flow rate continued to increase and eventually led to catastrophic release of water and tailings.
