Failure Analysis on Premature Fracture of Polyethylene Pipe for Floor Heating System

Abstract Polyethylene (PE) pipes are widely used in floor heating system due to their corrosion resistance, low cost and other advantages. This paper investigated the premature fracture of PE pipe for floor heating system in a residential building in the northern part of China for only serving less than 3 years, while the design service life was 50 years. In order to ascertain the root causes of this failure, a series of macro- and micro-scope characterization methods were conducted. The comprehensive analysis results showed that failure mechanism of the failed pipe was slow crack cracking with defects. Low molecular weight and substandard molecular weight distribution are the root causes of that premature fracture. Excessive bending, fibrous inclusions and shrinkage holes in the matrix are also important causes of the failure. Subsequently, the influence of polymer molecular weight on the mechanical properties of materials and the micro-configuration response of polymer pipes under tensile stress was analyzed in depth. It is theoretically demonstrated that polymer microstructures such as molecula

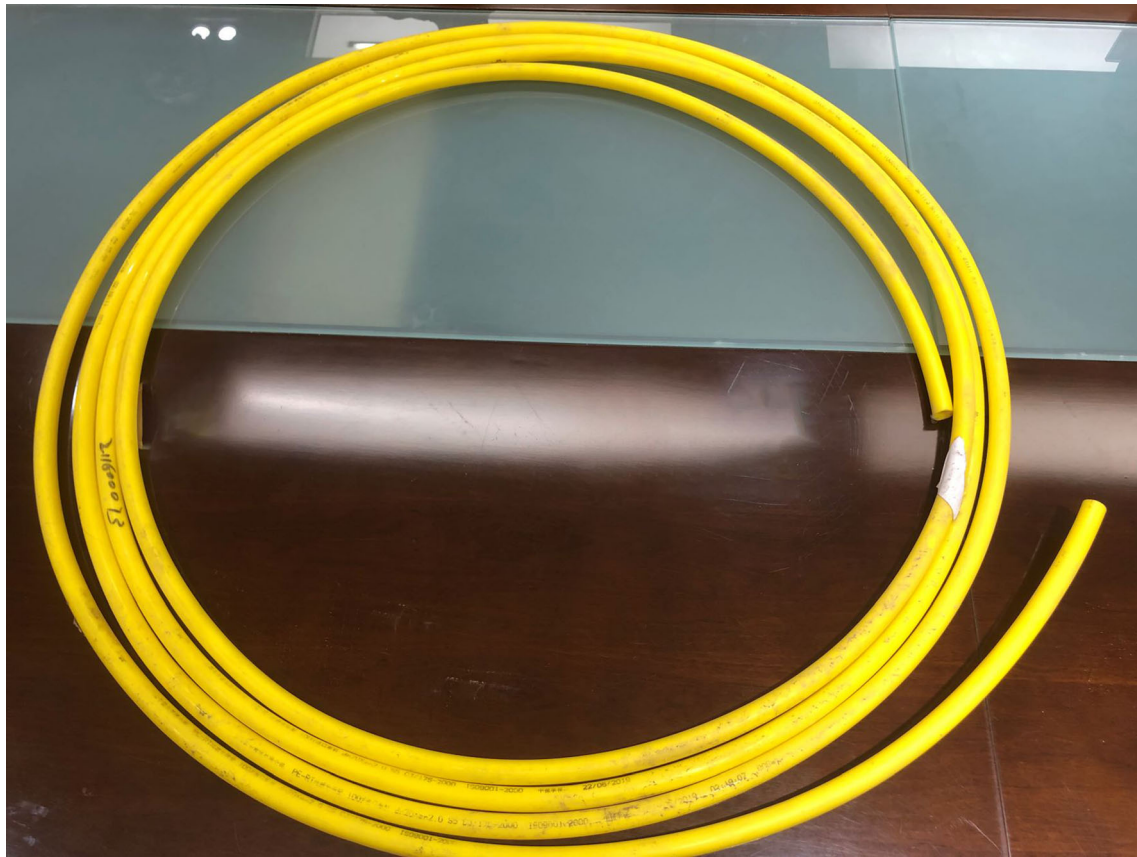
This paper conducts failure analysis on a premature fracture of PE pipes for floor heating system in a residential building in northern China. The designed service life was 50 years, while multiple fractures occurred in less than three years of service. As shown in Fig. 2, the failed floor heating pipeline studied in this article is a set of coiled tubes. Coils are easier to bend than straight pipes and therefore use fewer joints, thereby improving structural integrity and safety reliability. However, due to the special structural characteristics of coils, excessive bending often occurs during construction and installation.

Fig. 2 Appearance of floor heating pipe
