Geotextiles and Geomembranes

Investigations of geomembrane integrity within a 25-year old landfill capping

Investigations have been undertaken at a 16 ha landfill capping to assess performance of the geomembrane component some 20–25 years after installation. The site has been the subject of quite extensive monitoring together with hydrological and other studies. Although environmental monitoring has shown no major concerns, there have been discrepancies in calculated water balance, leading to the recent investigations reported here. The capping, which is an interim solution, comprises about 1 m of cover soils over 0.375 mm LDPE geomembrane and surrounded by a perimeter drain. A robust final capping system will be constructed at a later date. Various remedial works were undertaken between 2010 and 2014 at the cap perimeter drains, also at a series of gas vent/probe holes through the geomembrane, to address the discrepancies in water balance, and the opportunity was taken to investigate the condition of the geomembrane which revealed a series of unanticipated gaps in the geomembrane. These investigations were subsequently extended over the whole cap to characterise the nature and e

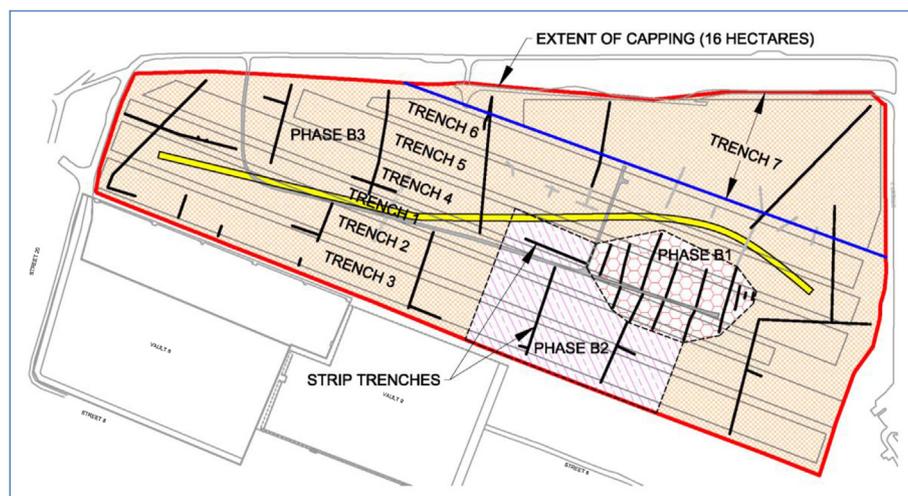
During these initial repairs and investigations, significant unexpected damage was identified to the geomembrane in places, essentially at seams, including gaps/areas of missing geomembrane. Additional investigations were undertaken to identify the nature, location and extent of that damage. The scope of these additional investigations was amended and extended as greater knowledge was obtained, ultimately comprising three further phases of investigations, B1, B2 and B3, described below and indicated in Fig. 7.

Fig. 7. Site plan: positions of 2013 strip trenches (black) and inferred position of original construction-phase haul road (yellow) at crest of cap. (For interpretation of the references to colour in this figure legend, the reader is referred to the web version of this article.)

Ultimately three phases of additional investigations were implemented, with the areal extents of investigations increasing each time until the full extent of the trench cap had been investigated to some degree (Fig. 7). It was initially thought that the main damage might be in a limited area around the southern crest and associated with a construction haul road (Fig. 9). As the investigations proceeded it became clear that this was not the case. Strip trenches of about 1 m width were located throughout the cap area, essentially random, but extended to follow seams, particularly where gaps were found (Fig. 10).
