International Journal of Applied Earth Observations and Geoinformation

New insights into the 2020 Sardoba dam failure in Uzbekistan from Earth observation

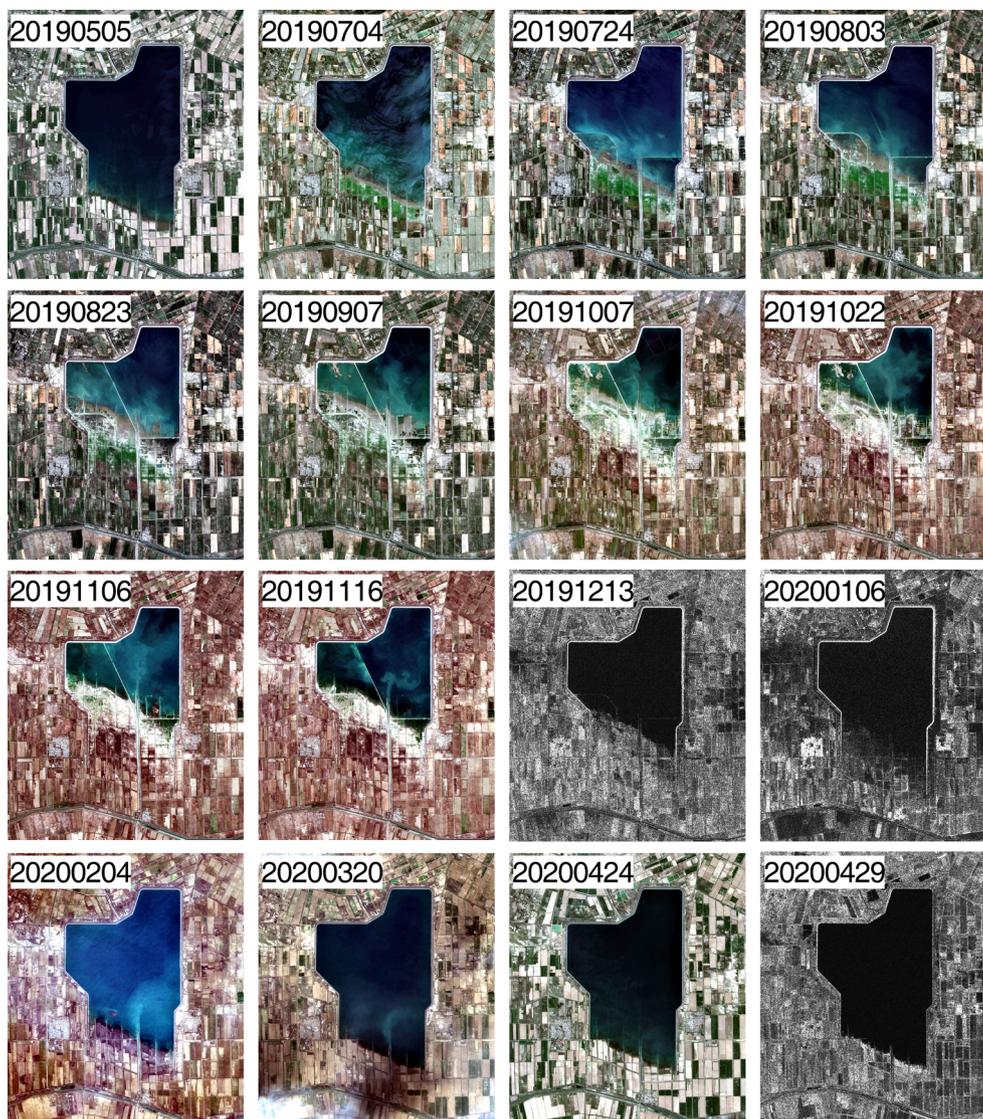
Fig. 3. Remote sensing images show the water area changes in the Sardoba Reservoir from May 2019 to April 2020. The optical images in colour are from Sentinel-2 satellites, and the SAR images in grey (dated 2019-12-13, 2020-01-06 and 2020-04-29) are from Sentinel-1 satellites.

filling happened in the Sardoba Reservoir, one of which is shown in Fig. 3. Therefore, the south sections of the dam underwent two "first fillings". Also, the external loads from the reservoir at the south sections are smaller due to the shallow water. To a certain extent, these may have contributed to the insignificant horizontal displacement in the south dam sections.

evacuation, and refilling) of significant water level changes occur during the study period, one of which is shown in Fig. 3. However, the deformation time series for the five selected sites (Fig. 10) show quasi-linear subsidence, and none of them presents clear rhythm relevant to changes in water level. This suggests that consolidation governs the settlement of the Sardoba Reservoir dam, although the deformation is controlled by both the dissipation of excess pore water pressure and seepage pressure.

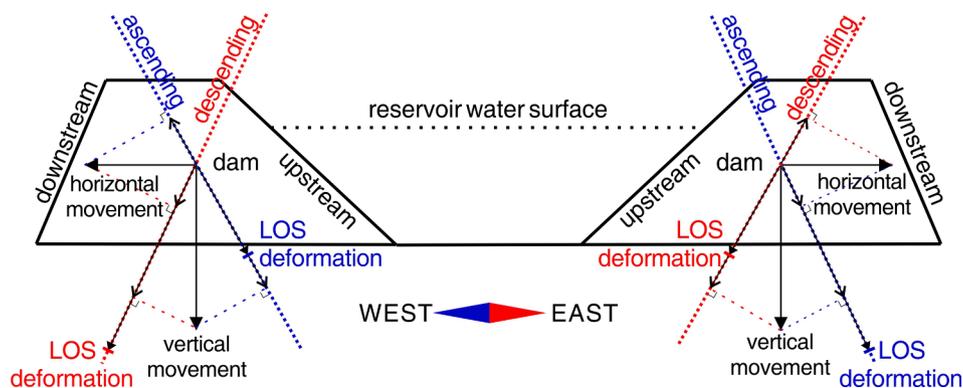
Fig. 8. A diagram shows the geometries between InSAR LOS observations and dam motions.

and vertical movements of the dam are projected onto the satellite ascending and descending LOS directions. As the embankment moves eastwards and downwards, the deformation magnitude in the ascending track is larger than that in the descending track. That is because the deformation components cancel each other out when projected to the descending track. A single geometric observation does not provide accurate measurements and may lead to misinterpretation of the dam's deformation pattern, as the LOS displacement may differ noticeably from the real motion. This explains the difference in deformation observed by SAR instruments with different look angles and why we need to combine the ascending and descending images to reveal more accurate dam motions.
