MSE Wall Failures Lessons Learned

Jim Collin, Ph.D., P.E., D.GE., F. ASCE The Collin Group, Ltd. jim@thecollingroup.com

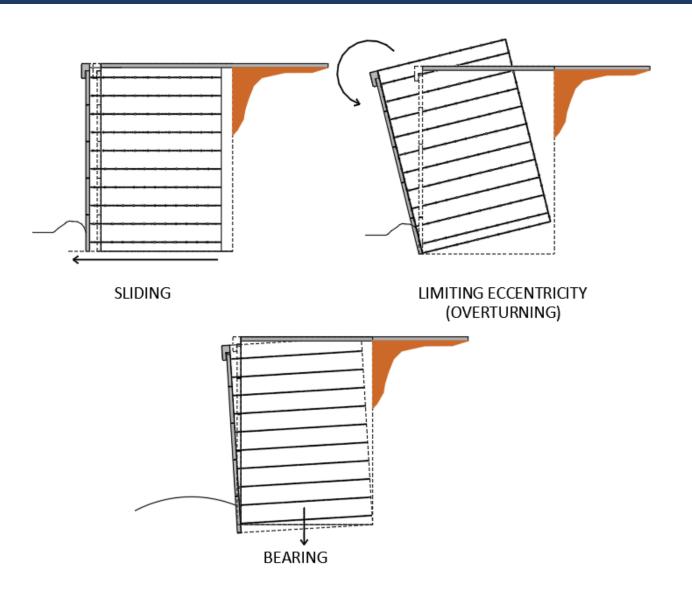
FGI External Stability

- Internal Stability met industry standard factors of safety for both the as-design and as-built (i.e., rupture and pullout).
- External Stability met industry standard factors of safety for both the as-design and as-built (i.e., bearing capacity and sliding).

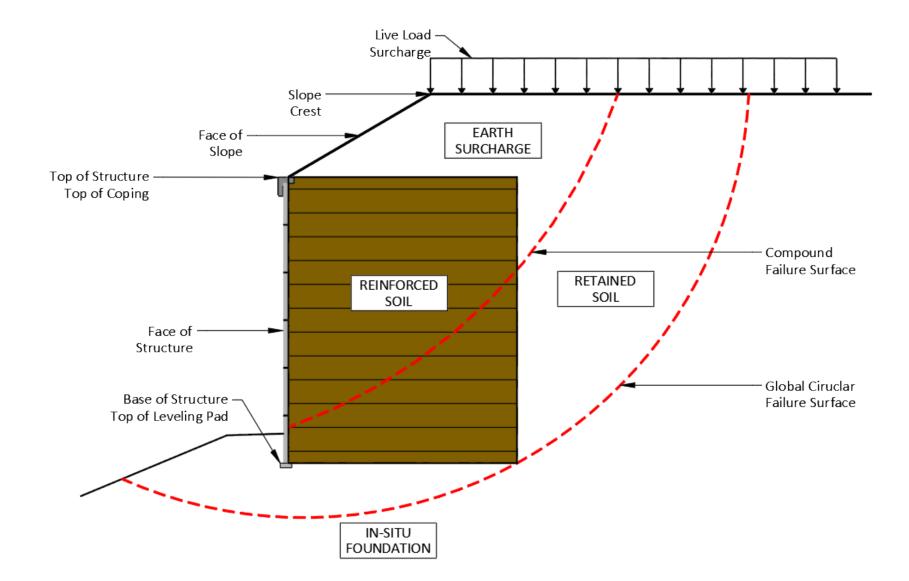
Global & Compound Stability

- Grade bottom of wall not level slopes at 14°
- Soils used to construct wall are not free draining (35% fines), no external drainage was provided
- Direct shear testing of foundation soils peak effective friction angle of 28 degrees
- Shear strength of foundation soil (ϕ = 28°) is less than used in original design (ϕ = 30°)
- Surcharge from strip footing is greater than 100 psf assumed in design (actual 1000 psf)
- Post construction borings showed groundwater at the bottom of the wall, original design assumed no ground water

Description	ϕ_{F}	Sloping Toe	Surcharge	Water elev.	FS _{global}	FS _{sliding}	FS overturn
As designed	30	no	100	170	1.3	>1.5	>2.0
As built	28	yes	100	170	1.25	>1.5	>2.0
As built	28	yes	100 + 1000 strip	170	1.14	>1.5	>2.0
As built water @ El 194	28	yes	100 + 1000 strip	194	0.89	>1.5	>2.0

- Water is the trigger to most failures
- Drainage structures should be included as part of the wall design
- Site conditions should be verified by the wall designer
- Global stability is a critical component of the design of an SRW
- Include instrumentation to monitor the structure during the remediation

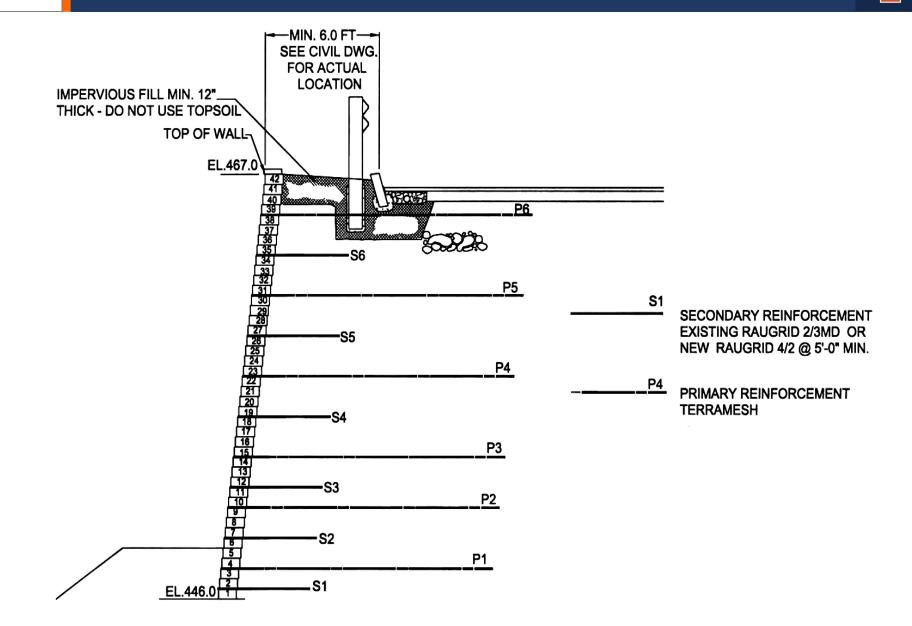
FGI SRW Design Cross-Section

- Did not consider connections
- Used proprietary software for one SRW system and substituted another system with different connection properties
- Did not consider hydrostatic effects on stability

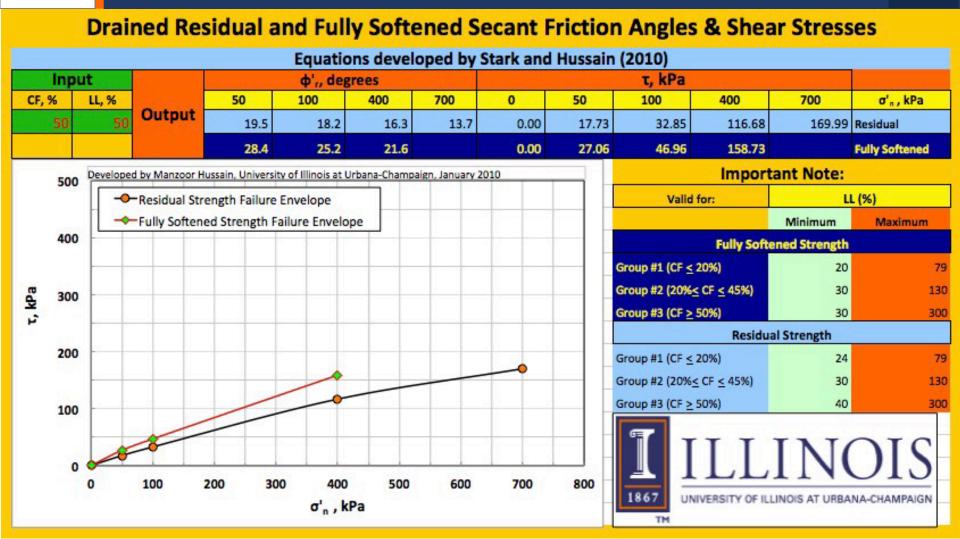
CL Properties

CL directly below wall normal load 50 kPA use $\varphi = 28^{\circ}$
