In-pipe Ultrasonic Inspections of Mud and Tailing Lines: how to manage difficult to remove Scaling, provide quality and accurate Defect Assessments of steel and HDPE

A. O'NEILL¹; H. QUAKKELSTEIJN² > ¹RIO TINTO YARWUN REFINERY; ²INTERO INTEGRITY SERVICES AUSTRALIA

RTY has been working since 2019 to introduce Intero's Pipeline Surveyor as inspection technology for difficult-to-inspect mud, slurry, and caustic pipelines. In 2021 an inspection was carried out on an 8kms steel mud line of DN750.

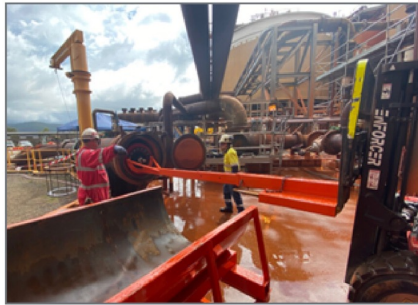
Figure 2: Launcher location during launch of gauging bidi

For launching the permanent installed equipment was to be used. The launcher was, however, likely designed for MFL operations. To launch the single body Surveyor correctly a special push rod was designed to safely push it into position.
