Aging of drinking water transmission pipes during long-term operation as a potential source of nano- and microplastics

Joanna Świetlik^{*}, Marta Magnucka

Adam Mickiewicz University, Faculty of Chemistry, Department of Analytical and Environmental Chemistry, Uniwersytetu Poznańskiego 8, 61-614, Poznań, Poland

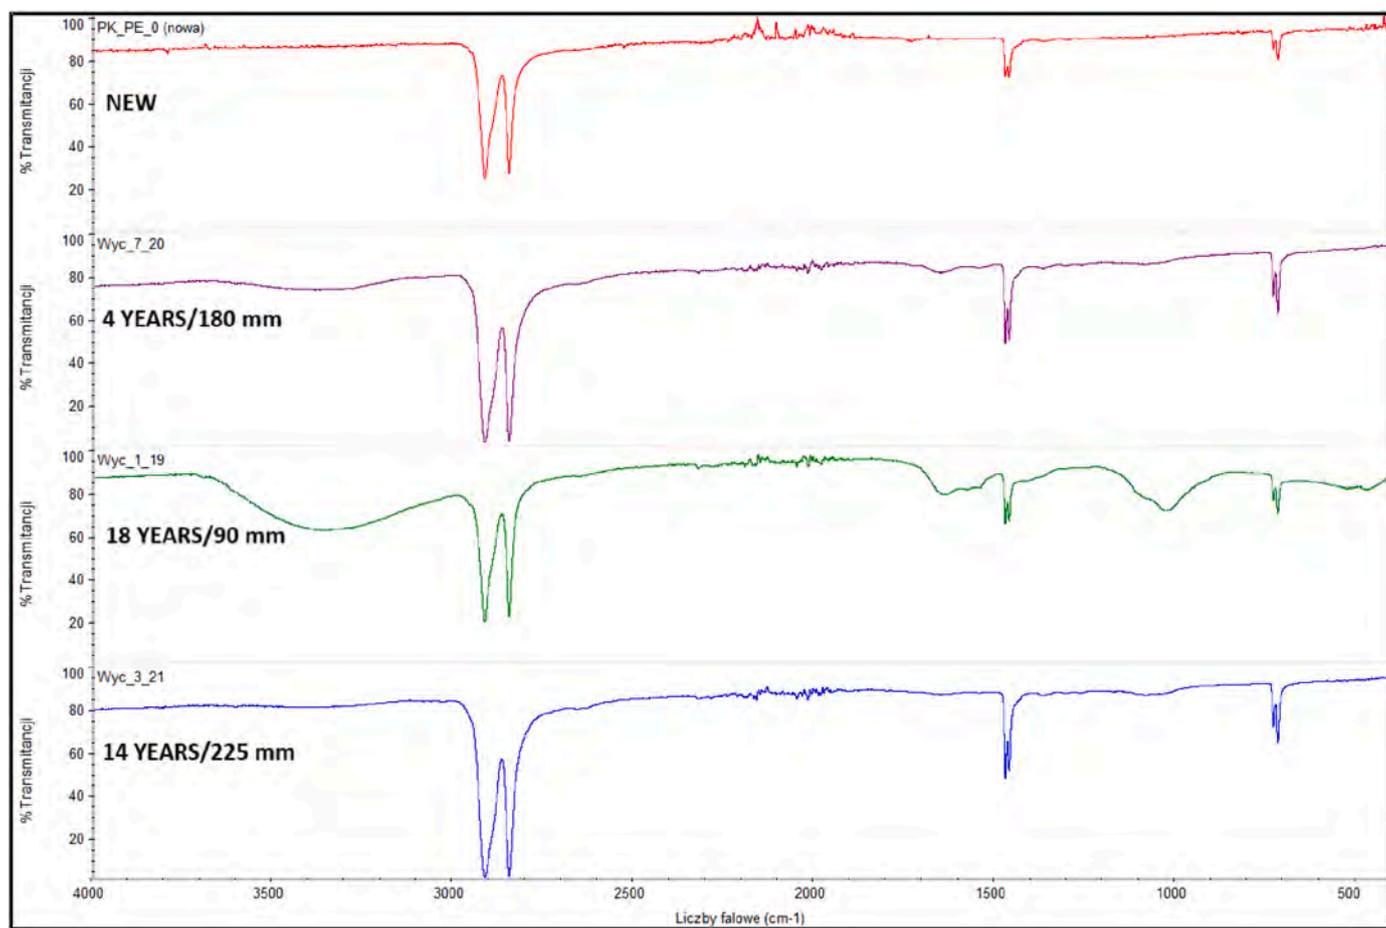
Fig. 3. ATR-FTIR spectra recorded for PE pipes.

Analysis of the ATR-FTIR spectra (Fig. 3) and determination of the carbonyl index (CI) provided more information on the aging process of the analyzed pipes. The results showed that during the operation of polyethylene water pipes, the degradation processes taking place extend into the deeper layers of the material. In addition to bands in the region of 2950–2850 cm⁻¹; 1460–1470 cm⁻¹ and 720–730 cm⁻¹, which are characteristic of PE and originate from stretching and bending vibrations of the -CH₂ groups building the polymer chain (Almond et al., 2020; Kerr et al., 2013; Abaroa et al., 2022; K  ppler et al., 2018), the spectra recorded the formation of new bands in the ranges of 3360–3370 cm⁻¹, 1700–1520 cm⁻¹ and 1180–900 cm⁻¹. Their intensity increased with the time of pipe operation and was particularly evident for pipes of small diameters. The presence of bands in the 3360–3370 cm⁻¹ range, attributed to the presence of the -OH group, is most likely

related to an increase in PE roughness, leaching of additives from deeper layers resulting in the formation of voids between polymer chains (formation of a sponge-like structure that facilitates the migration/diffusion of water and other contaminants, both from the transferred water and from the external environment (Whelton et al., 2011; Zhang et al., 2018; Song et al., 2021; Davis et al., 2007; Tang et al., 2013; Rysel et al., 2015)) and/or oxidative degradation of both the antioxidant coatings and the plastic itself. The co-occurrence of these, increasing over time, damages result in an increase in: 1) wettability, 2) water retention capacity of the polymer structure, and 3) hydrophilicity of the PE surface, associated with the formation of hydrophilic breakdown products of the protective coatings and the polymer itself (containing -COOH and -OH groups) in reaction with disinfectants present in distributed water (Fernández et al., 2021). On the other hand, the bands appearing in the range of $1700\text{--}1520\text{ cm}^{-1}$, with clearly marked maxima at 1650 cm^{-1} and 1550 cm^{-1} , are related to the appearance of an

increasing number of -C=O, -COOH and -CH=CH₂- groups, associated with oxidation and cleavage of the polymer chain occurring in the material, which results, among others, in the formation of biodegradable ketones and carboxylic acids (Fernández et al., 2021). The presence of a broad band with a maximum at $1010\text{--}1030\text{ cm}^{-1}$ attributed to the presence of an ether group (Kerr et al., 2013; Fernández et al., 2021) is also a direct indicator confirming the degradation of PE under the influence of factors causing oxidation and cleavage of bonds building the polymer backbone (such as residual disinfectant). This band is particularly well visible for pipes with small diameters and long service life (Fig. 3). Changes in intensity and width in the area of the band's characteristic of PE were also noted. In the case of pipes with a lower degree of degradation (shorter service life and/or larger diameters), their intensity increased, which is associated with an increase in disruptions of the crystallinity in polymer structure and thus an increase in amorphousness leading to increase in water binding capacity (Kerr et al.,

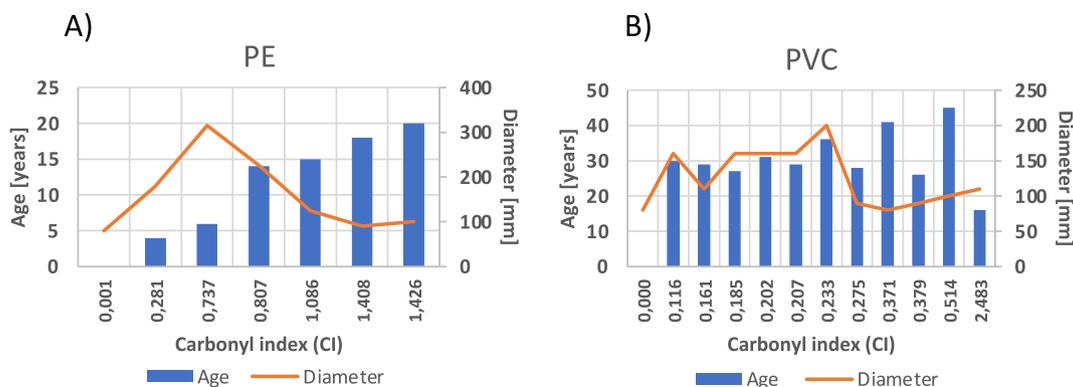
Fig. 4. Carbonyl index (CI) values as a function of pipe diameter and service life: A) PE and B) PVC.

2013; K appler et al., 2018). This effect was less pronounced for the more heavily degraded materials, in which the formation of PE oxidation products manifested by the appearance of the previously described new bands occurred. The carbonyl index determined from the ATR-FTIR spectra confirmed the increasing degradation changes in the PE structure over time. The CI value increased with pipe age up to a value of 1, 426 and was higher for small diameters than for pipes with large cross-sections in the longest service life (Fig. 4A).

respectively (Fig. 4B). For large diameters, the CI values were very similar. An exception among the materials tested was a 110 mm diameter pipe that had been in service for 16 years and had the highest CI (2, 483), indicating a very high degree of degradation of this material. It is likely that the pipe was made of low-quality PVC. For pipes operating for about 30 years, similar CI values were obtained (in the range of 0,075–0, 202), while for the longest-operating pipes these indices increased, taking values of 0,371 after 41 years of operation and 0,514 for a 45-year-old pipe.

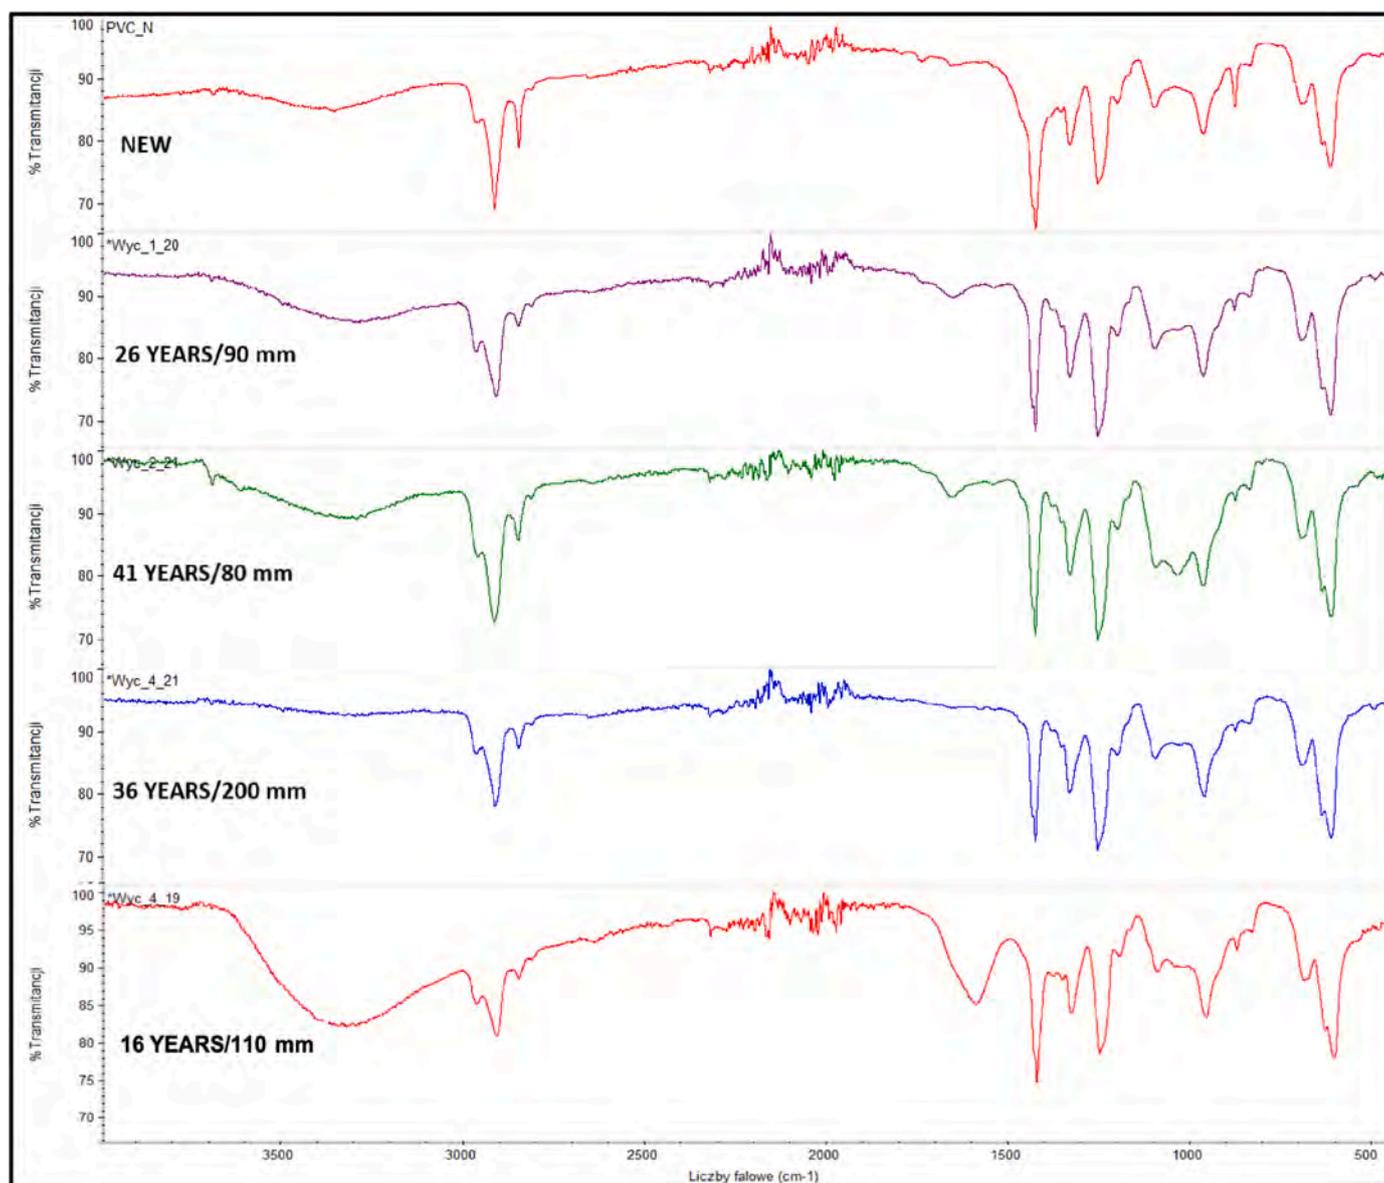
Fig. 9. ATR-FTIR spectra recorded for PVC pipes.

identification of changes in the chemical structure of the material occurring during aging. All analyzed fragments had bands characteristic for PVC in the areas $2800\text{--}3000\text{ cm}^{-1}$ and $1200\text{--}1430\text{ cm}^{-1}$ originating from stretching and bending vibrations of -CH and =CH_2 groups, as well as bands 690 cm^{-1} and 610 cm^{-1} , which confirm the presence of -C-Cl group in the structure and serve to identify the polymer type (Kerr et al., 2013; K  ppler et al., 2018). Changes in the intensity of characteristic PVC bands and the appearance of new signals were observed, confirming the gradual degradation of the tested materials. In small-diameter pipes, the intensity of the bands at $2800\text{--}3000\text{ cm}^{-1}$ and $1200\text{--}1430\text{ cm}^{-1}$ increased with service time, while in larger-diameter pipes this effect was barely visible (Fig. 9). An increase in the intensity of the bands associated with -C-Cl stretching vibrations ($700\text{--}550\text{ cm}^{-1}$) was noted in all the materials analyzed, which may indicate degradation of the polymer structure. The spectra recorded for small-diameter tubes also showed the appearance of new signals in the range $1700\text{--}1500\text{ cm}^{-1}$ with maxima at 1650 and 1530 cm^{-1} , also visible on PE spectra, attributed to polymer chain scission and the formation of oxidative degradation products containing -C=O , -COOH and -CH=CH_2 groups (Fern  ndez et al., 2021). Additional confirmation of the degradation of PVC chains and the formation of its oxidation products are bands appearing in the $1100\text{--}980\text{ cm}^{-1}$ region originating from groups containing oxygen in their structure (Solovyeva et al., 2021). Their intensity increased with time of operation and was particularly pronounced for pipes with small cross-sections. Similarly to PE, bands originating from water ($3360\text{--}3370\text{ cm}^{-1}$) also appear on the spectra recorded for PVC (Solovyeva et al., 2021). Confirmation of the degradation of the PVC polymer backbone by oxidation, particularly intense in small diameter pipes, was provided by changes in the contact angle values. For PVC pipes, slightly higher CI values were observed for small diameters than for large diameters, amounting to $0,202\text{--}0,514$ and $0,11\text{--}0,207$,

The youngest of the analyzed cuttings worked in the distribution network for only 16 years, which indicates that degradation processes occur on the surface of PVC from the first years of their operation (Fig. 9). In addition, during the formation of cavities, most likely as a result of peeling and detachment of the polymeric material, numerous fragments of varying morphology are formed, classified mainly as nanoplastics, which can be released into the distributed water. Thus, the aging process of PVC under operating conditions can be a significant source of microplastics in tap water.
