Effects of Ultraviolet Radiation on Recycled and Virgin HDPE Corrugated Pipes Used in Road Drainage Systems

Abstract

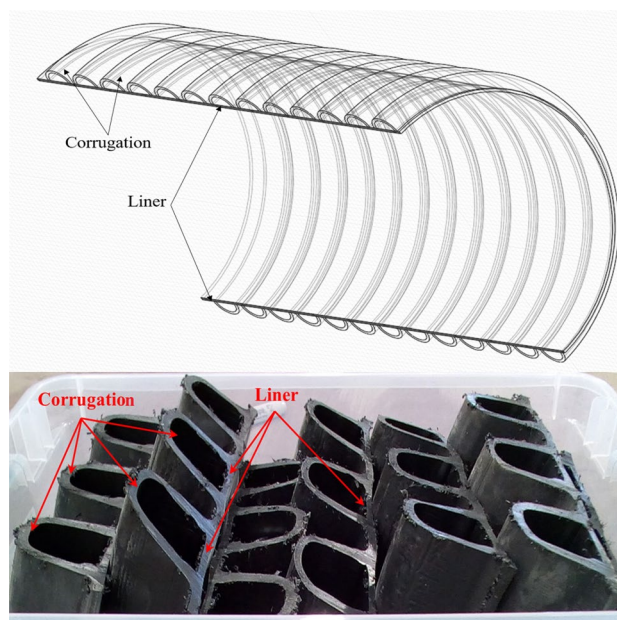
Fig. 1 A sectional view of an HDPE pipe showing the location of the corrugation and liner

Small specimens (15 mm × 15 mm) were cut from the corrugated part of the pipes with the exception of tensile specimens. To avoid bending due to the shape of the corrugated part and facilitate cutting, the tensile specimens were taken from the pipe liner (Fig. 1). The specimens cut from the corrugated parts of pipes A-R, A-V, B-R, B-V, C-V, and D-R were 7.30, 7.30, 7.80, 7.80, 3.25, and 4.50 mm thick, respectively. The tensile specimens cut from pipes A-R, A-V, B-R, B-V, C-V, D-R were 4.80, 4.40, 7.50, 7.60, 2.70, and 3.80 mm thick, respectively. The sections below provide details about specimen shape and dimensions.

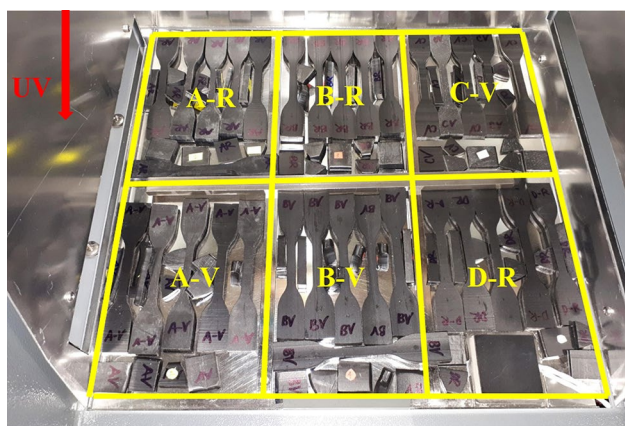
Fig. 2 Specimens placed for aging in the UV chamber

Specimens were placed under fluorescent UVA in a test chamber that simulates the spectral irradiance of daylight, as shown in Fig. 2. To reduce the effect of humidity on the UV aging of the pipes, the cycles for irradiance of 0.89 W/(m² nm) at a wavelength of 340 nm in accordance with ASTM D4329 (2013), procedure A [33], were modified in our study. Specimen conditioning consisted of a 12-h cycle, comprised of 8 h of UV radiation at 60 °C and 4 h with no UV radiation at 50 °C, corresponding to no water condensation. The test exposure time was 3600 h.

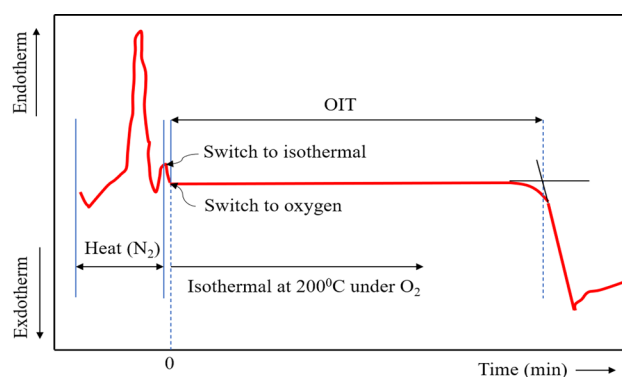
Fig. 3 Evaluation of OIT from recorded time-based thermal curve

The OIT of the unexposed and UV-exposed HDPE pipe specimens was measured with differential scanning calorimetry (DSC 6000 by Perkin-Elmer) in accordance with ASTM D3895 (2019) [35]. A 5 to 10 mg specimen was heated from room temperature to 200 °C at a rate of 30 °C/min under nitrogen. After an isotherm of 1 min, the gas was switched to oxygen. After some time, an exothermic peak appeared and the time corresponding to the onset was taken as the OIT value. Figure 3 provides a typical OIT assessment from a recorded time-based thermal curve.

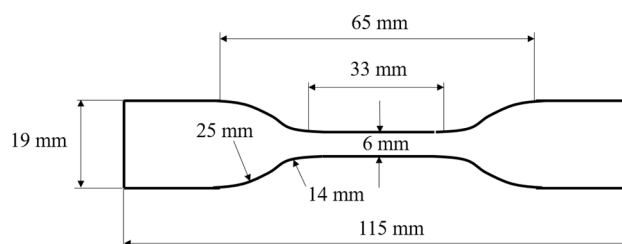
Fig. 4 Typical dog-bone specimens for evaluating tensile strength

The tensile properties of HDPE pipes were evaluated according to ASTM D638 (2014) [32] with dog-bone specimens. Tensile specimens were punched directly from the pipe liner with a stainless-steel die. The specific geometry of the specimens is described in detail in ASTM D638 (2014) and illustrated in Fig. 4. This test was conducted at 23 °C with an MTS universal testing machine equipped with a 5 kN load cell. A constant crosshead speed was maintained at 50 mm/min. A 634.12F-24 extensometer was used to measure sample extension. The stress–strain curve of the unexposed and UV-exposed HDPE specimens was reported after five replicates. The average tensile, elastic modulus values, and standard deviation were determined for each pipe.

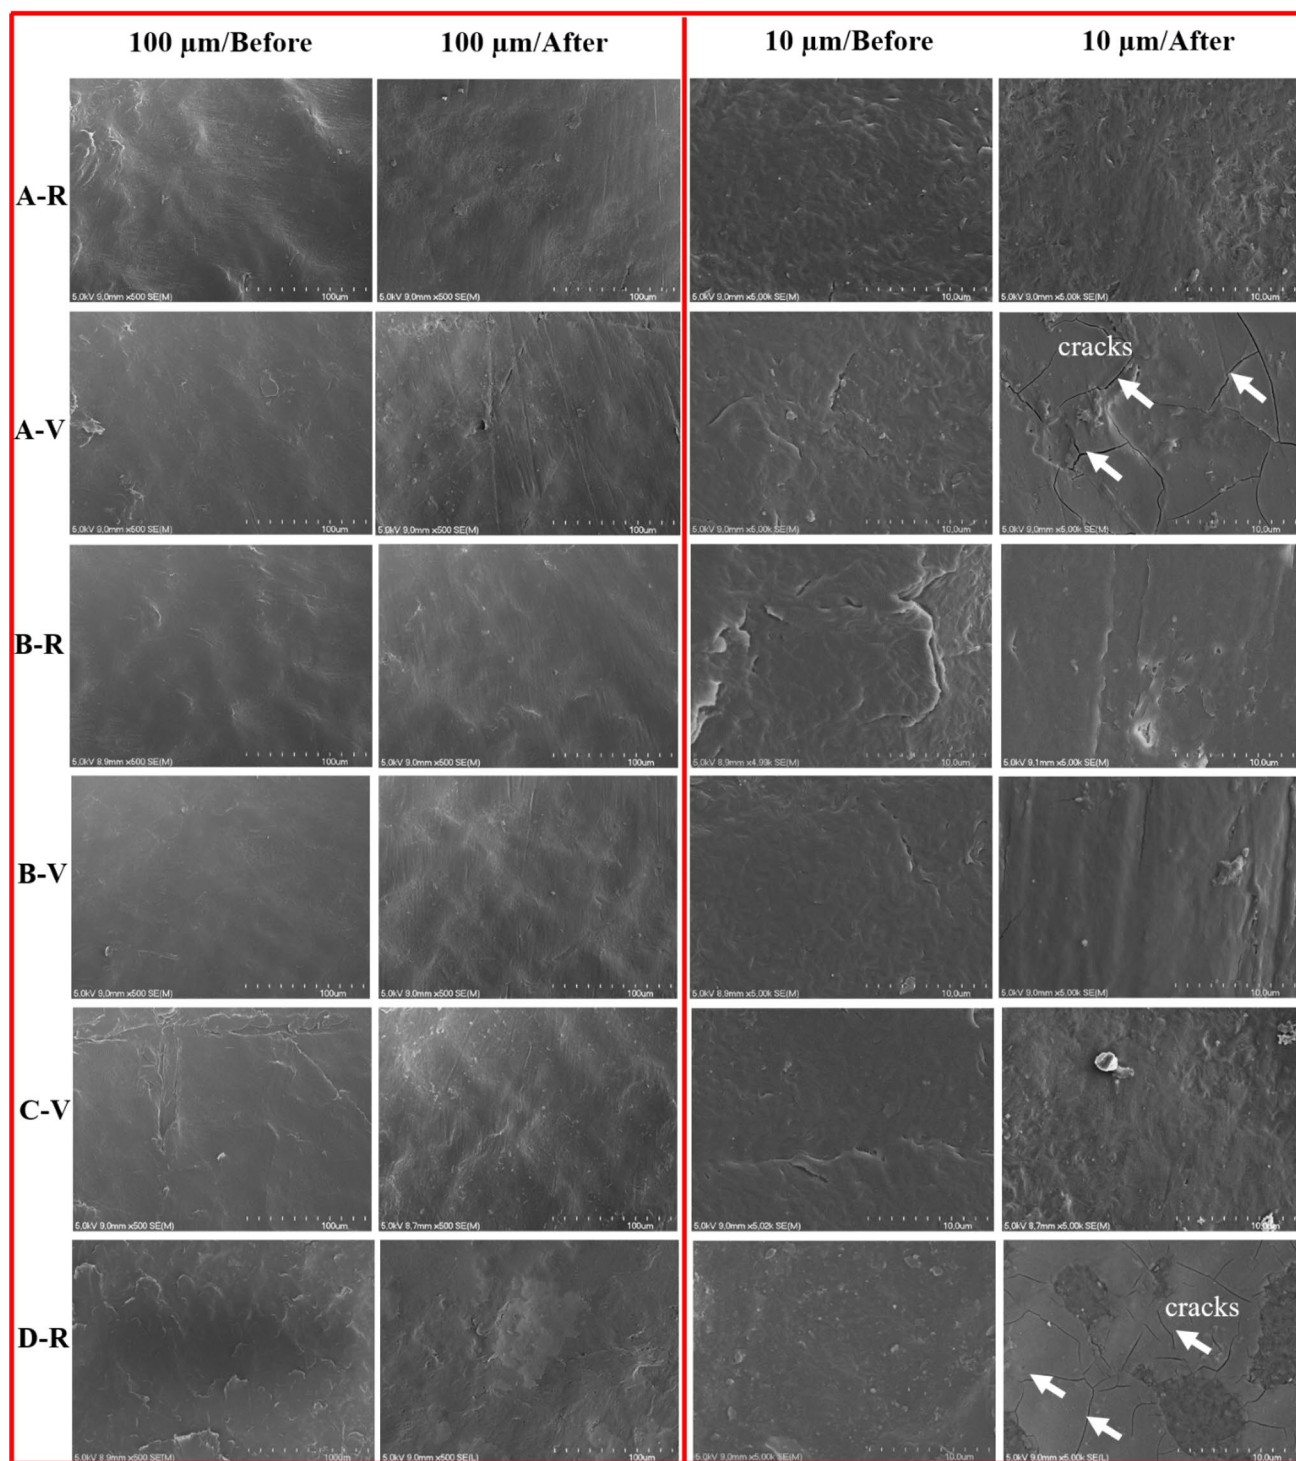
Fig. 6 Morphological structure of HDPE pipes before and after UV exposure at scan widths of 100 μm and 10 μm

SEM analysis of the surface of the HDPE pipes before and after exposure was carried out to observe any changes caused by UV radiation (Fig. 6). In general, as the SEM micrographs show, the specimen surfaces were relatively smooth at scan widths of 100 μm and 10 μm before UV exposure. After 3600 h of irradiation, the specimen surface at the scan width of 100 μm evidenced no morphological changes. At the scan width of 10 μm , some cracks were observed on the surface of pipes A-V and D-R, possibly due to UV radiation. The presence of vinyl and carbonyl groups observed under FTIR created more brittle materials, which

led to the formation of superficial microcracks in specimens A-V and D-R [41, 42]. These microcracks only occurred on one light area (contaminant) of the sample surfaces and not on the darkest areas (resin). EDS (energy dispersive spectrometry) analysis revealed that these two areas had different chemical compositions (Fig. 7). The darkest areas were constituted of elements in the resin compound (mainly carbon); the lightest areas contained nitrogen, sulfur, and oxygen. The EDS spectrum shows peaks at around 0.29 and 0.55 keV corresponding to carbon and oxygen, respectively. Nitrogen and sulfur were detected in the lighter area, which was presumably contaminated, but not present in the darker zones constituted of neat resin. It should be noted that the samples were wiped with alcohol prior to analysis to prevent contamination. Consequently, it could be assumed that it was not the HDPE itself that was microcracked, but rather a contaminant probably deposited during the manufacturing process.

similar for specimens after UV exposure. When the scanning width was 10 μm , some cracks appeared on the surface of virgin pipes (A-V) from manufacturer A and recycled pipes (D-R) from manufacturer D. This was not observed for either recycled or virgin pipes from manufacturer B.
