Adjusters' Insight

Coating Failures and their Costly Consequences

Andrew Hodkinson, Regional Head and Senior Resources Adjuster –
Australia & New Zealand

Dr John Scheirs, Director, ExcelPlas

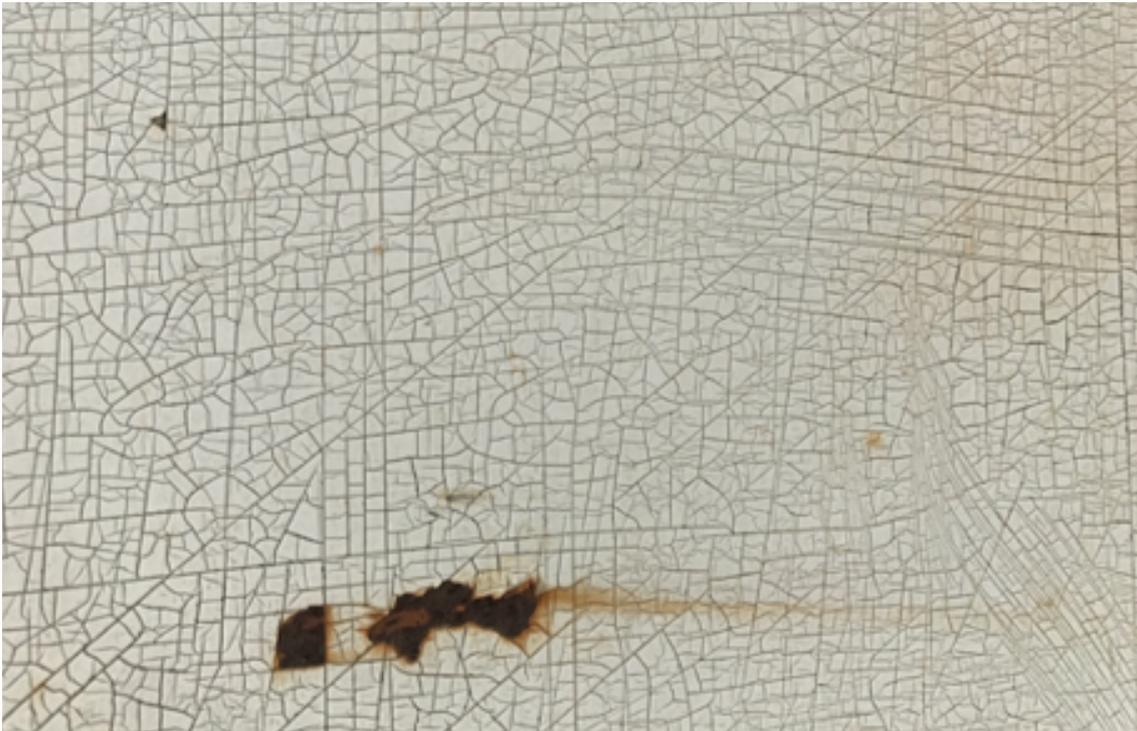
Mosaic Cracking and Underlying Corrosion of an Epoxy Coating on a Metal Tank (Source: ExcelPlas)

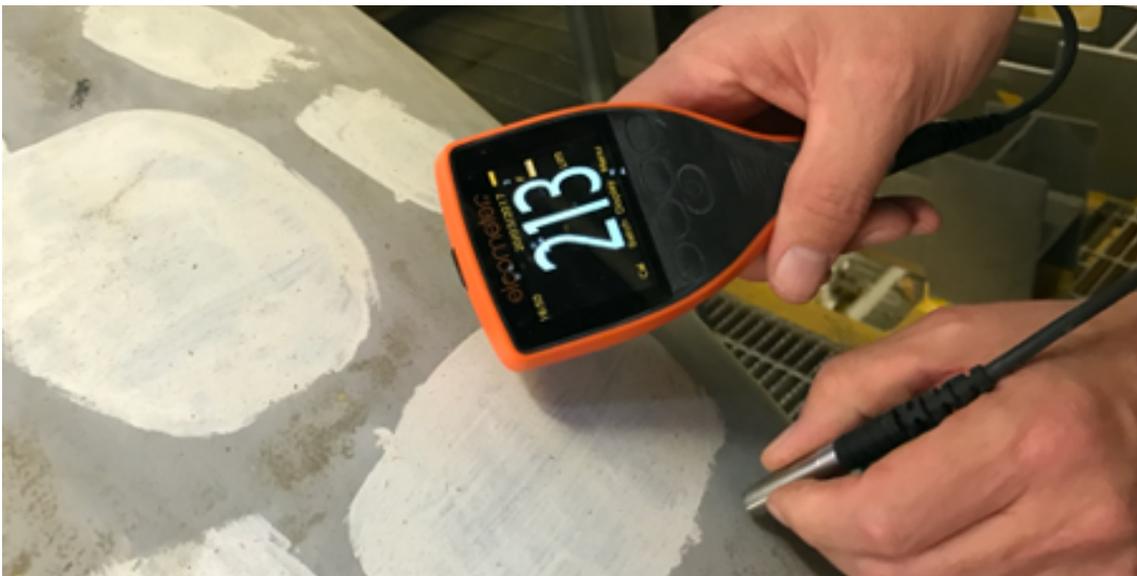
Measuring Dry Film Thickness (DFT) of an Epoxy Phenolic Coating (Source: ExcelPlas)
