## A Comprehensive Analysis of PVC Pressure Pipelines' In-Service Performance

Bob Walker, P.E., M.ASCE<sup>1</sup>

### ABSTRACT

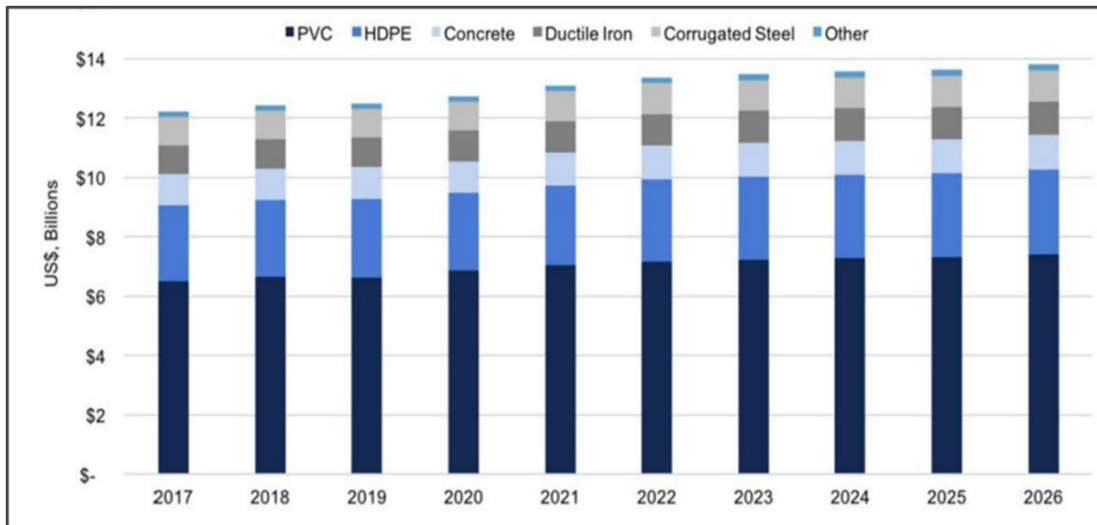
**Figure 1. Total U.S. municipal water and sewer pipe investments by material type, 2017-2026 (Bluefield 2017)**

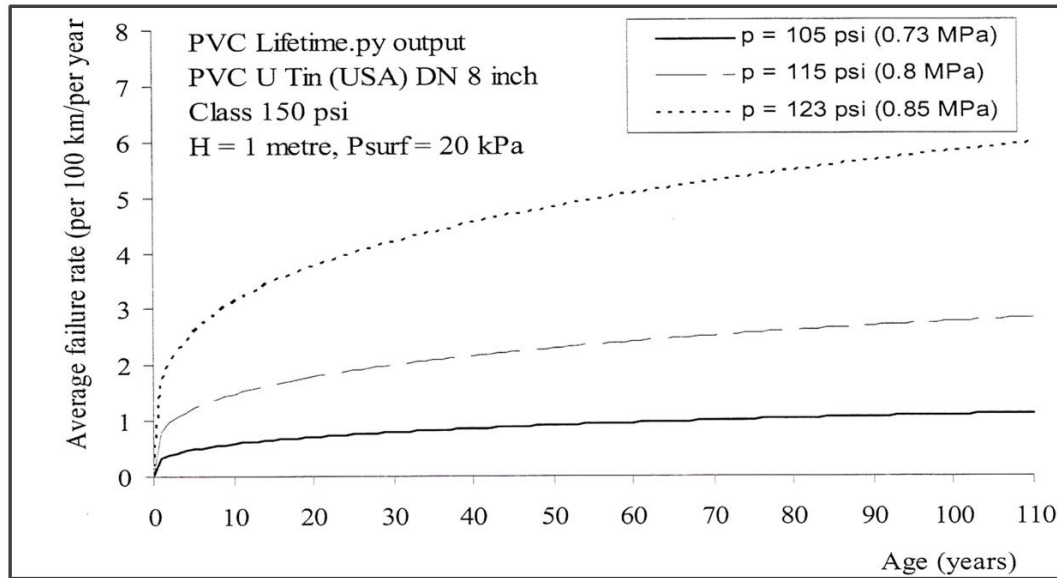
**Figure 3. Average Failure Rate Versus Age for Class 150 psi, PVC Pipe (Burn 2005)**

Absent significant material degradation, PVC pipe breaks are nearly always the result of localized elevated stresses that greatly exceed the stresses caused by the anticipated internal operating pressures (AWWA M23 2020, Burn 2005, Shumard 2006, Winn 2018, Youssef 2008). Figure 3 depicts in-service PVC pipe break rates over 110 years (Burn 2005). PVC pipe's asymptotic failure rate pattern has substantiated the product's inherent resistant to in-service degradation and supports that failures are primarily caused by localized high stresses.
