Detecting Corrosion in Online Insulated and Bare Piping Using Automated Radiographic Testing Technology

Ian Moreau, Technology Manager MISTRAS Group, Inc.

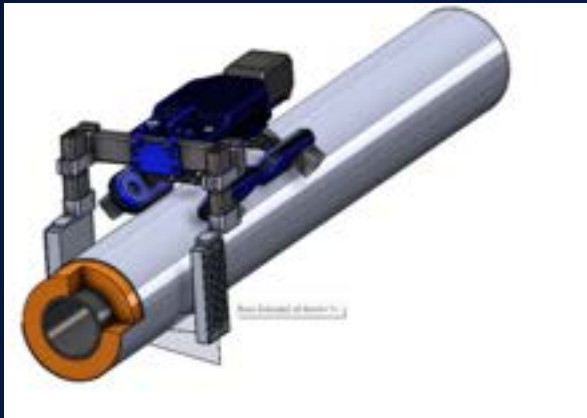
CUI Mini single-view

ART Crawlers are remotely operated platforms designed to deploy radiation sources with digital imagers to generate radiographic mapping of insulated and non-insulated piping for the rapid detection and qualitative assessment of CUI, moisture and internal corrosion.

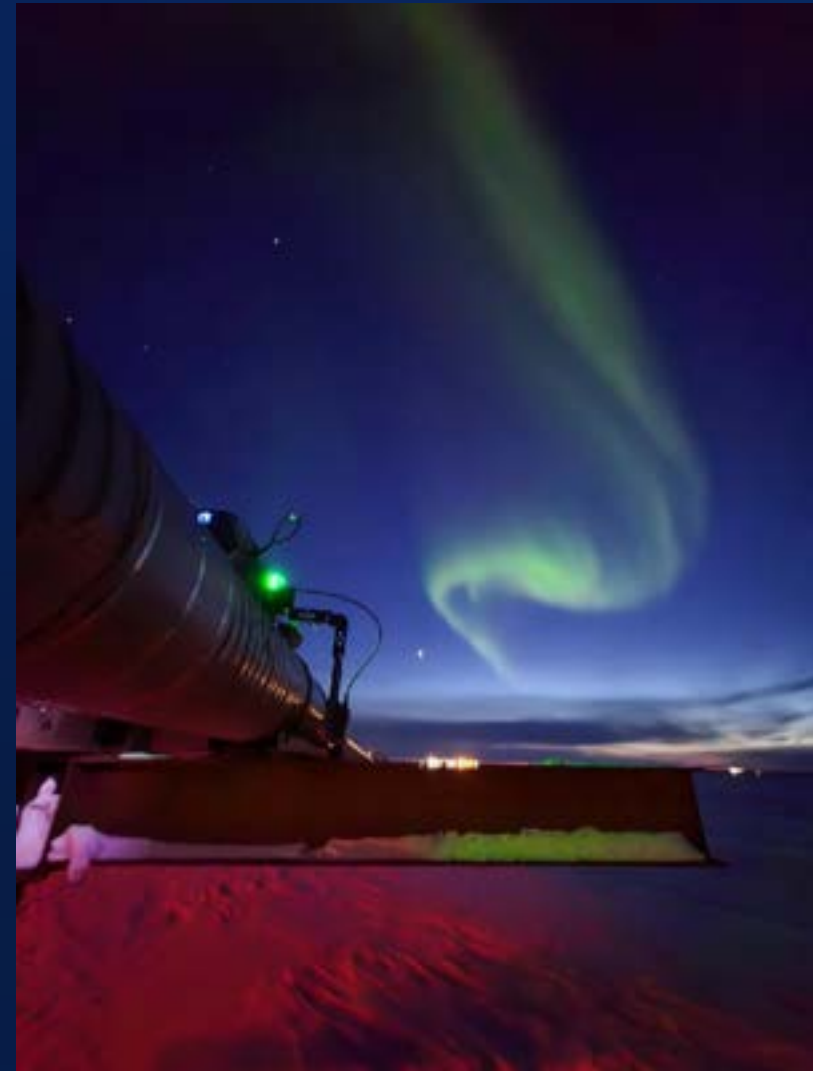
Wireless	Up to 1km line of sight
Power	20-56VDC Lithium-Ion battery
Deployment	Single or multi point deploy & retrieve, Rope Access
Detector	Photon detecting line scanner with Time Delay Summation
Radiation	Collimated X-ray: 50kV up to 225kV
Controls	Remote laptop; Semi-autonomous self balancing
Piping range	CUI 2 to 60-inch OD Internal 2 to 24-inch OD

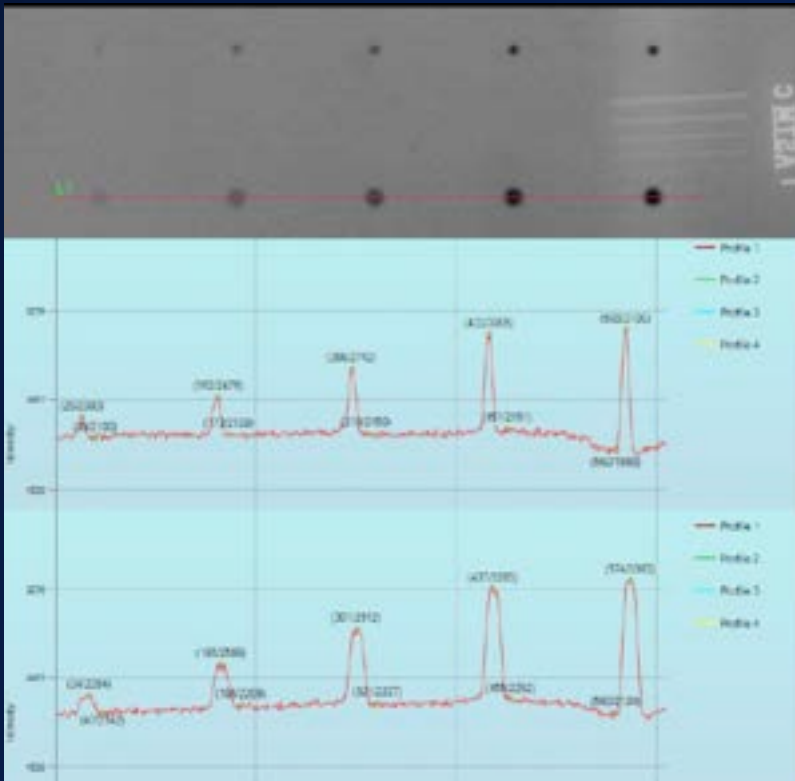
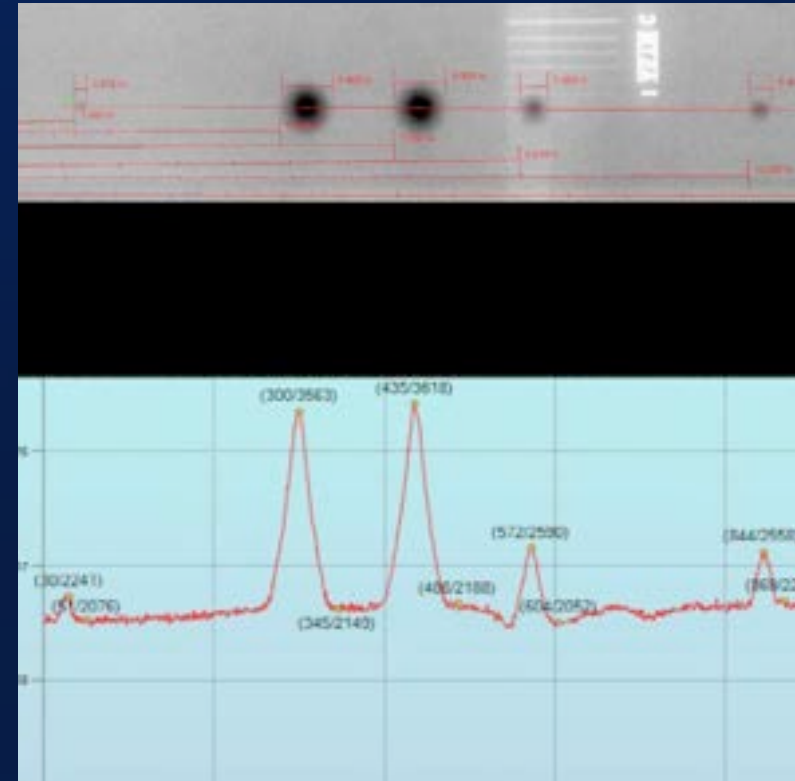
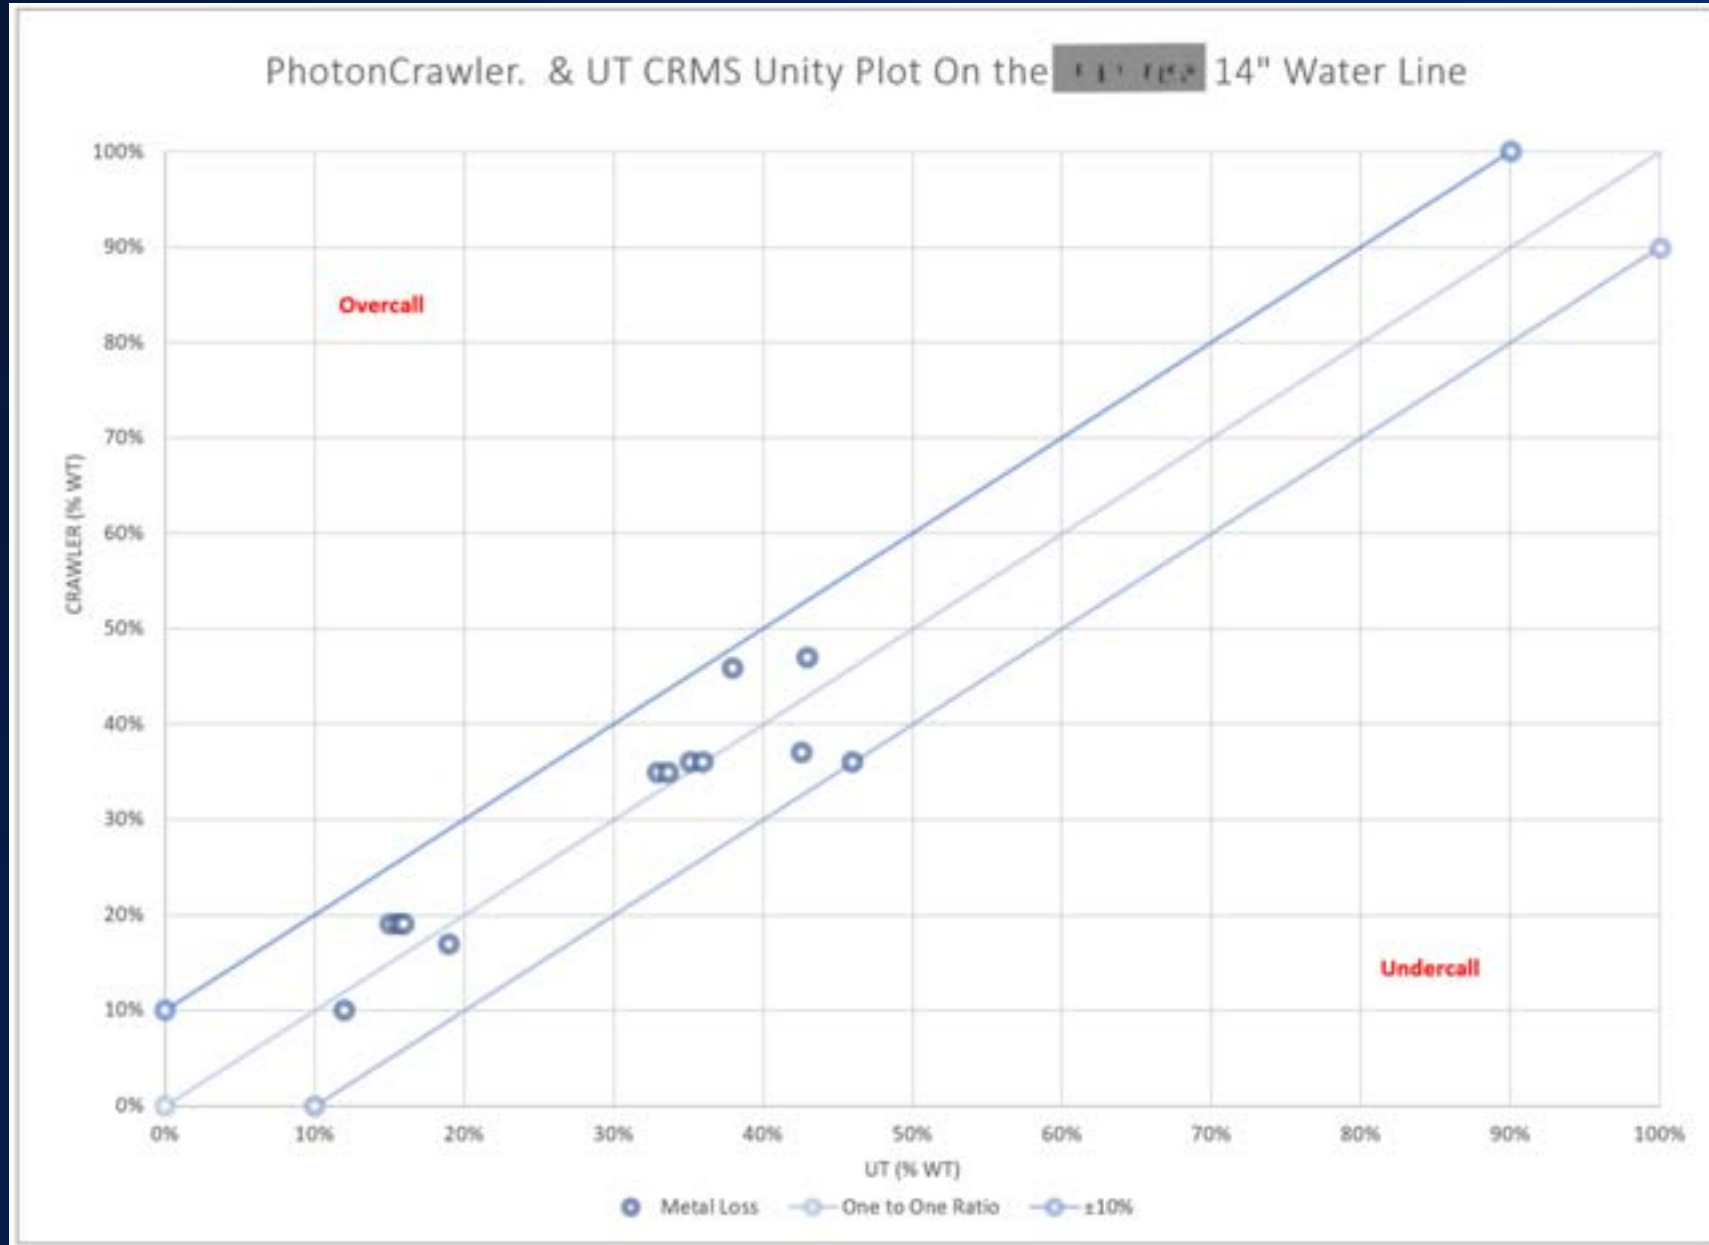
The internal corrosion detection system was validated on a series of test spools with wall thicknesses of 6mm to 22mm and reference holes of diameters 3mm and 6mm at depths of 10% to 50% wall thickness. Spool specimens were tested empty, and water filled.

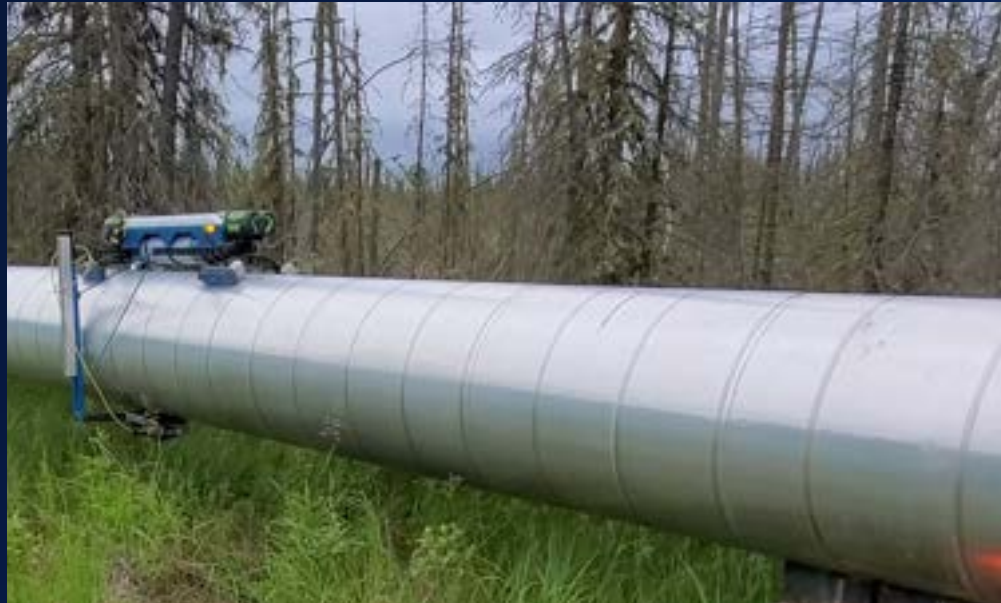
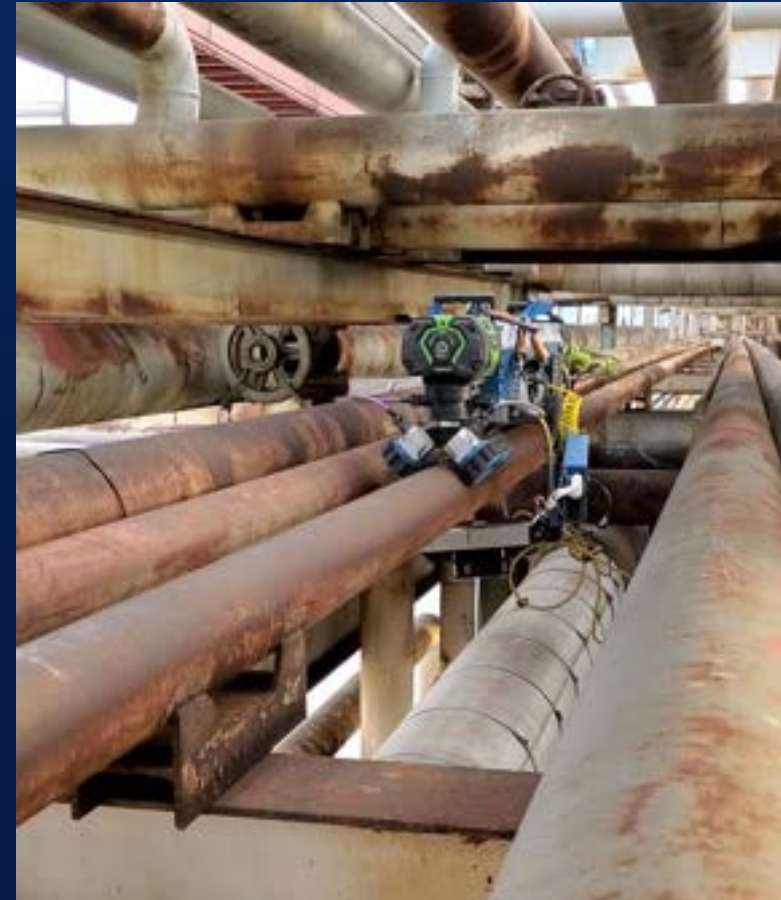
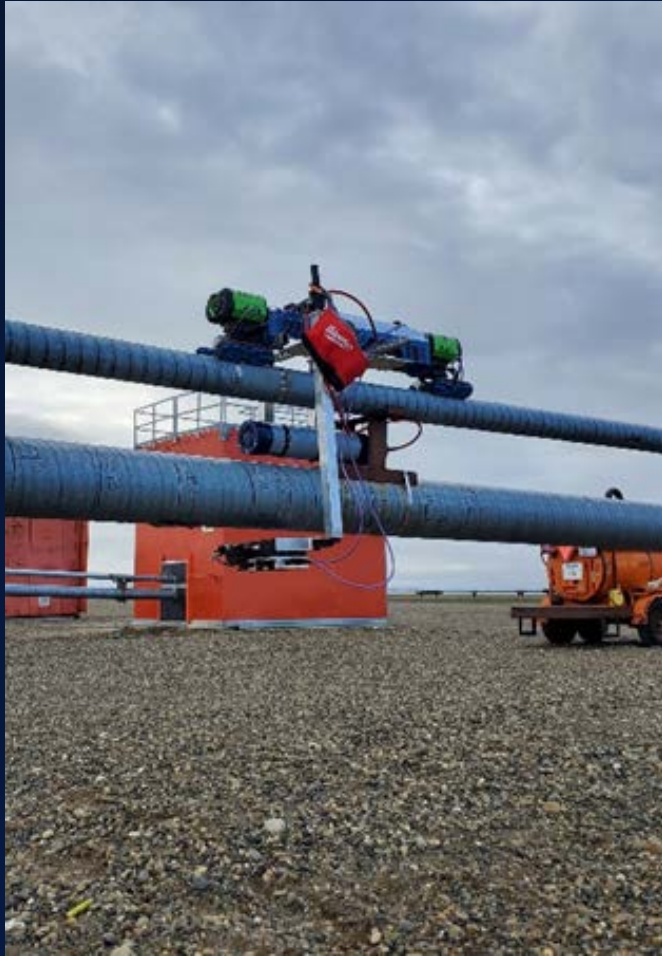
Internal Survey at Pipe Bottom

A recent application of the ART internal corrosion crawler required the crawler to crawl on a 2-inch insulated line directly overhead a 6-inch insulated line while scanning the 6-inch insulated line for internal corrosion.

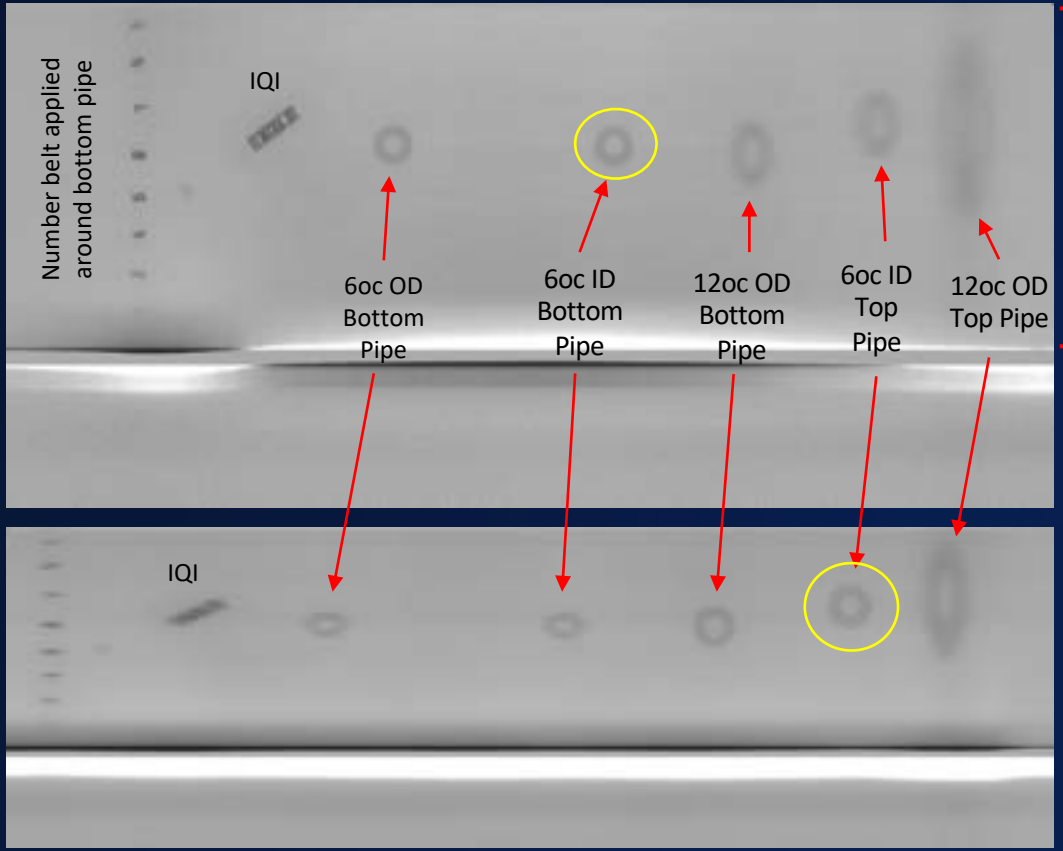
FOCAL SPOT POSITION CONTROL APPLIED TO BUNDLED LINES

FSC @ 85%
Targeting 6oc
of bottom
pipe

FSC @ 50%
Targeting 6oc
of top pipe

Focal spot positioning was applied to a 4-line bundle to determine if the technique could distinguish between the 6oc region of both pipes as they are stacked one over the other. In addition, the technique was also able to distinguish 12oc indications on the top pipe.

As the focal plane is adjusted all other indications outside of the focused plane will lose sharpness as seen in these images.

The demonstration bundle was uninsulated, empty 6in pipe schedule 80. The addition of insulation or contents will not change the ability to focus the imaging at specific planes.

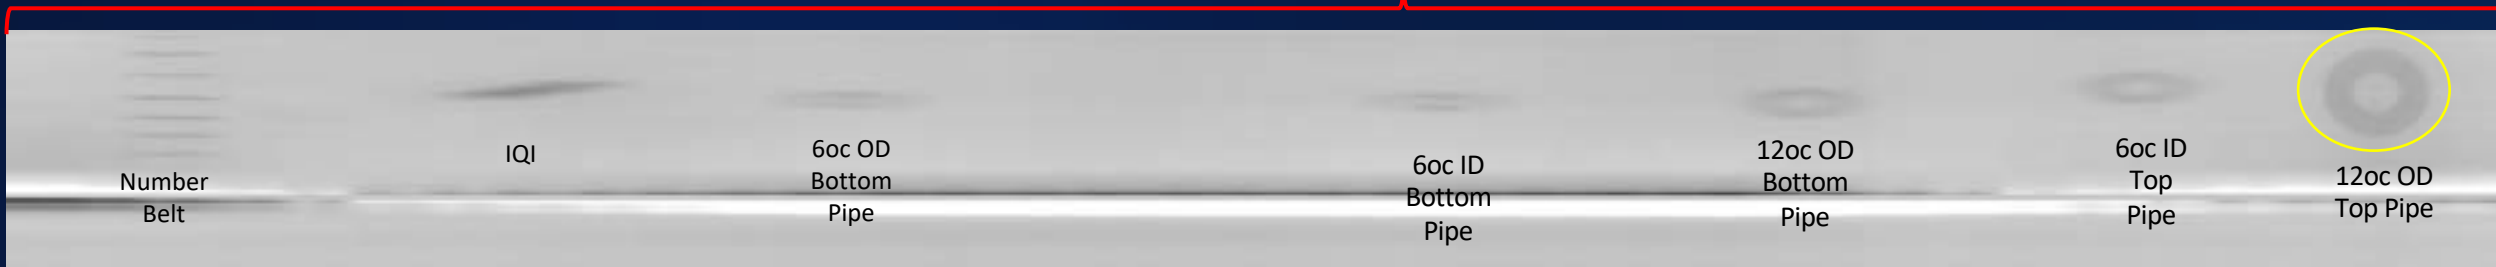
FSC @ 15% Targeting 12oc of top pipe

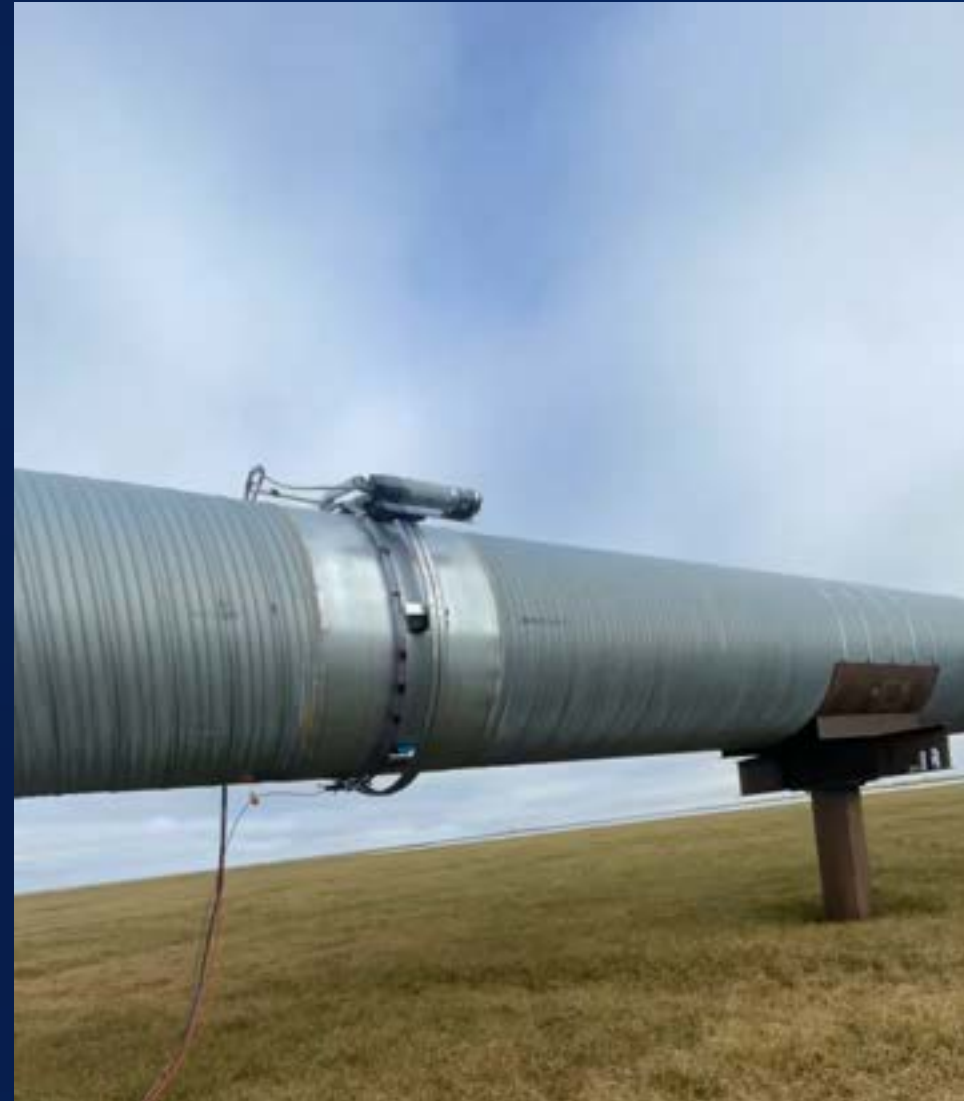
ART 360-degree CUI scanners capture a true 100% coverage of the outside diameter of a pipe detecting CUI and moisture.

*Time-delay video of 360-degree scanner

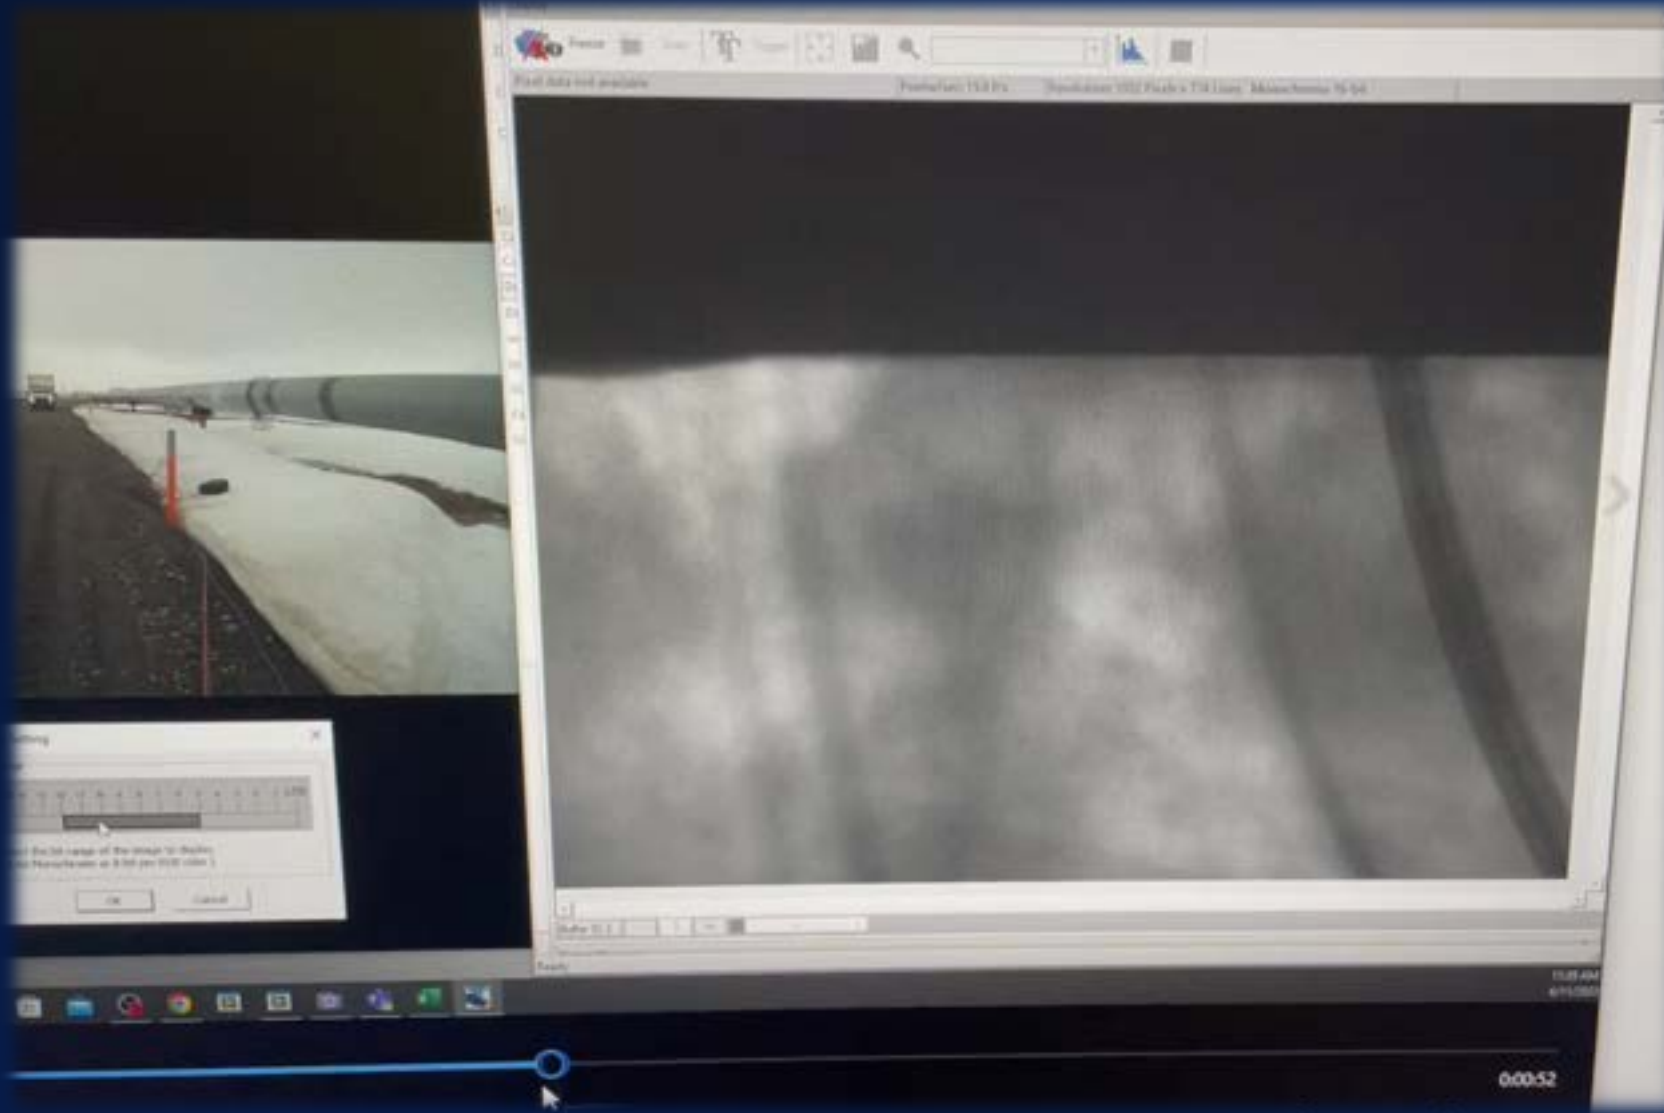
ART 360-degree CUI scanner displaying real time digital radiography.

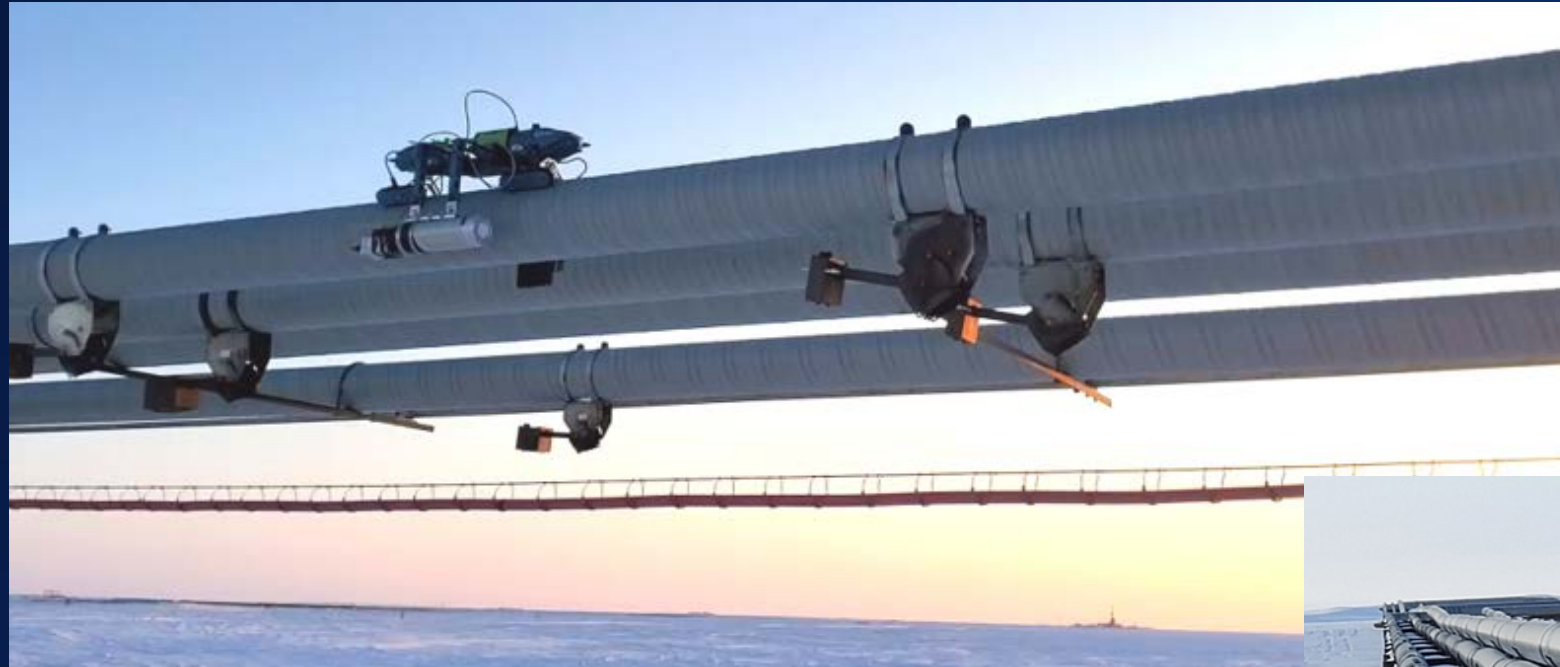
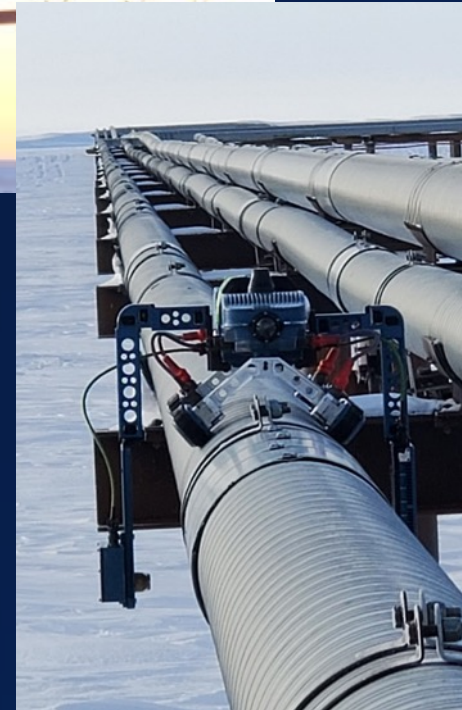
The multi-azimuth CUI crawler in Alaska was specifically designed for the North Slope's oil assets. These crawlers operate yearly in rain, snow, ice, fog and extreme sub-zero temperatures. ART crawlers produce digital radiographic maps of each line segment in a fraction of the time it would take to manually inspect these lines.

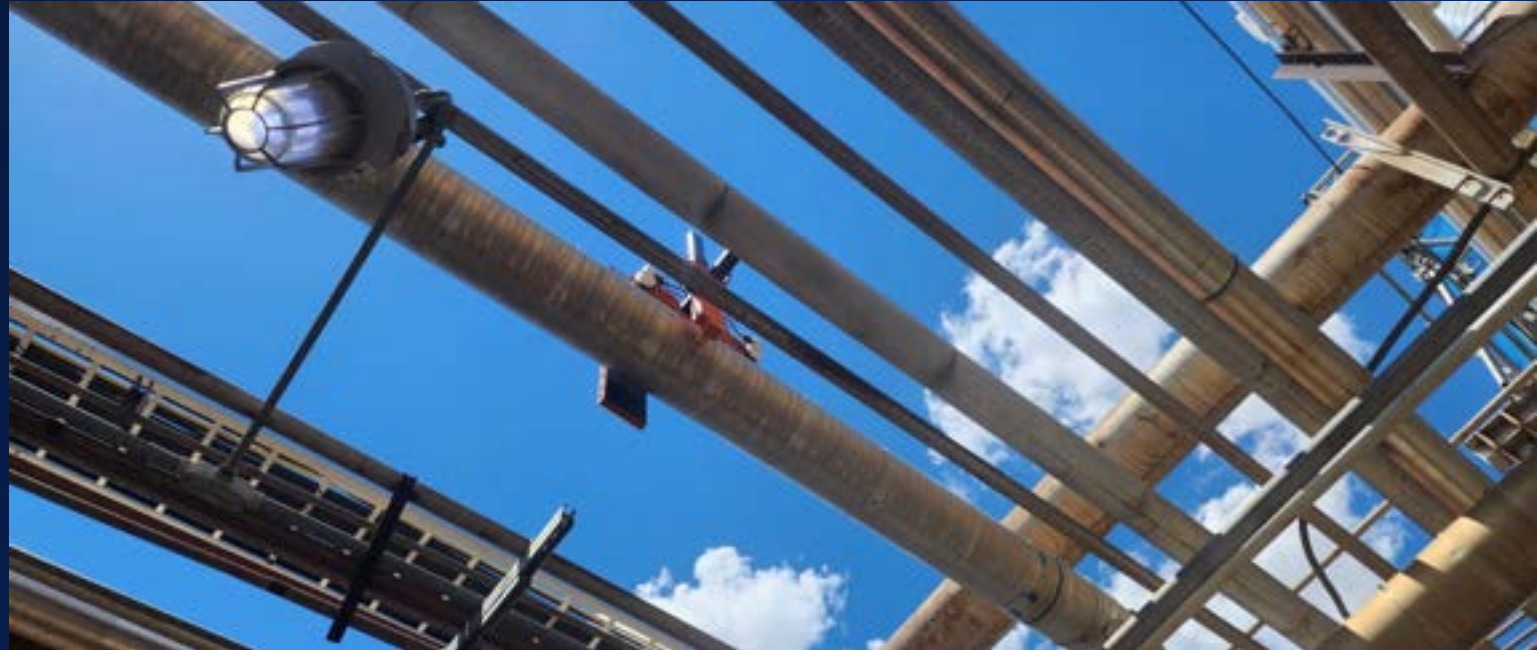
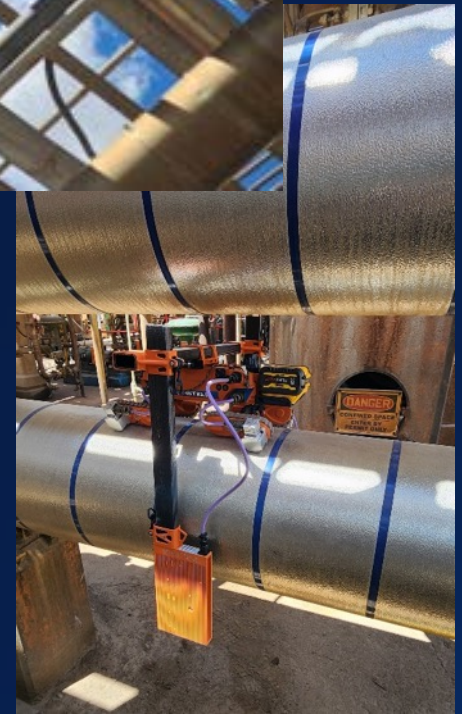
The CUI-mini crawler utilized rope access techniques to accessible horizontal spans. The CUI-mini crawler quickly generated radiographic maps of CUI indications and moisture saturated locations within the insulation. Due to the advanced photon counting imager and low energy X-ray generator impact to the facility and nearby crews was minimal. The CUI-mini crawler successfully reduced man-hours at risk simultaneously providing higher quality data for the customer.

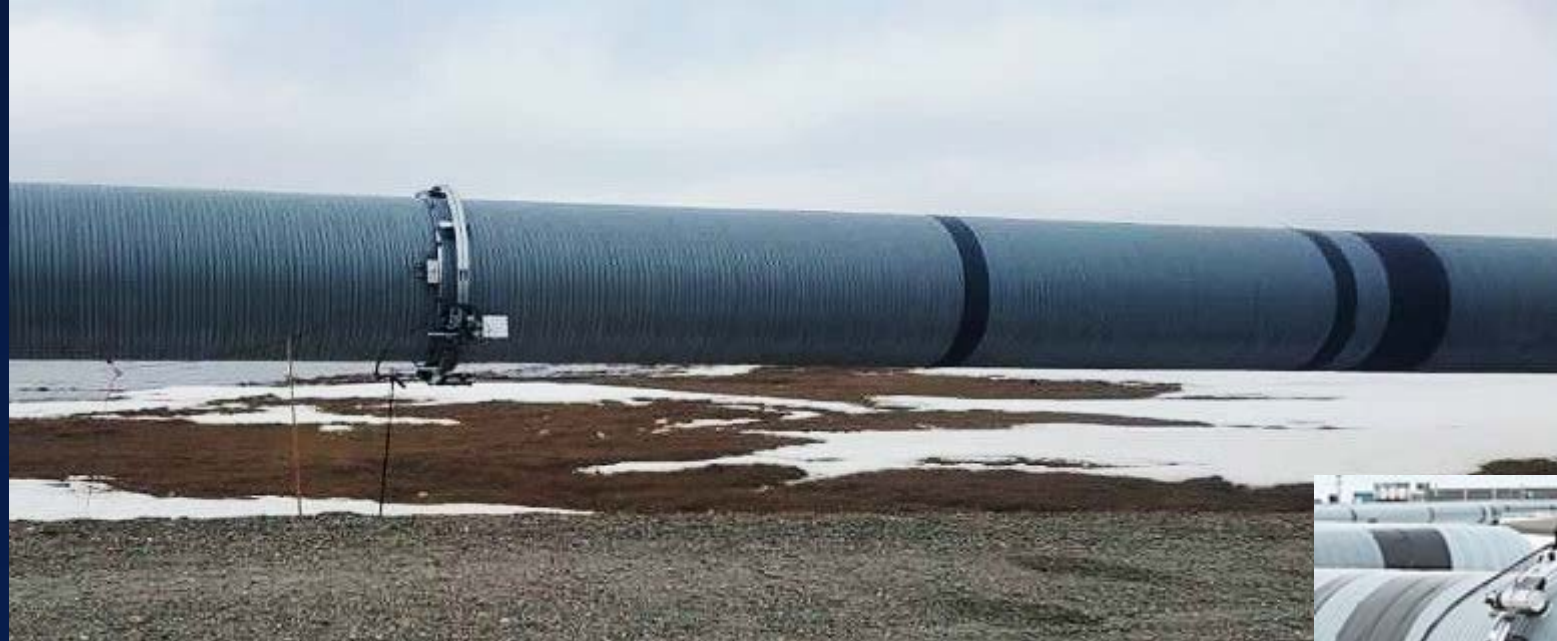
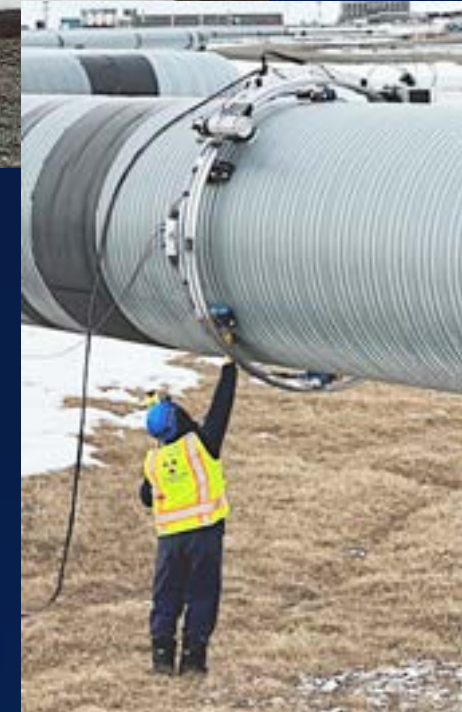
The 360 crawler was designed for the inspection of the 60-inch diameter pipeline. The system included a proprietary 24-inch wide-area real-time CMOS X-ray imager paired with a 225kV X-ray tube controlled remotely from the operator's vehicle. The crawler traveled both circumferentially and axially along the pipe achieving 100% coverage of accessible areas.

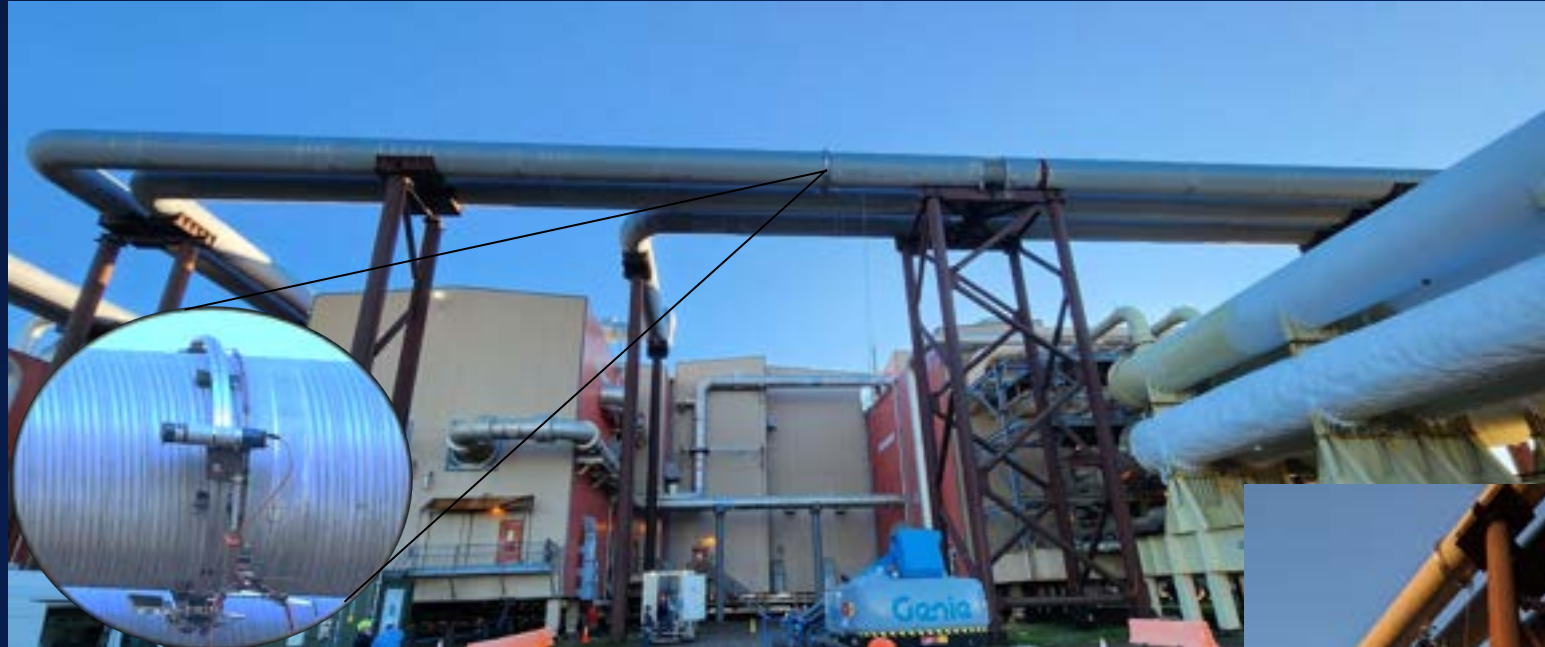
The 360 crawler was deployed safely from manlifts to accessible horizontal spans. Once the deployment crew was safely on the ground the operator activated the crawler interpreting real-time digital radiographic images of the pipe OD detecting CUI and moisture saturation. The crawler traveled both circumferentially and axially along the pipe ensuring 100% coverage of accessible areas.

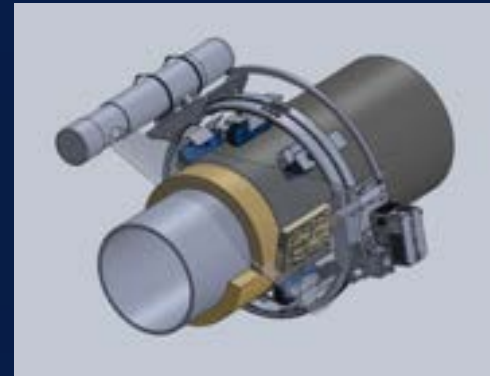
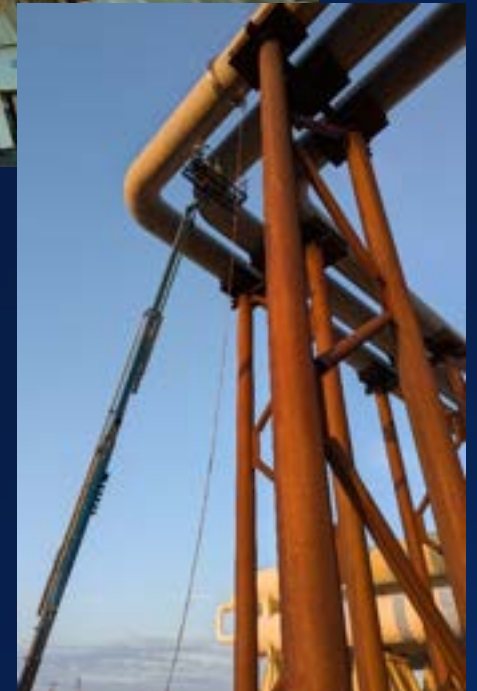
Duration:	53 days
Inspected:	2,616 feet
CUI findings:	19 locations
Moisture findings:	71 locations
Incidents:	0

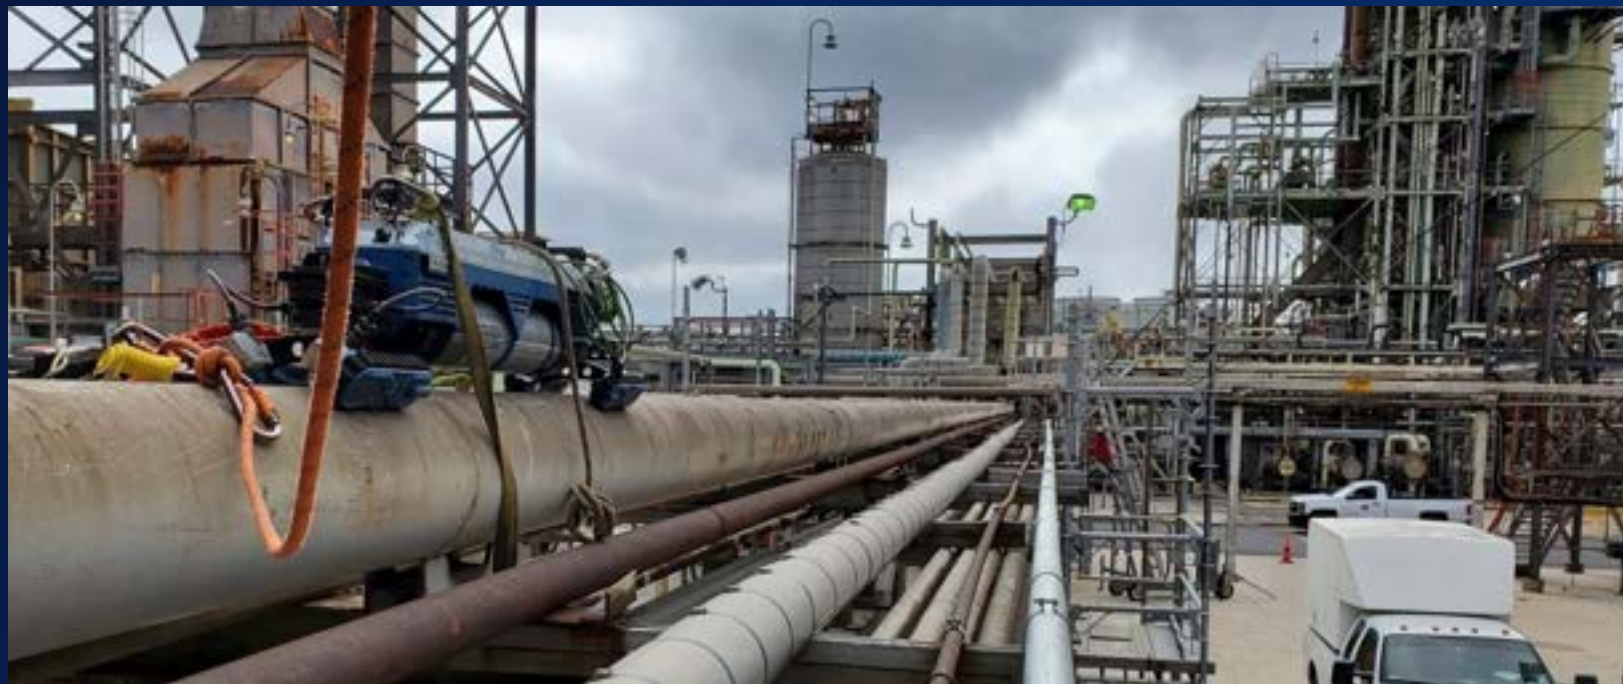
The internal corrosion crawler was deployed across all diameter lines. The crawler was capable of rapidly screening all lines for indications of internal corrosion at the 6oc region and provided the customer with an actionable plan for further investigation and mitigation.

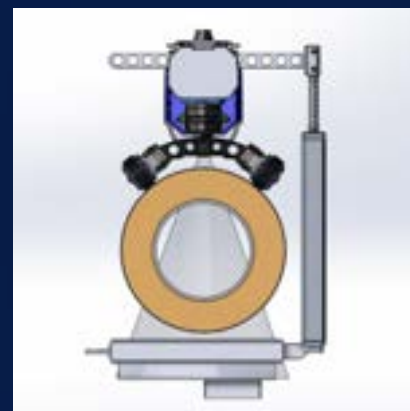
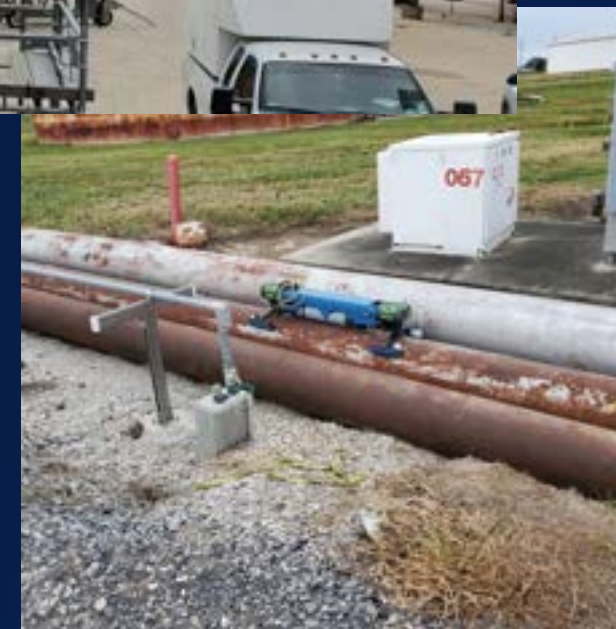
Corrosion findings: 338 locations
Maximum finding: 70% wall loss
Efficiency: 3x faster
