MINIMIZING FAILURES TO PVC WATER MAINS

Roy Brander, P.Eng.
Sr. Infrastructure Engineer, Waterworks, City of Calgary

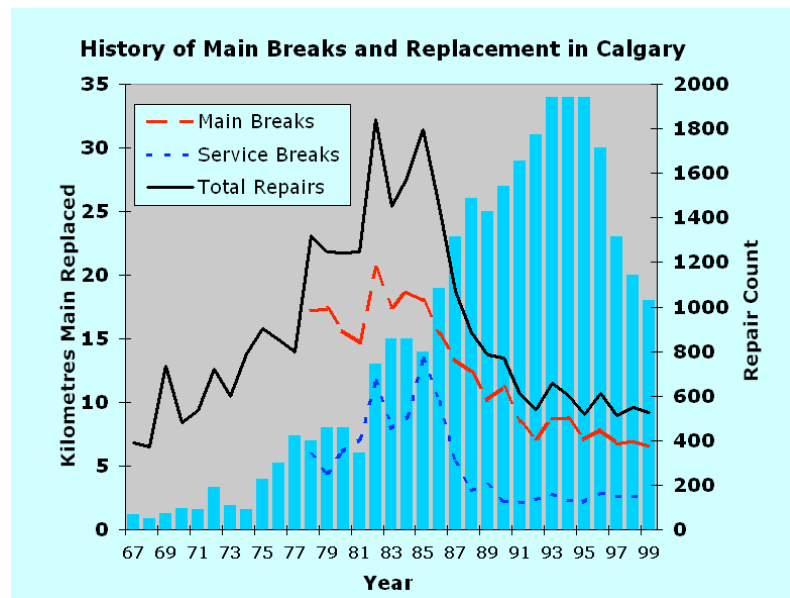
Figure 2, at left, shows the story of Calgary's difficulties with metallic water pipe and part of their response to it. Between 1971 and 1983, Calgary's repairs per year jumped over four-fold, from about 400 to 1600 and even 1800 per year. The rate shocks from the rising repair costs and customer complaints became the major issue facing the utility.

The even more expensive response was a huge and rapid increase in main replacement, as shown by the blue bar chart

in Figure 2, from less than 5km/year to over 25 km/year. This increase was actually continued to 34km/year after break rates began to fall; it was not easily determined at the time that another “wave” of repair increases was not on the way as different generations of pipe materials moved through their lifecycle. It was not until the mid-1990s that a comprehensive research project was begun to determine an optimal replacement level. The project took an inventory of all mains of all material types, computed their various repair history patterns, and projected a lifecycle for each.

The trends at the end of Figure 2 have continued for these past five years: breaks continue to average about 400-430 per year, and main replacement has been further reduced, standing in 2004 at only 12 km/year. In partial substitute for some of the main replacement, Calgary has retrofitted 15-20km/year of DI with cathodic protection anodes since 1999, and in 2004 will retrofit ~35 km of DI and CI. Combined with 12-15 km/year of replacement, Calgary expects this to hold breaks to the current level over some decades to come.

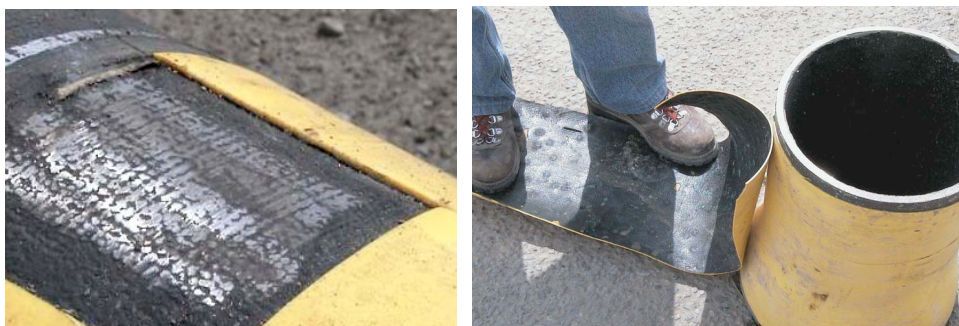
The 'yellow jacket', as shown in the two photographs of Figure 4, above, is a 40mil (1.6mm) thick polyethylene coating which is extruded directly onto the pipe in the factory with a strong bonding agent to permit no gap between. The system was developed for welded oil

pipelines; Calgary's innovation was to get the coating manufacturer to extrude it onto bell & spigot mains used for water. Even this coating, alone, has proven unable to control corrosion of DI in Calgary's more aggressive soils (resistivity <2000 ohm-cm).

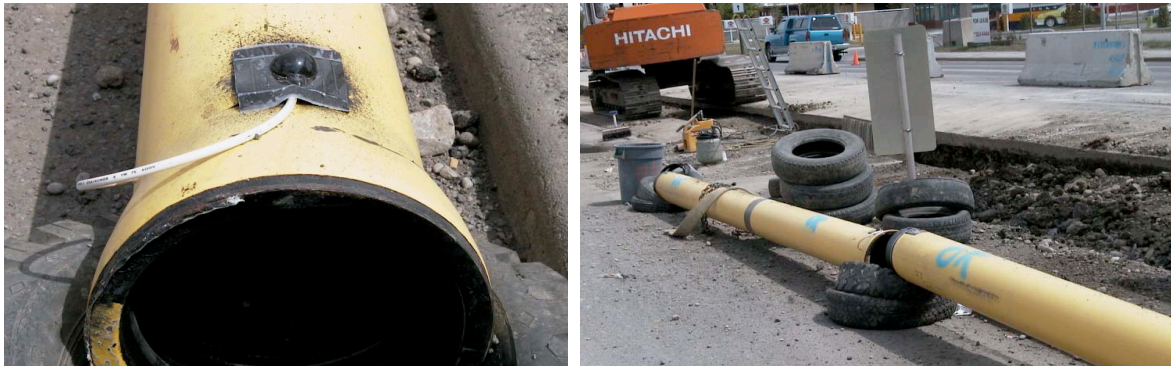
The specification introduced in 1973 required not just a yellow-jacket coating on all DI pipe, but the level of cathodic protection used in the oil industry and recommended by NACE (National Association of Corrosion Engineers). In practice, this comes to a magnesium anode for roughly every 100m of pipe of 150mm diameter – about 16 pipe-lengths. Calgary uses 32-lb (~15kg) anodes, getting roughly 20 years of protection from them before they need to be replaced. One anode per 16 pipe-lengths necessitates electrical bonding straps to connect pipe-lengths, along with extreme care to avoid scratches in the coating, as indicated by the picture of pipe resting on old tires after 'jeeping' (electrically check the coating integrity), both shown in Figure 5, below.

To prevent scratches from occurring during installation, the pipe is moved with cloth straps, not chains; and bedded in 150mm of sand or “pea gravel” (smooth rock, 10-15mm) followed by an additional 150mm to cover the top of pipe. Only then is granular fill such as gravel or native soil backfill permitted. The electrical continuity of the pipe, and current flow from the anode, is tested before backfill is complete. Avoidance of coating scratches is crucial.

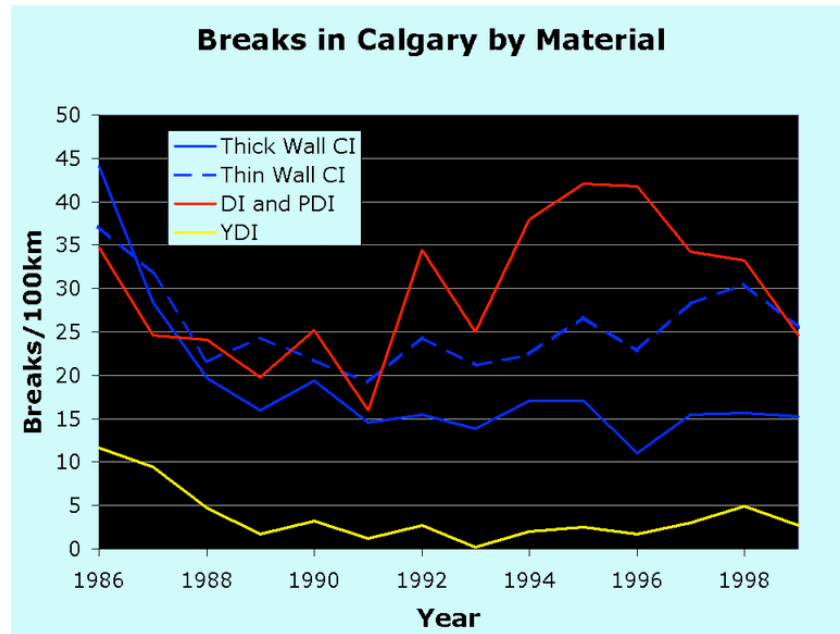
Figure 6, at left, shows the break-rate for Calgary's metallic distribution mains in recent years. DI and PDI are lumped together into one because the PDI on average has only about 30% fewer breaks than “bare” DI, in Calgary's experience. The YDI pipe, with a better coating and cathodic protection, has only 10% the break rate of PDI. The 2-5 breaks/100km/year that do occur, happen at the tiniest breaks in the

coating, if the cathodic protection is lost or ‘shorted out’ through a copper service.

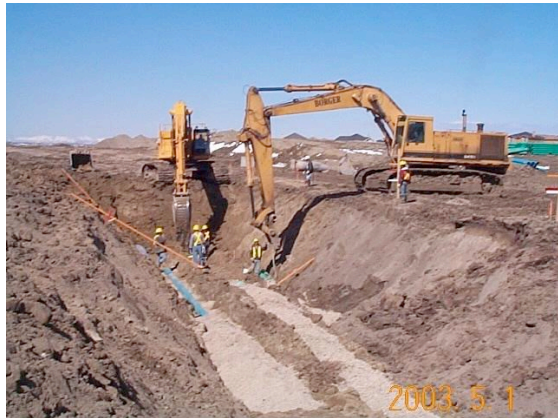
The efforts of the City inspection staff are crucial to the enforcement of those construction standards. The construction of the three “deep utilities” – water, sanitary and storm sewer – is inspected by a single group, the Water & Wastewater Joint Inspection staff. They are called the “deep utilities” because Calgary, along with other inland Canadian cities, has a remarkably deep frost penetration: up to 2.5m in severe winters. The water-bearing pipes must thus be buried almost 3m deep to avoid freezing, making construction of these utilities expensive. Figure 7, below, shows an ordinary residential street under construction with a

“triple trench” that simultaneously installs the water, wastewater, and storm sewer mains, below.

Doing all three pipe systems in one large trench before any other construction of the subdivision realizes significant economies. For the City to do repairs after the subdivision is complete and the road is paved, a typical water main repair costs some 5000 Euros; main replacement runs about 500 Euros per metre at present. The original construction contractors, with no

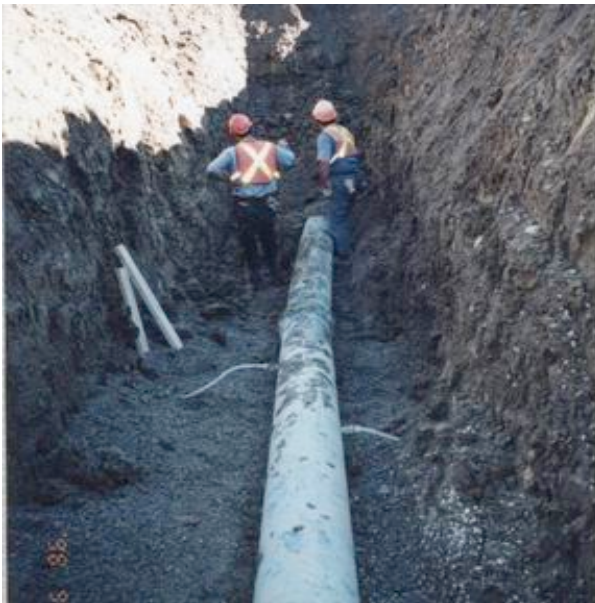
The installation in Figure 8, at left, for instance, was rejected because the contractor attempted to handle a without a 5-degree bend element. Calgary inspectors have learned the hard way that permitting deviations of even a few degrees on main over 200mm offer a slight

but measurable risk of leakage at the gasket, which then begins a process of erosion-corrosion of the gasket, the bedding, and even the pipe itself. The leak only increases with time until finally a major failure can occur if the leak is not detected. Exactly that happened with Figure 9, right, a major failure of a 400mm main in 2003.

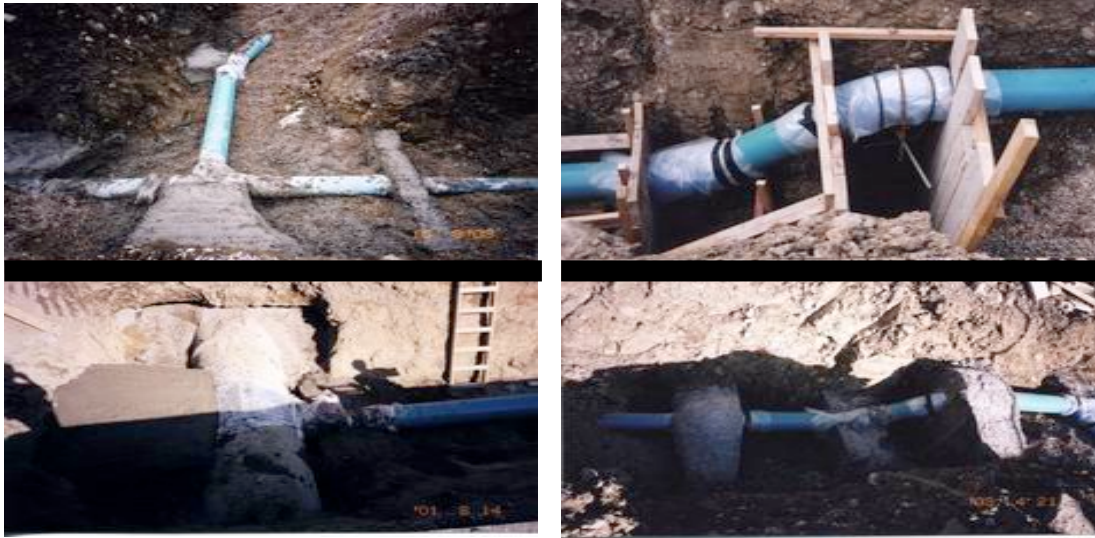
Five degree bend elements are the most allowed without a thrust block; and contractors have

learned that inspectors view concrete as very cheap and repairs very expensive, so thrust blocks and concrete forms tend to be sized conservatively as shown in Fig 10, above.
