Study on the detection method of HDPE electrofusion welding defect based on X-ray technology

To cite this article: Qiang Li *et al* 2023 *J. Phys.: Conf. Ser.* **2419** 012069

Study on the detection method of HDPE electro-fusion welding defect based on X-ray technology

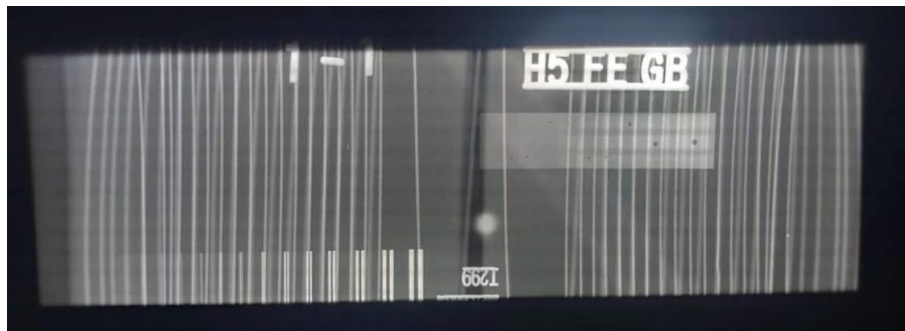
Figure 2 shows the X-ray negative of the normal welding sample. It can be seen that the resistance wires at the welding place are neatly arranged and clearly visible, and there are no obvious defects.

Figure 2. 1# Normal welding.

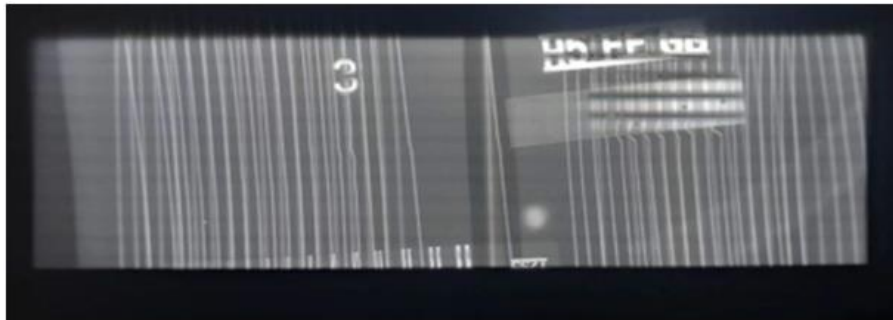
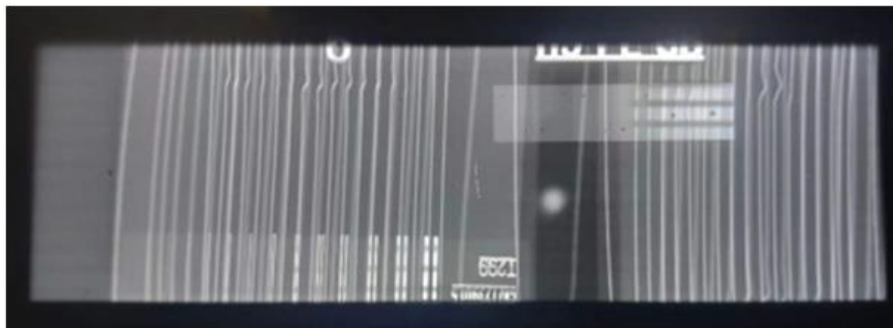
Figure 4. 3#, 4# Cold-welding.

During electro-fusion welding, due to the short energization time or low energization voltage, the welding input heat is insufficient, resulting in a small diffusion range and a low entanglement degree of molecules on the fusion surface. Thus, the connection strength reduces. The standard power on time of the electro-fusion pipe is 240 s and the power on voltage is 29.5 V. During the defect processing, the energizing voltage is not changed, and the energizing time is changed to 144 s and 120 s respectively, corresponding to 40% and 50% of the cold-welding degree. Figure 4 shows X-ray negatives, which can not clearly distinguish the cold-welding.

(a) 3# Cold-welding (degree 40%).

(b) 4# Cold-welding (degree 50%).
