Discussion on “Procedure for assessing the liquefaction vulnerability of tailings dams”

Jian Zheng

Static liquefaction
Tailings dam failures
Toe deformation
Fundão tailings dam

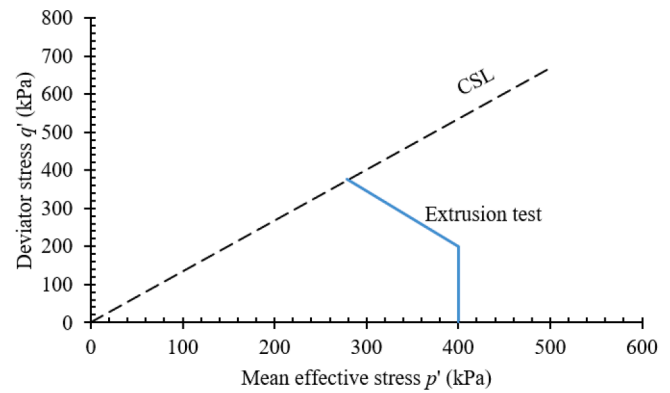
Fig. 1. Stress path for the extrusion collapse test conducted on Fundão tailings (adapted from Morgenstern et al., 2016).

partly drained condition. It is also the stress condition for the mine tailings in the back-analysis of the Fundão and Cadia tailings dams through laboratory tests and NorSand calculation (Morgenstern et al., 2016; Jefferies et al., 2019), as shown in Fig. 1. Under drained conditions, the underlying horizontal movement can lead to the decrease of the horizontal effective stress, while the vertical effective stress remains constant. This can in turn lead to the increase of the deviator stress and decrease of the mean effective stress, with the stress path approaching the instability line.
