Preliminary study on terahertz non-destructive testing for defect detection in hot melt joints of polyethylene pipes

To appear in: *Infrared Physics & Technology*

Keywords: Polyethylene pipes; Terahertz waves; Non-destructive testing; Welding defects; Signal modeling

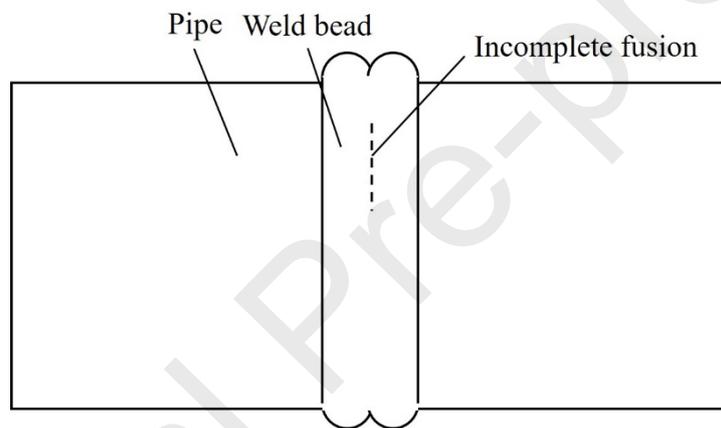
Incomplete fusion defects take their origin from welding factors such as local cracks formed on the fusion surface or weakly entangled local polyethylene molecules, resulting in a sharp decline in joint performance (see Fig. 1).

Incomplete fusion defects indicate that the local molecules of the fused surface are not tightly entangled, which has a serious impact on the life of the joint, giving rise to failure under load. As hot melt butt welding is a type of pressure fusion welding, a certain axial pressure is applied to the pipe in the welding process, causing the appearance of incomplete defects on the fusion surface.

Fig. 1 Schematic of an incomplete fusion defect.

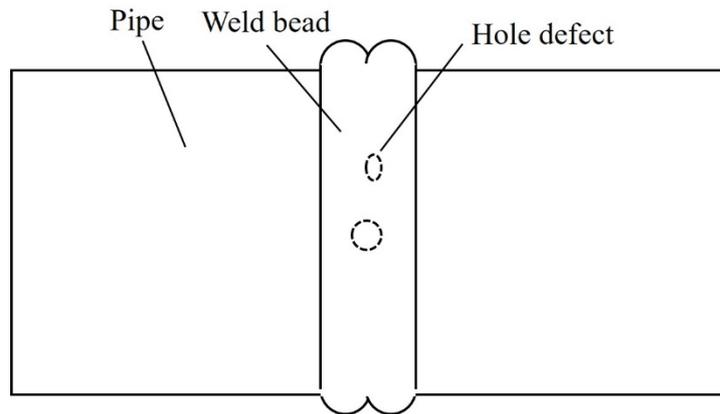
A hole defect is a hole inside the weld generated due to the inclusion of large solid particles or local large shrinkage holes, pores, and other reasons, resulting in a discontinuity of the weld structure and a joint performance reduction. It is a volumetric defect, as shown in Fig. 2.

Hole defects may appear on the fusion surface or in the heat-affected zone near the fusion surface. While the existence of holes deteriorates the mechanical properties of the joint fusion surface, it does not cause the non-fusion expansion failure of the joint like incomplete fusion defects, leading to the ductile fracture of the material near the hole.

Fig. 2 Schematic of a hole defect.

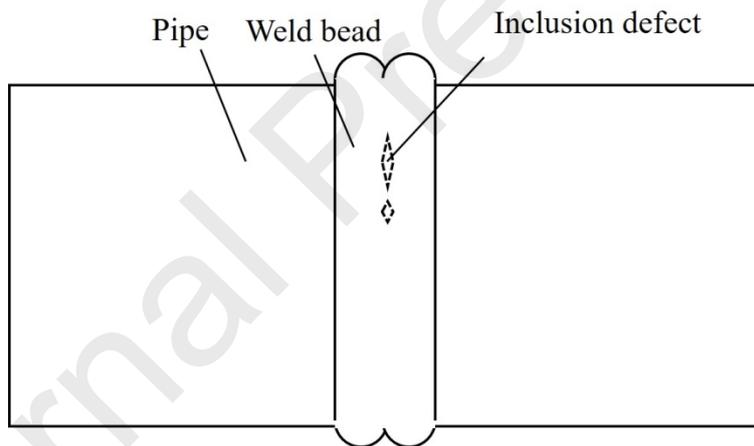
Inclusion defects are due to foreign substances that are mixed in the fusion surface to form heterogeneous inclusions during the welding process, resulting in poor bonding of the entire fusion surface and a sharp decline in joint performance (see Fig. 3).

Fig. 3 Schematic of an inclusion defect.

Inclusion defects lead to a worsening of the mechanical properties and the overall failure of the fusion surface, which is manifested as a brittle fracture of the whole fusion surface or an uneven ductile fracture within a large area.

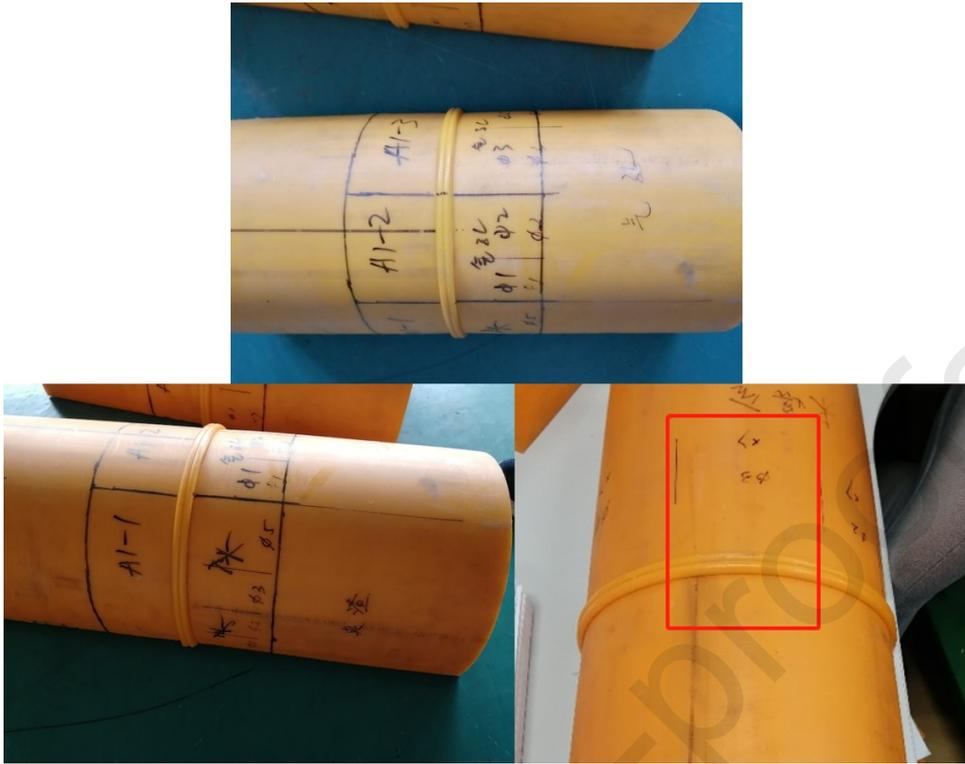
The types and sizes of the produced defect are listed in Table 1, and the defect samples are shown in Fig. 4.

Fig. 4 Defect samples of the hot melt joint as part of the polyethylene pipe.

A defect test block production method was independently developed for the hot melt welding joints of polyethylene pipes. According to the defect properties of hot melt welding joints, the prefabrication of incomplete fusion defects, hole defects, and inclusion defects was realized by designing the end face structure of the butt pipe. The minimum characteristic size of the prefabricated defects was 1 mm. In the defect prefabrication, the regular defect shape was used as the standard defect shape for assessing the technology as well as for scientific research. Varying the defect shape enables the manufactured defect to be closer to the actual shape of the site, making it more convenient for both simulation and comparison with the actual defects. On the other hand, the fabricated sample had the same curvature characteristics and geometric parameters of real polyethylene pipes to lay a foundation for the non-destructive defect testing of real pipes.

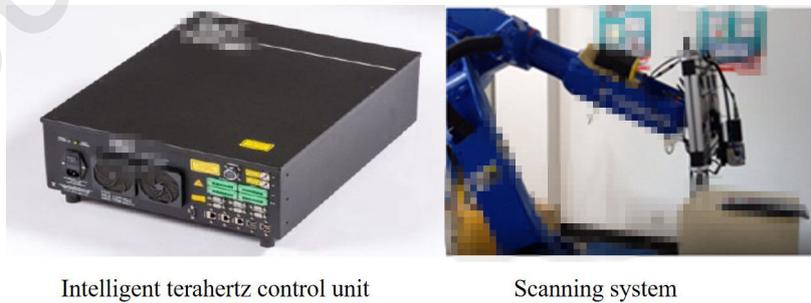
An ANTHz-8 THz time-domain spectral system in the reflection detection mode was employed for defect detection testing. The system consists of a data acquisition unit and a data processing unit. The data acquisition unit is a THz reflection probe driven by a mechanical arm. During the detection process, the sample surface is scanned vertically in equidistant mode, and the detection step is 1 mm. The detection data is stored in a computer and then processed using a special software to obtain the defect image. The THz detection equipment is shown in Fig. 5.

Intelligent terahertz control unit

Scanning system

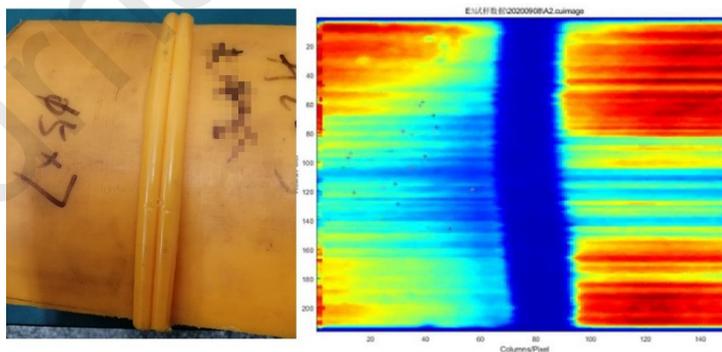
The scanning results obtained for the incomplete fusion defect sample are shown in Fig. 6. In the presence of a flanged edge, the THz wave was detected in the direction perpendicular to the workpiece surface, while the waveform could not be vertically incident on the flanged edge, hindering the detection of the reflected signal. Therefore, the THz detection technology cannot detect the internal defects of hot melt joints with flanged edges.

Fig. 6 THz scanning imaging data acquired for a hot-melt-joint sample with a flanged edge and an incomplete fusion defect.

In order to facilitate path determination during scanning with a robot arm, the hot-melt-joint defect sample was cut into shingles according to the defect type. In the presence of flanged edges, reflective C-scan detection was carried out on the unfused defect specimen. Meanwhile, owing to the excessive curvature of the flanged edge, the robot arm could not achieve a vertical incidence on the flanged surface, so the curvature at the flanged edge was ignored during scanning.

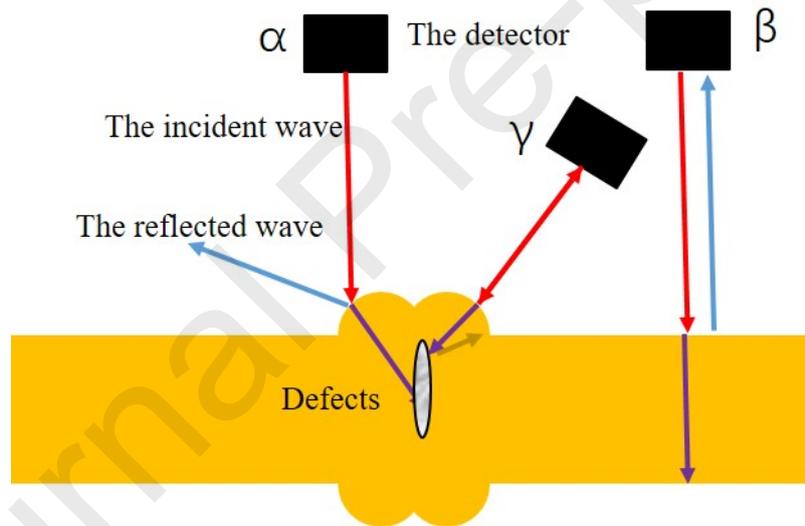
The influence of the flanged edge on the THz detection was analyzed, as shown in Figure 7. In the figure, α stands for the reflection detection mode of the equipment. In this method, the THz wave cannot be vertically incident on the flanged edge surface because of the excessive curvature of the latter; as a result, the reflected wave deviates from the expected path and cannot be sensed by the detector, making

β denotes an improved detection method. Through an appropriate modification of the scanning tool, the scanning path becomes more accurate, and the THz wave is thus perpendicular to the flanged edge surface, which can ensure that the probe can detect the reflected wave. However, the defect information collected in this method is distorted, making the existing tool and probe size still not ideal.

A mode defined as γ corresponds to the tube-body detection method, in which the surface curvature of the tube body is small, whereas the existing scanning tools and probe size can ensure that the incident wave is perpendicular to the surface of the workpiece, allowing the probe to detect the reflected wave and thereby ensuring the reliability and efficiency of the detection.

Fig. 7 Analysis of the influence of the flanging of hot melt joints on the THz detection of defects.

Through the above analysis, it can be seen that the reflection detection method is not suitable for detecting defects in hot melt joints with flanged edges. On the other hand, the transmission detection method can detect the defects in the flanged edge due to the fact that the detector is placed on the other side of the workpiece and is thus able to detect the transmitted signal. However, the transmission detection method is not suitable for defect detection within field pipelines.

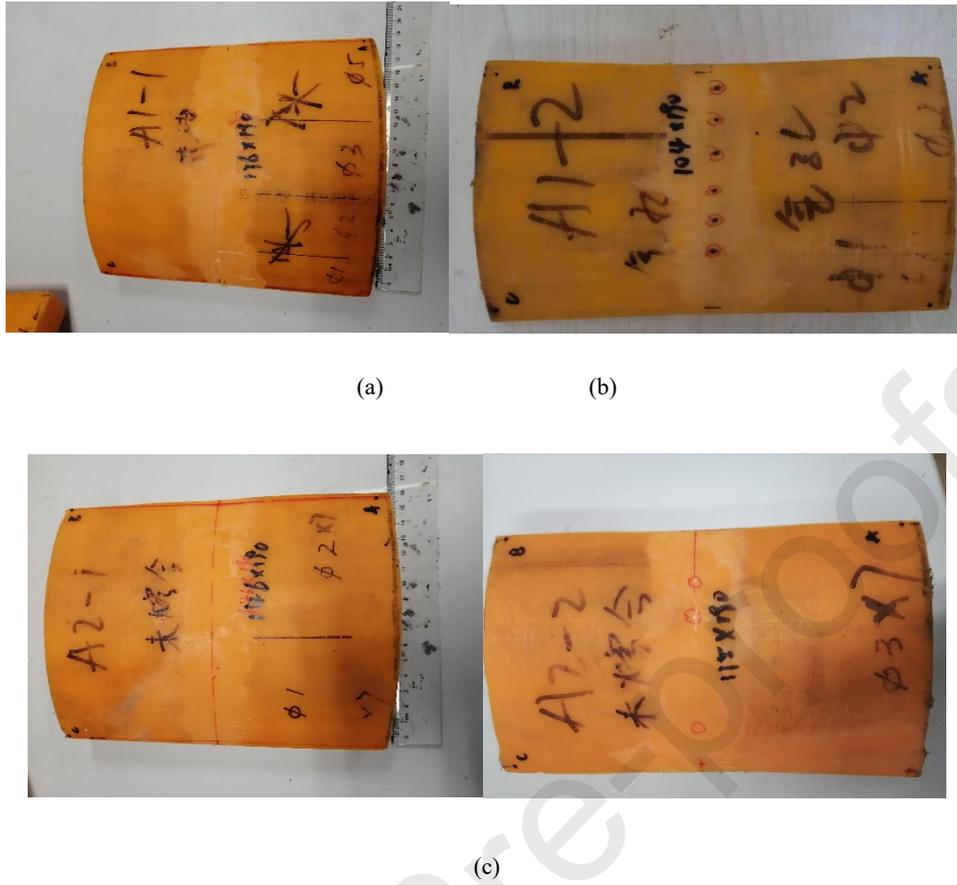
In order to eliminate its effect, the flanged edge was polished until it was as flat as the outer surface of the base material, as shown in Fig. 8. THz detection testing was carried out on the sample after removing the flanged edge, and the results are shown in Fig. 9, revealing the identified defects. The different colors in the figure represent the distribution range of defects by converting the reflected amplitude of different positions into different colors. The minimum diameter of the defects detected in the sample was 1 mm, meaning that the THz detection technology can localize incomplete fusion, hole, and inclusion defects with a feature size of at least 1 mm. In summary, when performing reflective THz non-destructive testing of hot melt joints, it is necessary to remove the flanged edge so as to be able to obtain the defect information.

Fig. 8 Photographs of the defect samples and the numbers of hot melt joints after cutting the flanged edges: (a) inclusion defect; (b) hole defect; (c) incomplete fusion defect.

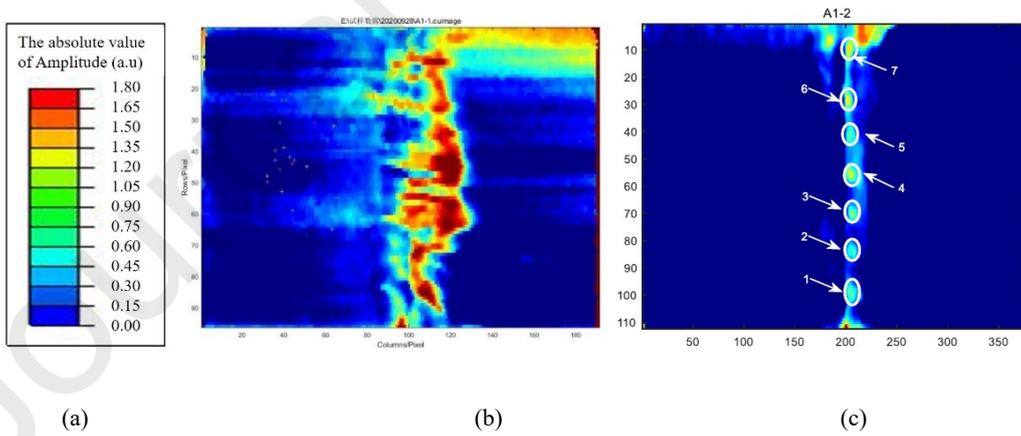
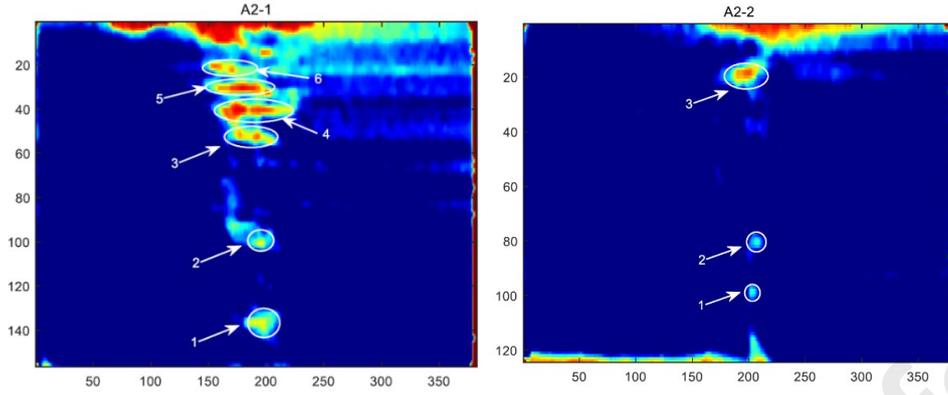
Fig. 9 THz detection images of unfused defects in hot melt joints after cutting the flanges: (a) color legend; (b) inclusion defect; (c) hole defect; (d) incomplete fusion defect.

The hole defects of a hot-melt-joint specimen were destructively assessed. There were eight prefabricated hole defects; seven actual defects were found through destructive detection, and seven defects were detected using the THz technology, with a defect detection rate of 100%. The size of the detected hole defects was calculated according to the method provided in Ref. [36].

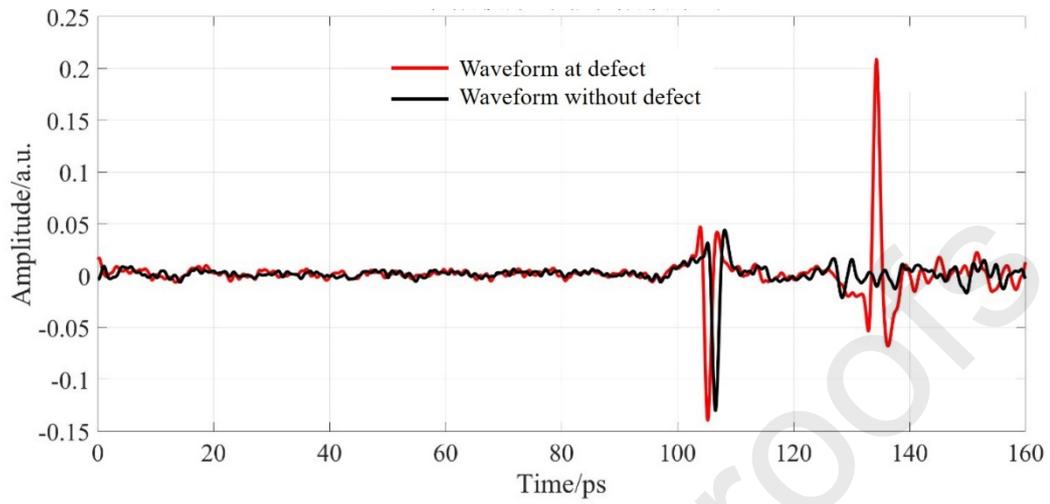
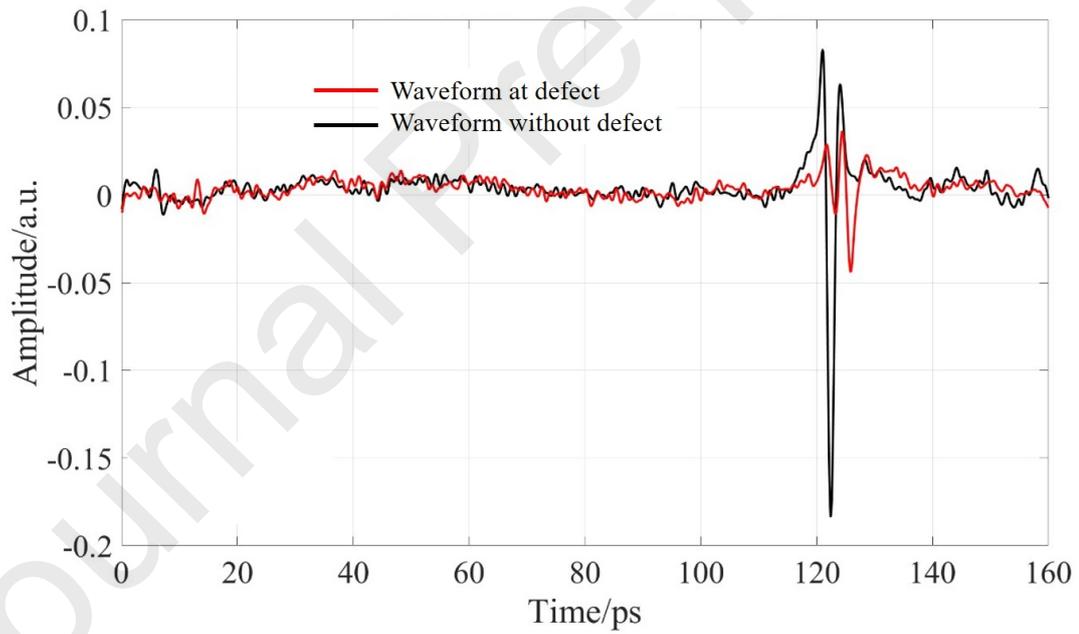
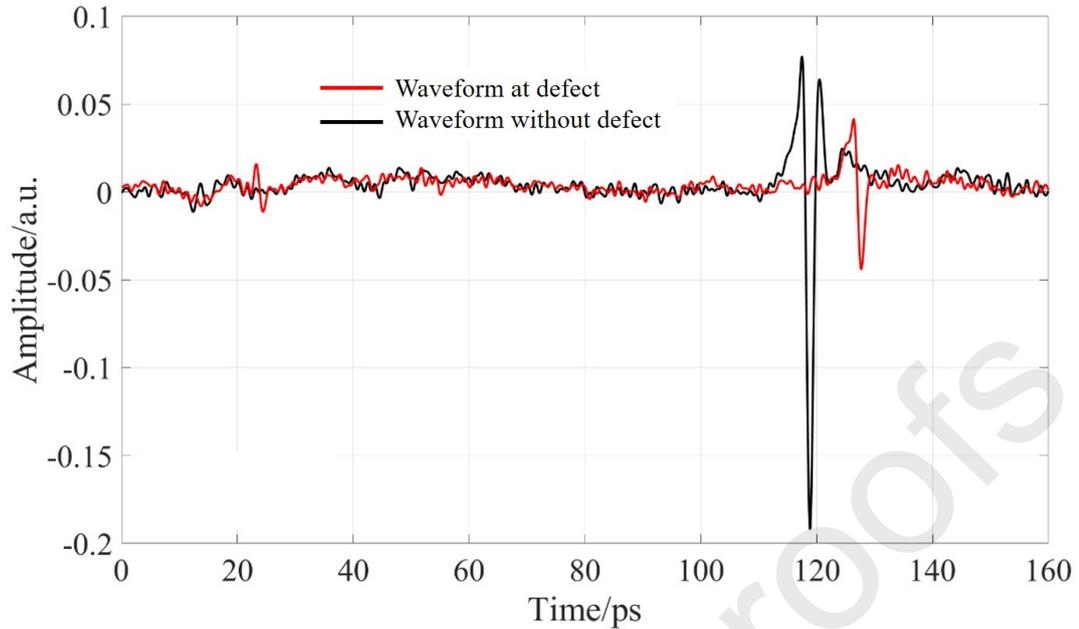
By extracting the single waveform at a defect, the relevant A-scan signal can be obtained. In the defect scanning data on the hot melt joint of the yellow polyethylene pipe, the single waveforms of inclusion, incomplete fusion, and hole defects were extracted, as shown in Fig. 10. According to the figure, the amplitude of the reflected wave in the non-defect area was large, changing from positive to negative and then back to positive in an M-shaped manner, while the reflected signal in the defect area exhibited noticeable variations.

As can be seen from Fig. 10(a), inclusion defects generate two discrete reflected signals, among which the first one is almost the same as the conventional M-shaped signal and is inferior to the second one, whose positive and negative values are opposite to the first signal.

In Fig. 10(b), the reflected signal of hole defects presents multiple continuous peaks, which resemble jagged canine teeth with alternating positive and negative values.

Fig. 10(c) displays the reflected signal of the incomplete fusion defect, which is composed of two continuously changing peaks, one positive and one negative, forming an N-shape.

Fig. 10 Single waveforms at the defect of a polyethylene-pipe hot melt joint and normal waveforms: (a) inclusion defect; (b) hole defect; (c) incomplete fusion defect.

Defect type	Defect scan mode	
	A-scan	C-scan
Incomplete fusion	The reflected signal of the incomplete fusion defect presents two continuously changing peaks, one positive and one negative, forming an N-shape.	A smooth outline without edges is distributed along the middle line of the weld in an irregular manner, and the defects appear as long strips along the axis.
Hole	The reflected signal of hole defects presents multiple continuous peaks with alternating positive and negative amplitudes resembling jagged canine teeth.	The defects are distributed along the girth of the weld in a long strip, revealing a smooth outline without edges, but also along the middle line of the weld, exhibiting little differences in axial and circumferential dimensions.

Inclusion	Inclusion defects generate two discrete reflected signals, among which the first one is almost the same as the normal (M-shaped) signal and is inferior to the second one, whose positive and negative values are opposite to the first signal, forming an inverted M-shape.	The signal structure of the defect image is irregular, possessing multiple bar branches and sharp contours.
------------------	--	---

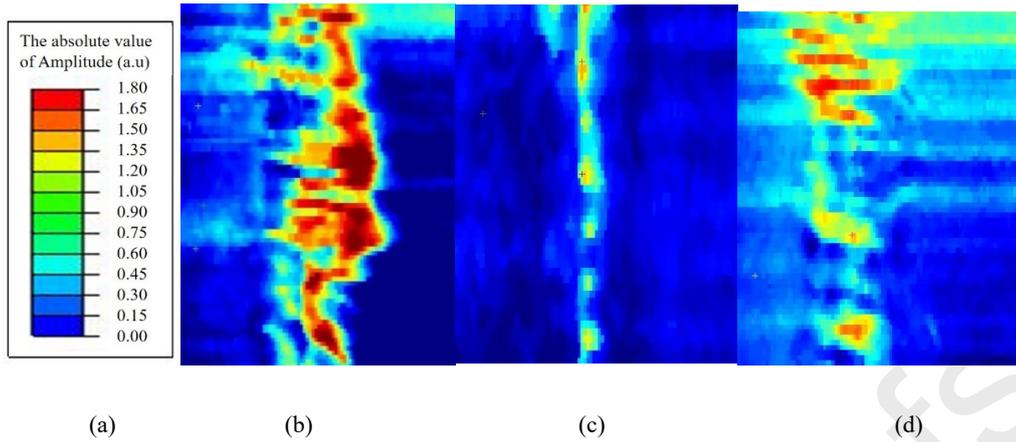
Through the tomography method, defects can be projected onto the scanning surface, as shown in Fig. 11. In the figure, the longitudinal coordinate corresponds to the expanded projection of the sample circumferential scanning surface, and the horizontal coordinate refers to the expanded projection of the sample axial scanning surface. Therefore, THz C-scanning imaging actually expands the two-dimensional surface into a plane for imaging analysis. The colors in the figure represent the amplitude of the reflected wave at a certain position.

As can be seen from Fig. 11(a), the peculiarities of inclusion defects are as follows: the signal structure of a defect is irregular, exhibiting multiple bar branches and sharp contours. According to Fig. 11(b), the imaging characteristics of hole defects consist of features distributed along the girth of the weld in a long strip, revealing a smooth outline without any edges as well as of features distributed along the middle line of the weld, with little differences between axial and circumferential dimensions. As can be seen from Fig. 11(c), the features of the incomplete fusion defects are as follows: a smooth outline without any edges is distributed along the middle line of the weld in an irregular manner, and the defects appear as long strips along the axis.

Fig. 11 Defect characteristics of polyethylene-pipe hot melt joints: (a) color legend; (b) inclusion defects; (c) hole defects; (d) incomplete fusion defects.
