The Effect of Feathering on Coating Performance

From *JPCL*, June 2019

By Patrick Cassidy and Michael Kibler, Elzly Technology Corporation; and Cameron Miller, Paul Slebodnick and James Martin, U.S. Naval Research Laboratory

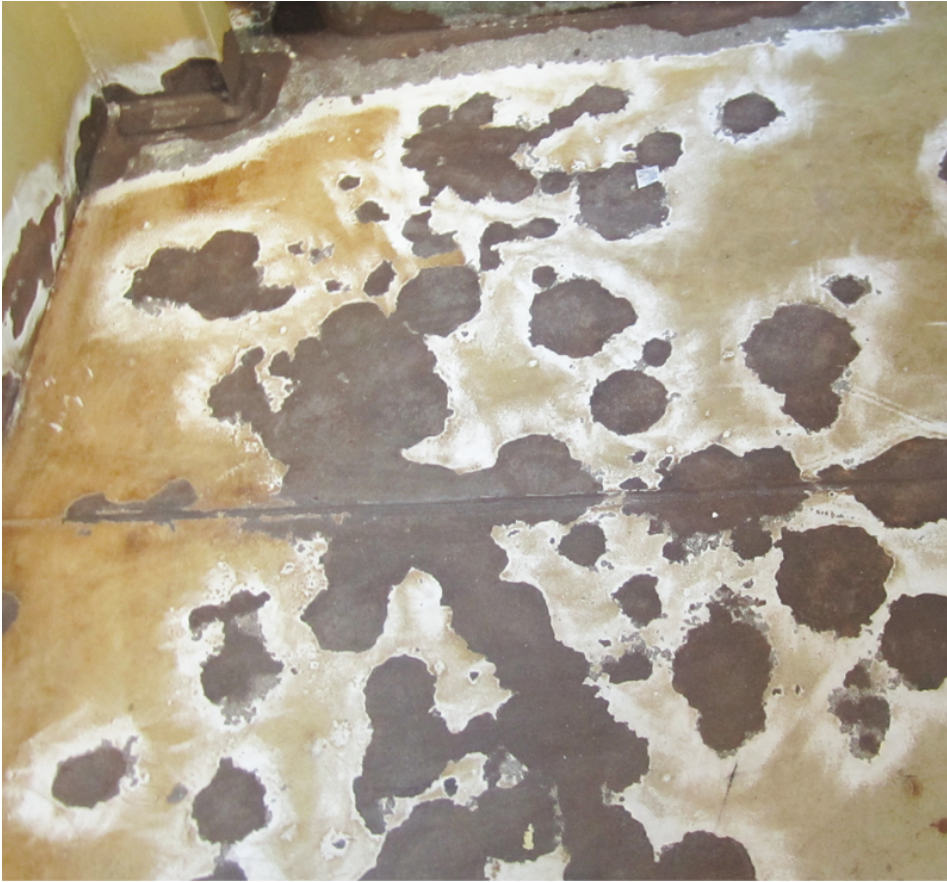
Fig. 1: Feathered intact legacy coating in preparation for maintenance painting. *Figures courtesy of the authors.*

Feedback from waterfront personnel performing maintenance painting for the U.S. Navy has consistently questioned the Navy's requirement for performing feathering. NAVSEA Standard Item (NSI) 009-32¹ defines feathering as tapering the edges of tightly adhering old paint at an approximate 30-degree angle into the newly prepared bare metal surface and requires that the contractor "feather edges of well-adhered paint remaining after cleaning for all surface preparation methods."

The requirement is impractical because feathering at a 30-degree angle on a 20-mil-thick coating would only give a 40-mil-wide feathered border. Performing and inspecting work to this requirement is not feasible. Feathering is a time-consuming and laborious process, which is further complicated by the legacy requirements, causing extensive rework on maintenance-painting jobs. Figure 1 shows an example of feathering performed as part of surface preparation to SSPC-SP 3² prior to application of the repair coating system in a void space.

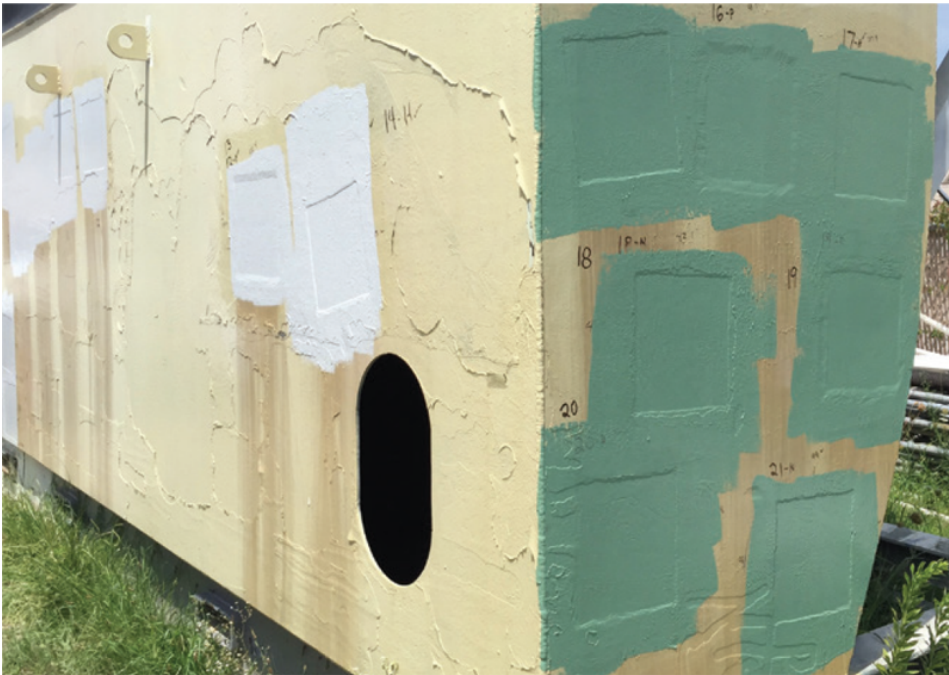
Fig. 4: Mock tank after repair primer.

One coat of the same UHS epoxy repair coating used for lab testing was applied to test patches 1–14. The repair coating was overlapped a minimum of 2 inches onto the intact coating on all sides. One coat of the polyamide epoxy repair coating used for lab testing was applied to test patches 15–21. A second coat of polysiloxane topcoat was applied to test patches 15–21 to complete the two-coat system (Fig. 4). All coatings were applied using a ¼-inch-nap synthetic roller. The average DFT of the one-coat UHS epoxy repair system was 15.1 mils and the average DFT of the two-coat epoxy/polysiloxane repair system was 12.5 mils.
