Failures Analysis of E-Glass Fibre reinforced pipes in Oil and Gas Industry: A Review

2017 IOP Conf. Ser.: Mater. Sci. Eng. 217 012004

Abstract: A comprehensive review is conducted on the failures in the field of manufacturing and installation of E-glass fiber reinforced pipes (GFRP). Some of the failures which are mainly encountered after the installation of E-Glass fiber reinforced pipes are the formation of air bubbles in between the polyester resin layer and the surface film, dispersion of moisture in between the tubing outer and inner layers after installation, heat released in between the layers of E-glass fiber reinforced pipes due to exothermic reaction which in turn results in the formation of cracks on the surface of the pipe. The recent findings and challenges performed in conducting research regarding the deterioration caused in glass fiber reinforced pipes are highlighted and each type of failure that was identified was illustrated with an appropriate high resolution photograph. Performing creep resistance and fatigue analysis are new aspects which are still required to be analyzed which have not been stated in the literature which are nominated.

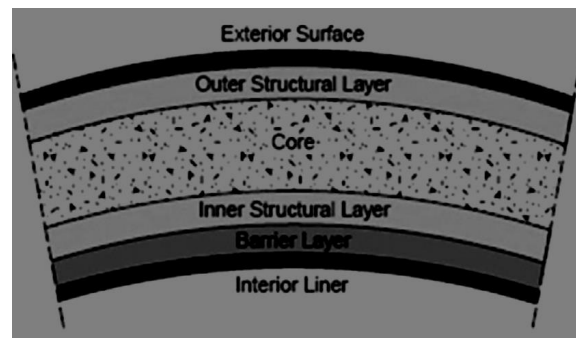
Figure-1: Systematic representation of GRP Wall construction [1]

reaction which results in the formation of cracks on the surface of the pipe. The operation temperature is another important variable that determines the degradation resistance of the E-Glass composite pipes. The temperature determines various factors such as moisture, air bubbles, heat produced within the pipes. They are also many other factors for failures in their performance, recent developments in computational techniques have shown the researchers to find more challenging problems. More research in this area has been done with composite materials by using different materials. As per the work done by Roham Rafiee et al, 2016 [1] and his team, constraints in the failure of composite pipes fall into two main categories of short-term and long-term requirements in accordance with international rules and regulations. For the long-term considerations, creep phenomenon, fatigue failure and environmental issues are the most important topics. Figure-1 shows the Layout of GRP Wall construction during the manufacturing process.

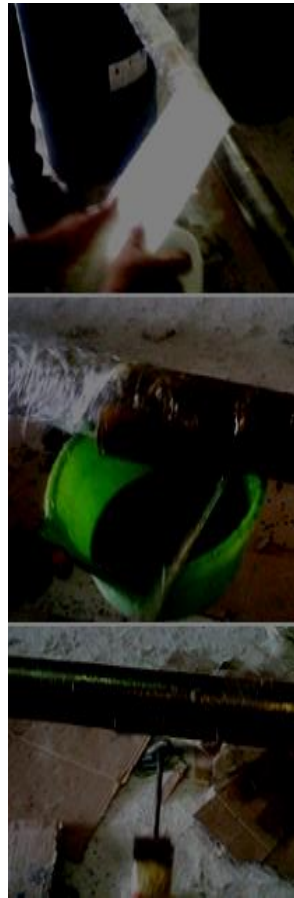
Figure-2: Systematic process of winding and applying resin during the preparation of E-Glass fiber reinforced pipe

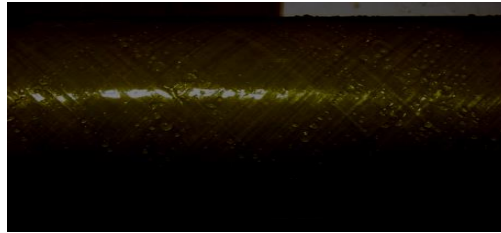
Figure: 3-Failure due the weepage caused by Air bubble formation inside the pipe

As per work done, Firstly failures were noticed during the process of Filament winding when a plastic-coated cloth is placed along the longitudinal section of the mandrel, air is vaguely trapped in the reinforcement and resulting in the formation of cells or holes in the wall, So during the forming and curing operations there is a decrease in the strength of the final piping and sometimes making it permeable and so the tubing will not be suitable for all kinds of uses. Also, because when a cloth type reinforcement is applied, it is well oriented into definite layers and is therefore likely to delaminate and also trapping of air in the reinforcement which consequently results in the production of tubing free of passage which promotes leakage and stress concentrations. Water molecules are spread in to fiber-matrix interface and to drifted along the fibers by surface tension reducing fiber-matrix bond. The figure-3 shows the failure caused due the weepage caused by Air bubble formation inside the pipe.

According to work done, The Coating resin which is applied must be free from air bubbles and dirt, so that the GFRP Pipe can with stand for long period of time. .

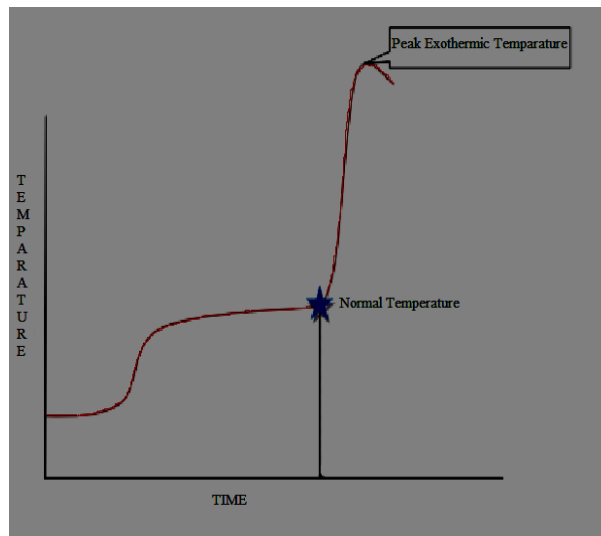
Graph:1-Time vs Temperature during curing operation for optimum temperature during manufacturing process of Glass fiber reinforced pipes [36]

Thirdly, when the composite is wrapped with layers heat is released inside the wrapping layer after few months which is termed heat gained by exothermic reaction. The excess heat produced will depend on various factors such as number of layers wrapped across each fiber during filament winding, so due to heat it results in poor fibre-matrix adhesion which then undergoes fibre and matrix de bonding and splitting. In such failure, fibres which are destroyed are located at any place along the specimen. By exothermic reaction in the pipe, thermosetting matrix problems such thick laminates formation, matrix distortion and few other small problems are noticed. In some cases during Manufacturing high exothermic temperature is produced within the layers of the fiber cloth which caused burning and chemical loss in the resin, to control this filler was added. The time to reach highest exothermic heat is also reduced with increasing filler amount, thereby reducing the cure cycle. The graph below shows time versus temperature during curing operation of the GFRP Pipe.

Sometimes due to high exothermic temperature degradation of resin may occur hence mould cooling is necessary to reduce the heat. The fiber-matrix adhesion reduction which is caused due to heat release will decrease the load transfer from one phase to another degrading the mechanical response of the pipe [37].
