## Compendium of Geomembrane Failure (2017)

## Cold Cracking of HDPE Geomembranes

## **Case History**

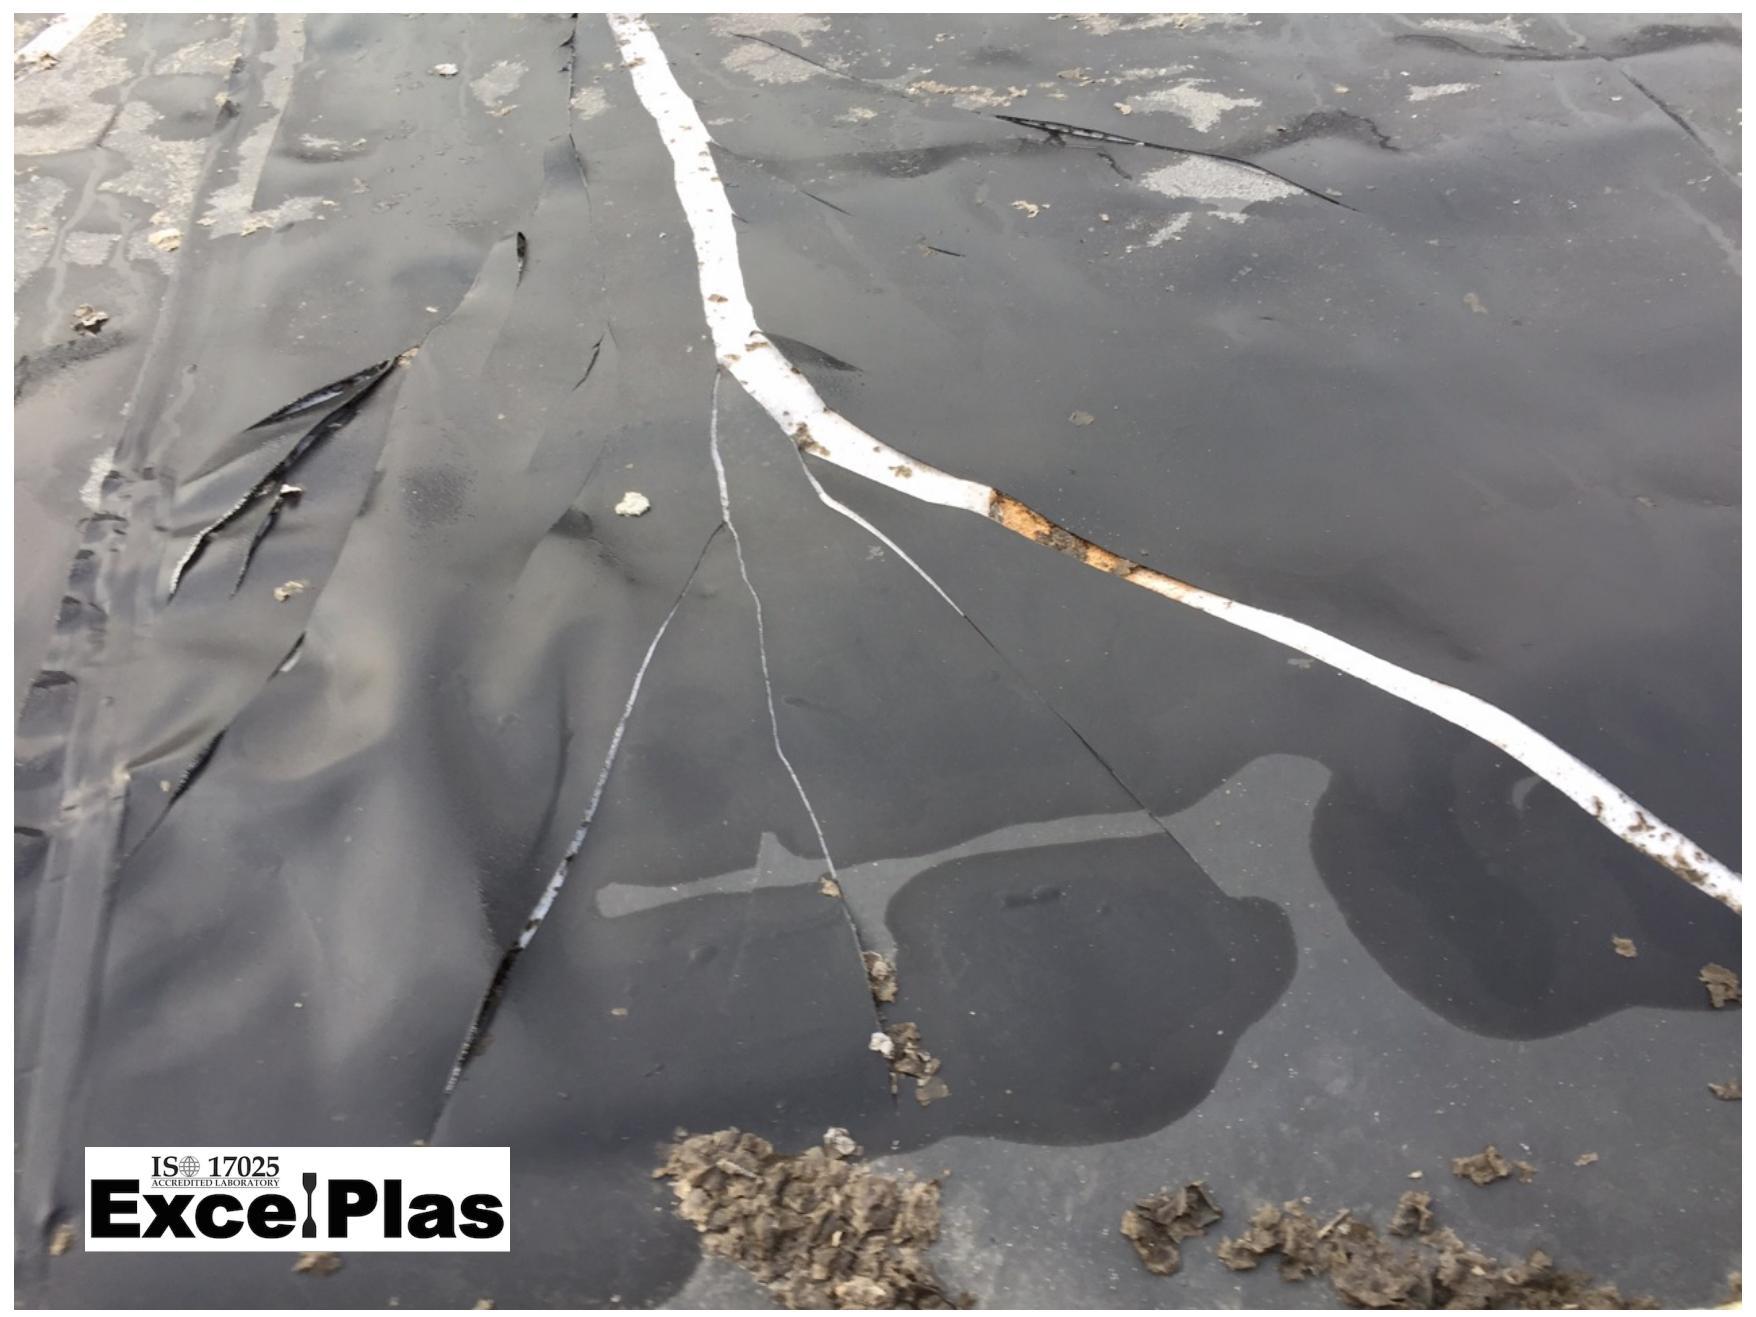
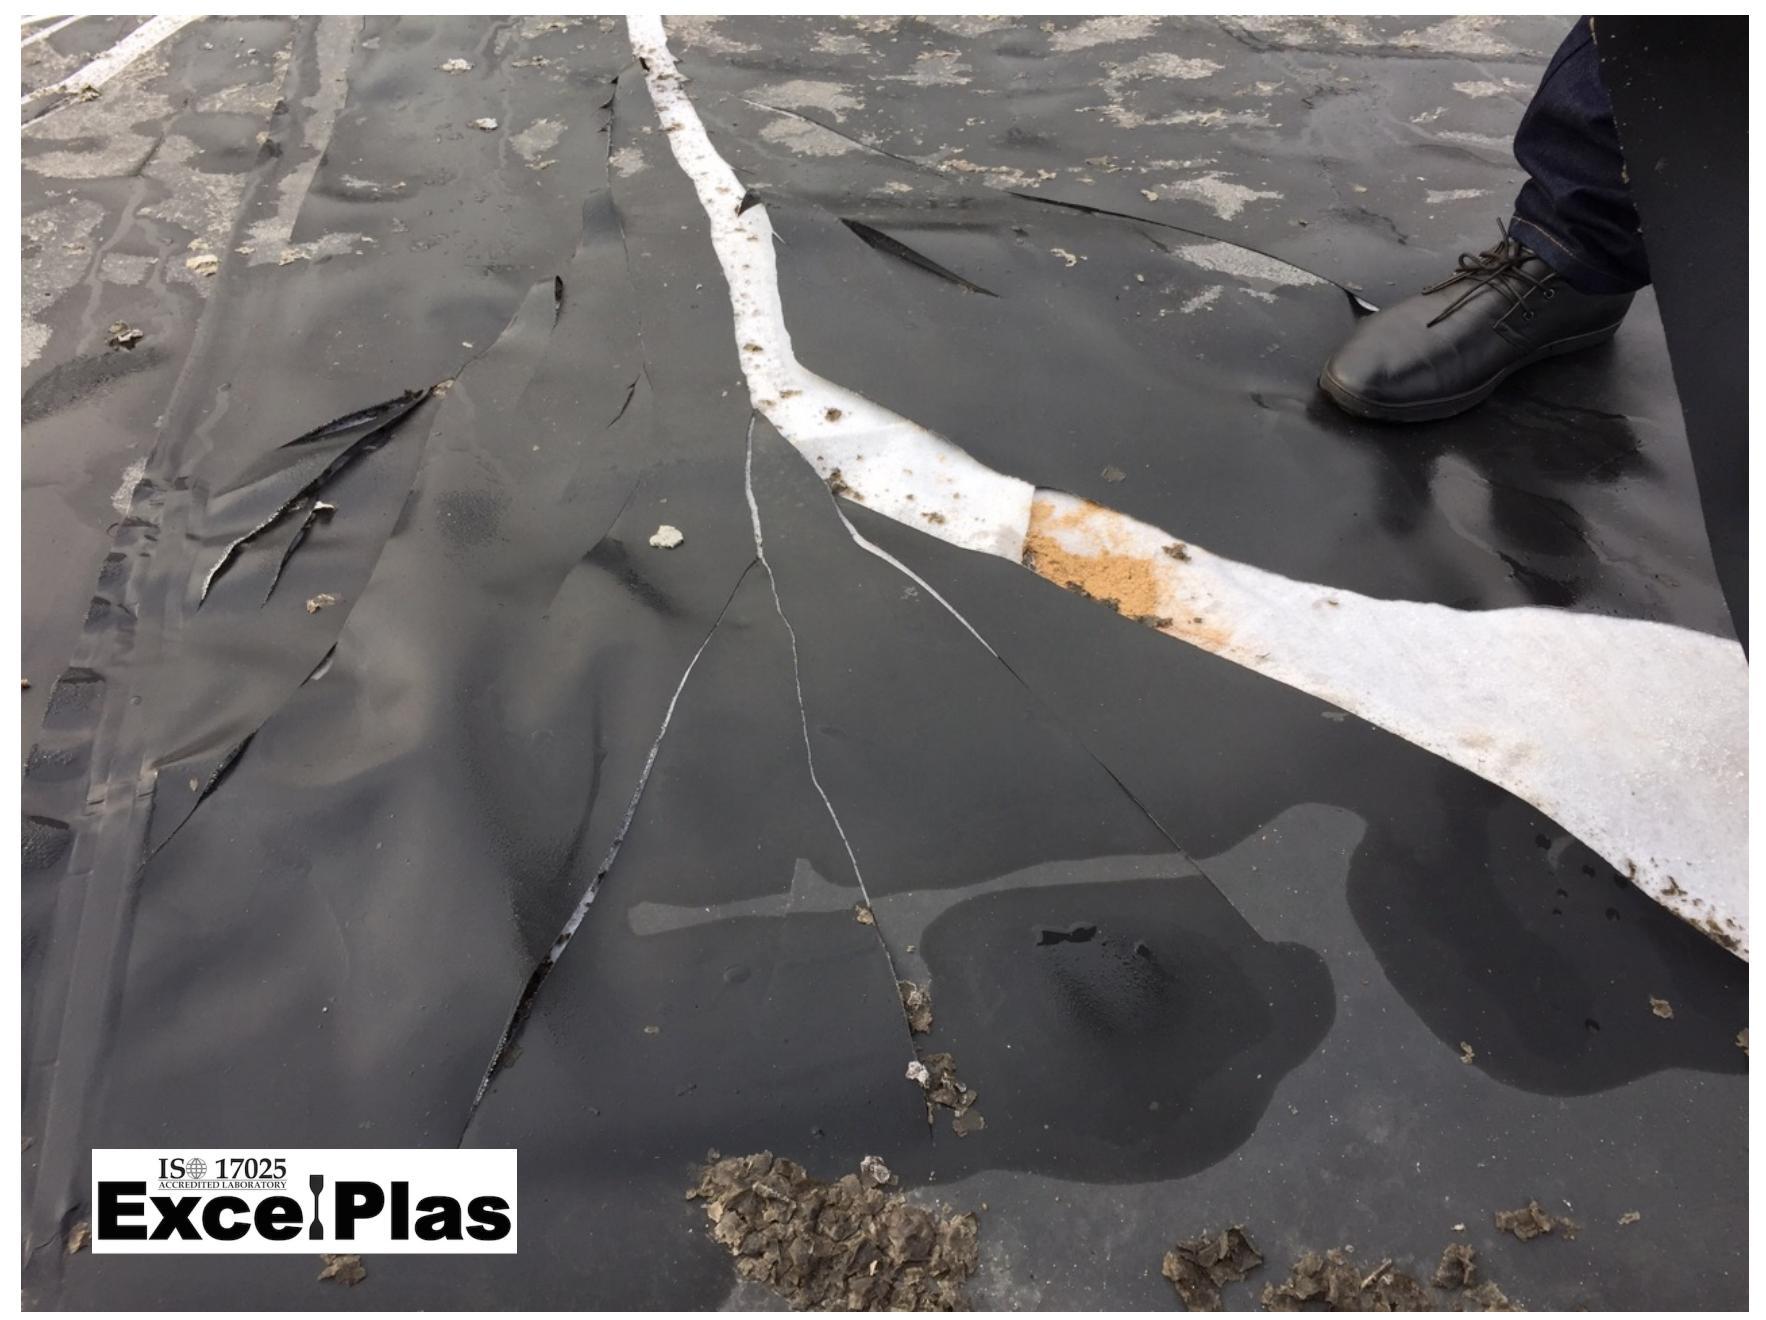
- Location: Kazakhstan
- Temperature: down to -30 to -35 deg.C
- Wind Speed: High (exposed area)
- Nature of Material: Exposed HDPE Geomembrane
- Thickness: 2 mm
- Application: mining application
- Details: liner was installed in May-June and cracked in winter time Dec-Jan (European winter)

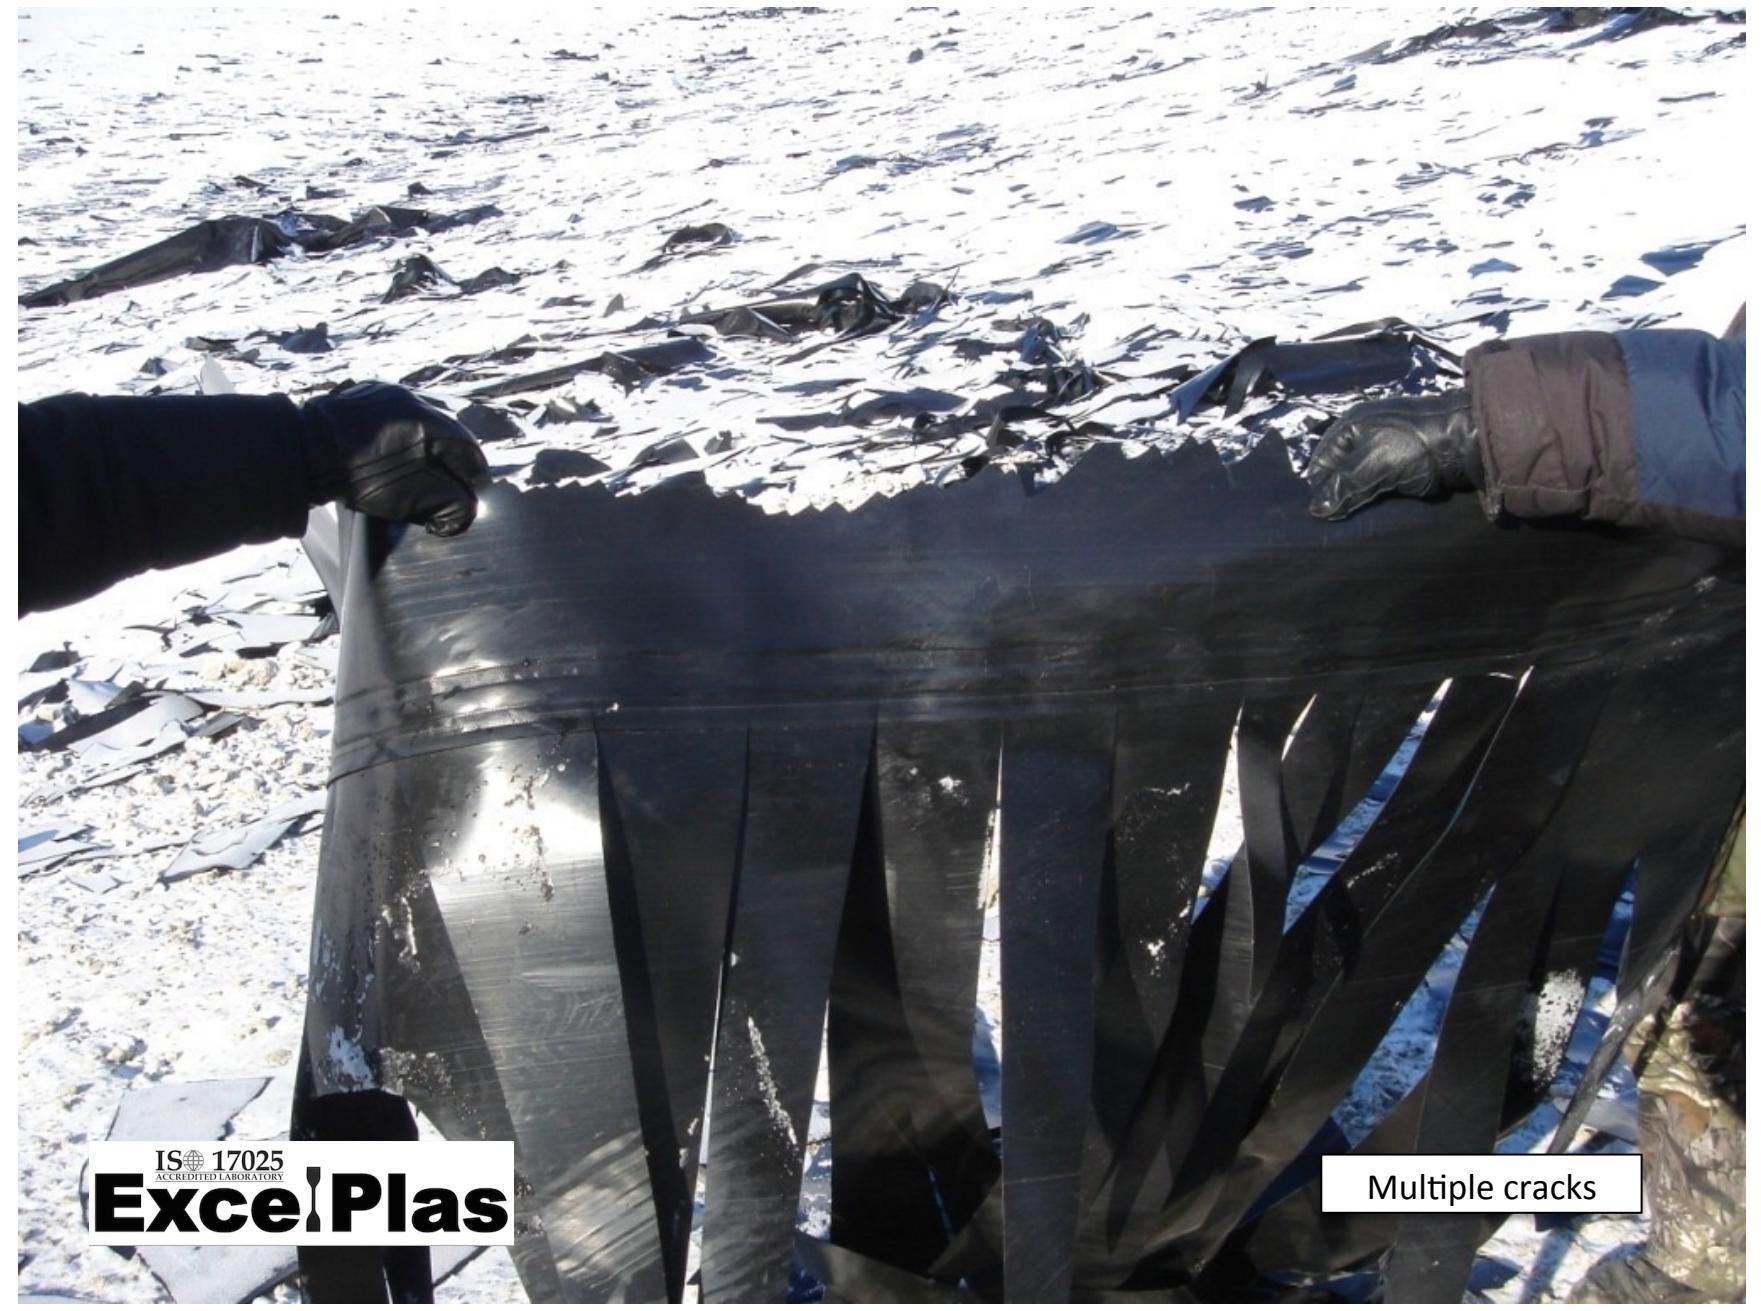
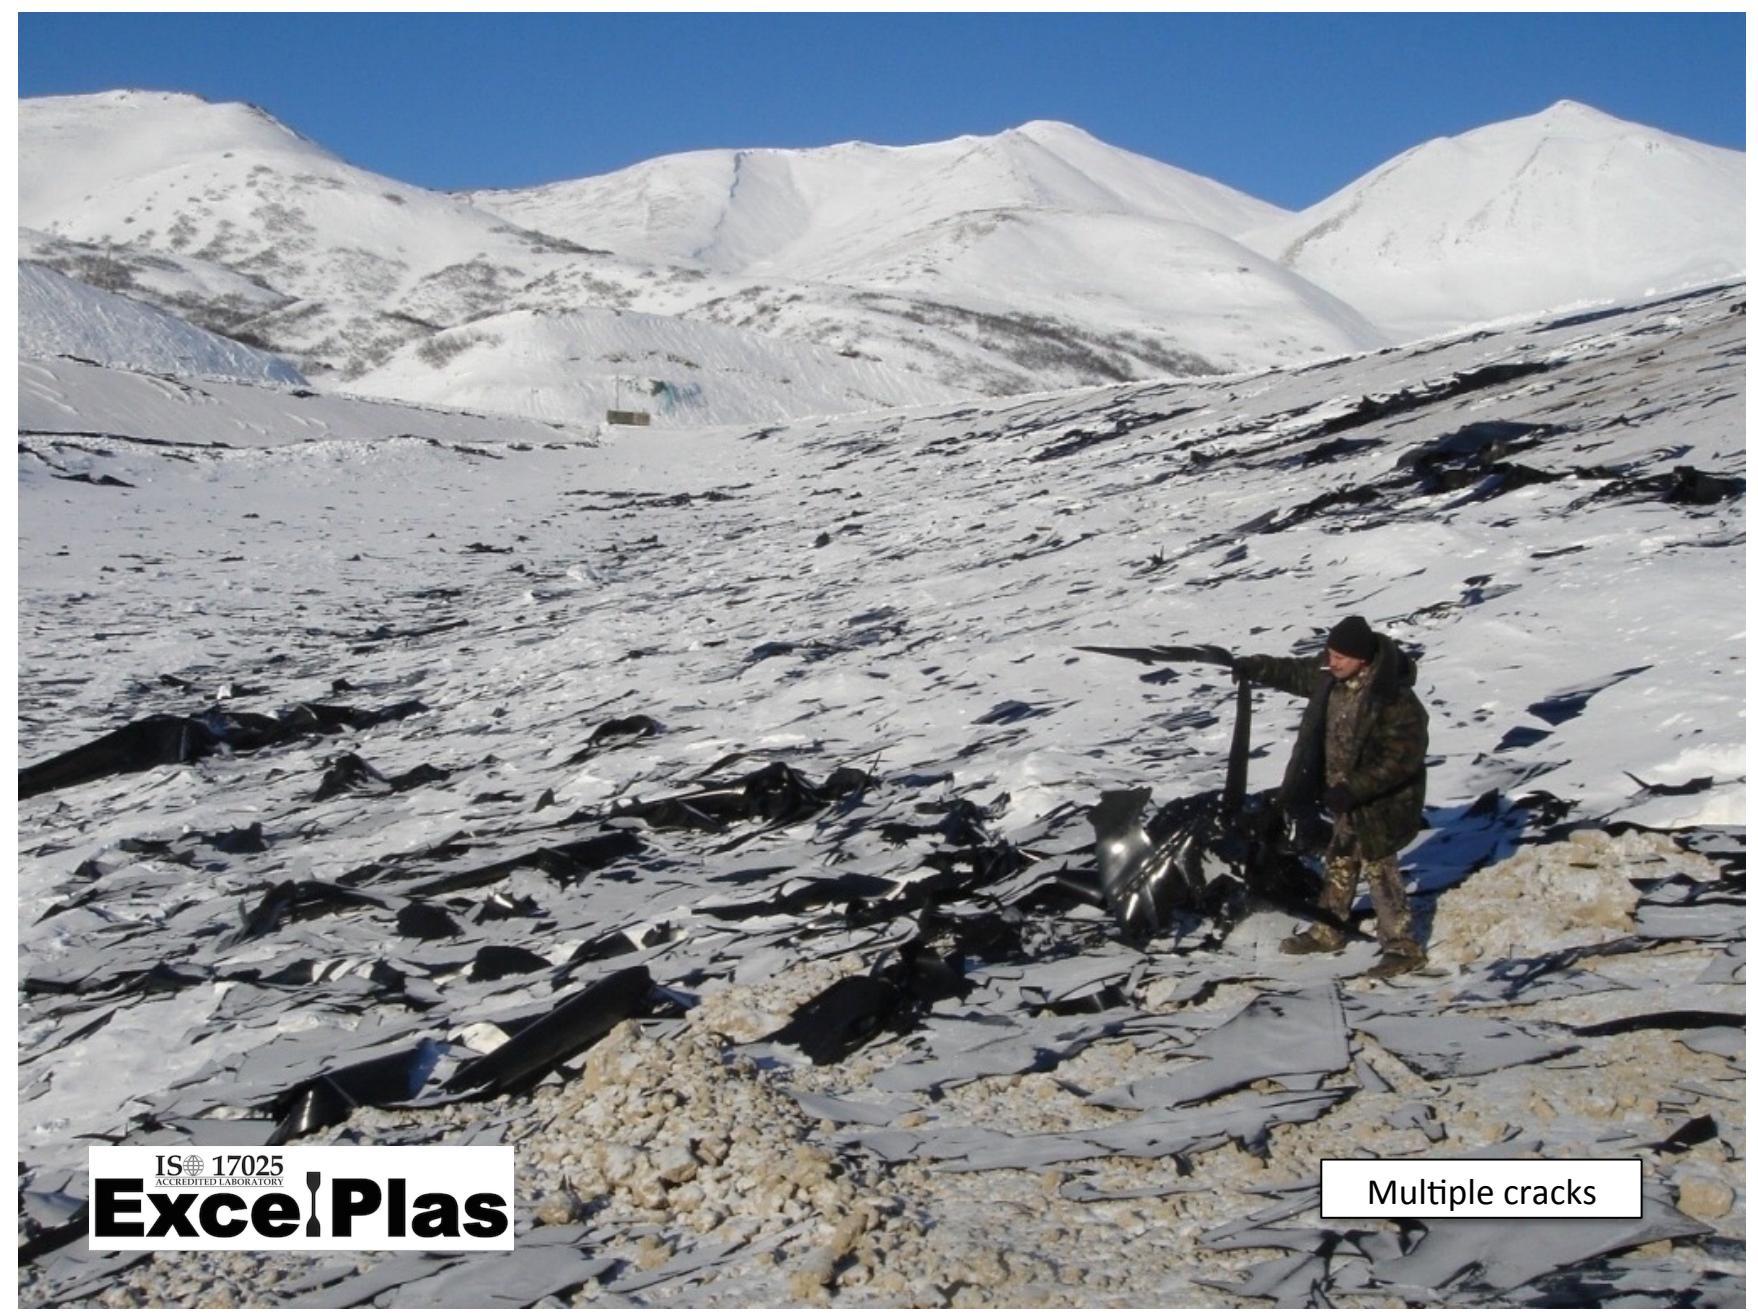
- Exposed HDPE geomembranes are susceptible to *rapid crack propagation (RCP)* under conditions of sub-zero temperatures combined with strong winds.
- Rapid onset of cold temperatures as well as strong gusting winds can combine to form conditions where rapid crack propagation (that is, crack advancing speeds of > 250 m/s) of HDPE can result leading to a spontaneous shattering failure mechanism.

- Exposed HDPE geomembranes are susceptible to rapid crack propagation (RCP) under conditions of sub-zero temperatures combined with strong winds. Rapid onset of cold temperatures as well as strong gusting winds can combine to form conditions where rapid crack propagation (that is, crack advancing speeds of > 250 m/s) of HDPE can result leading to a spontaneous shattering failure mechanism.

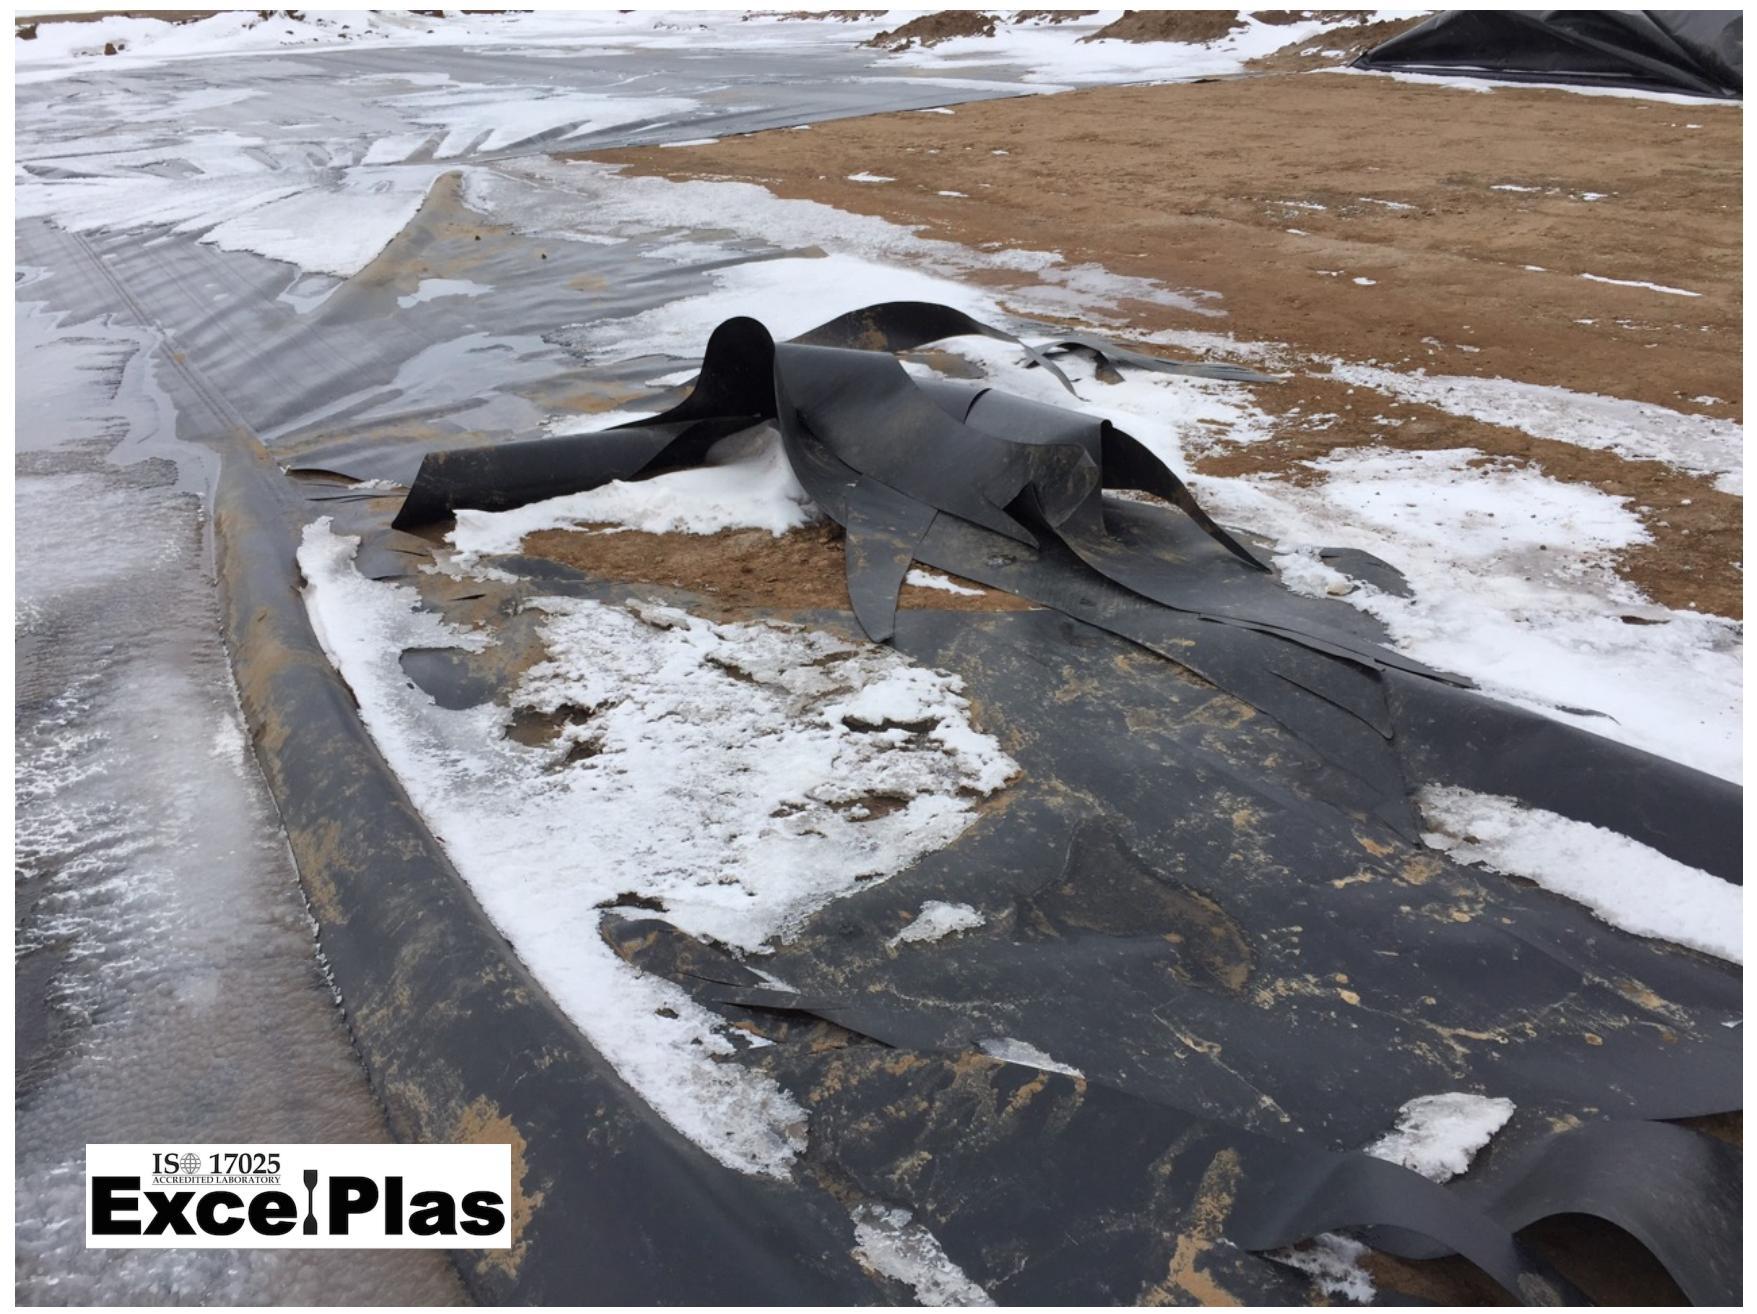
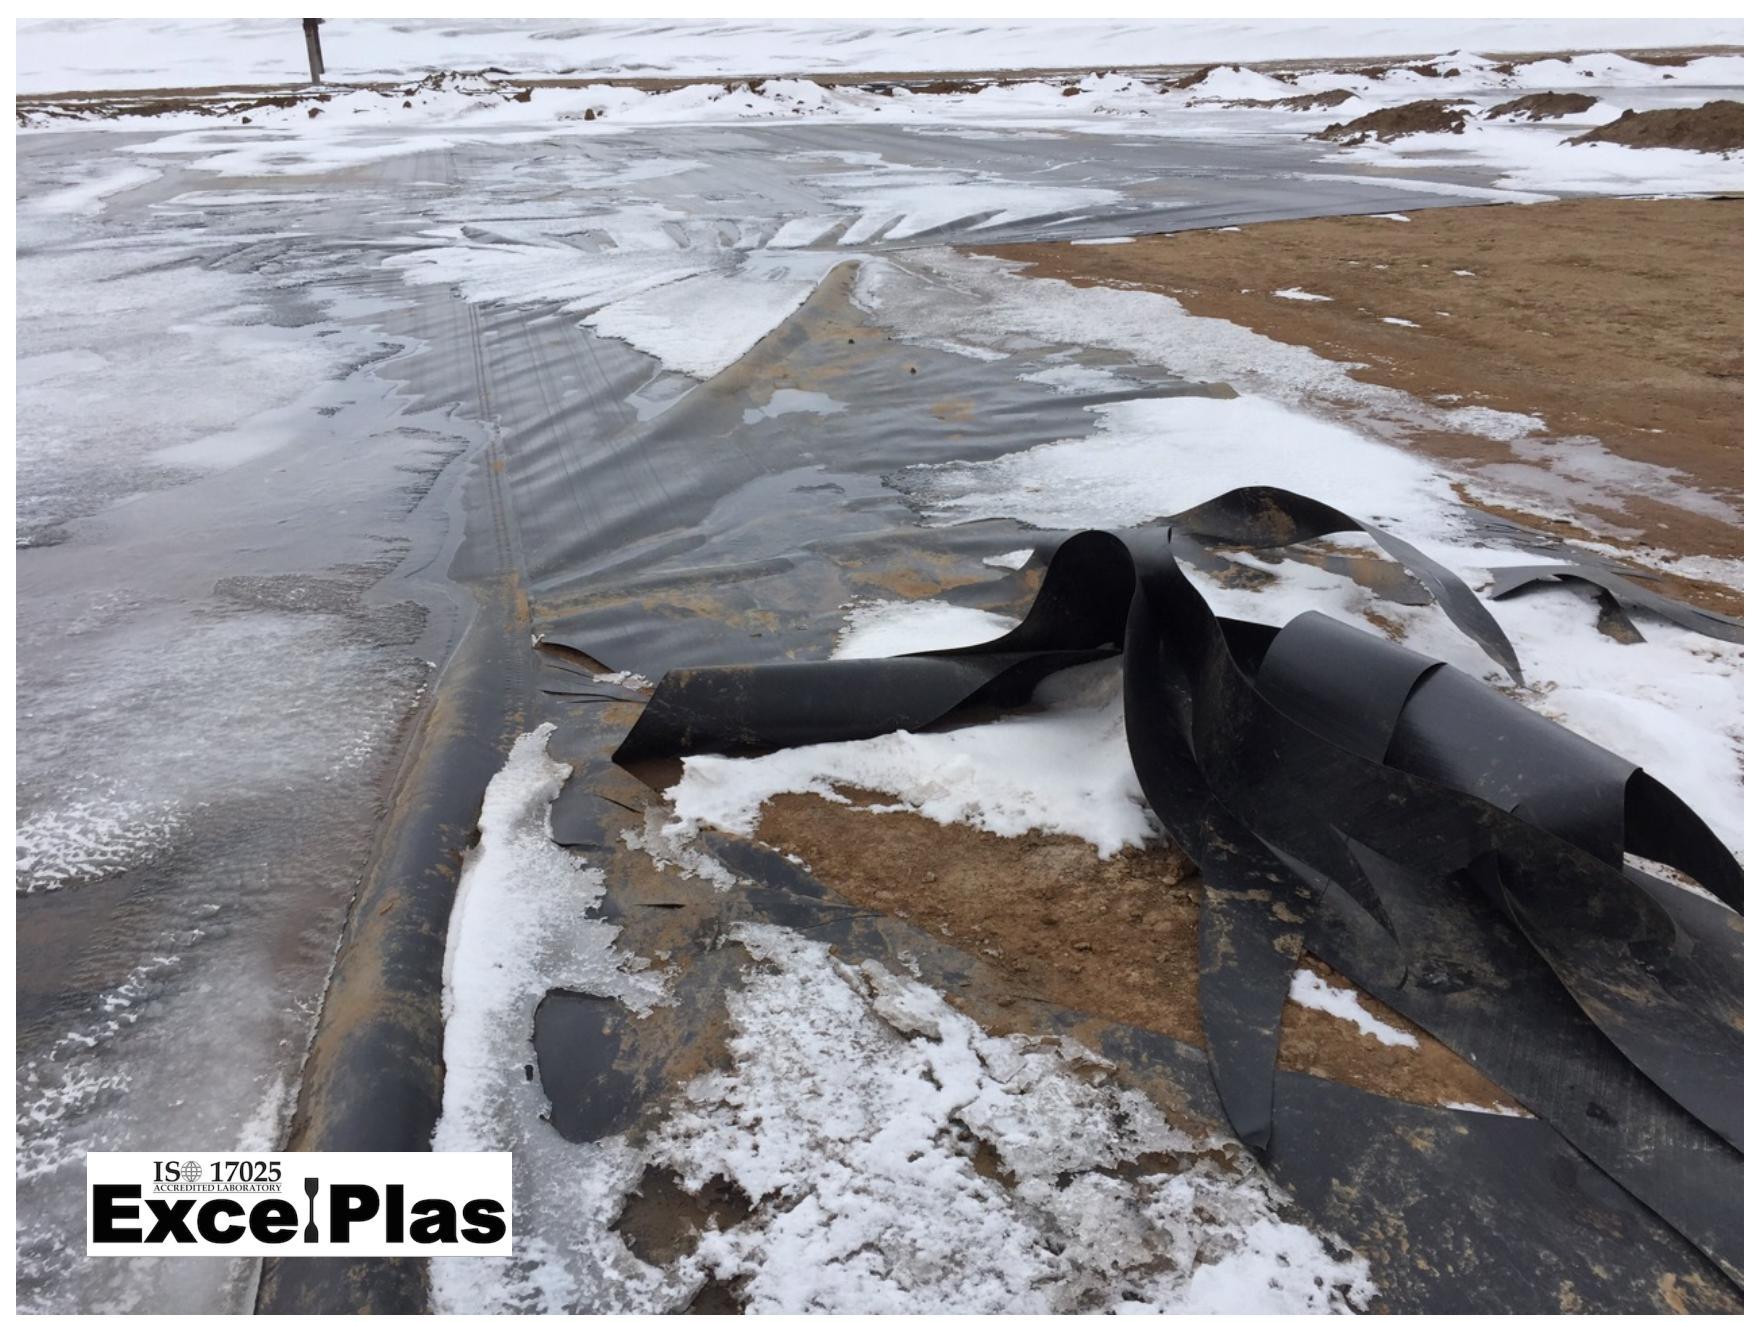
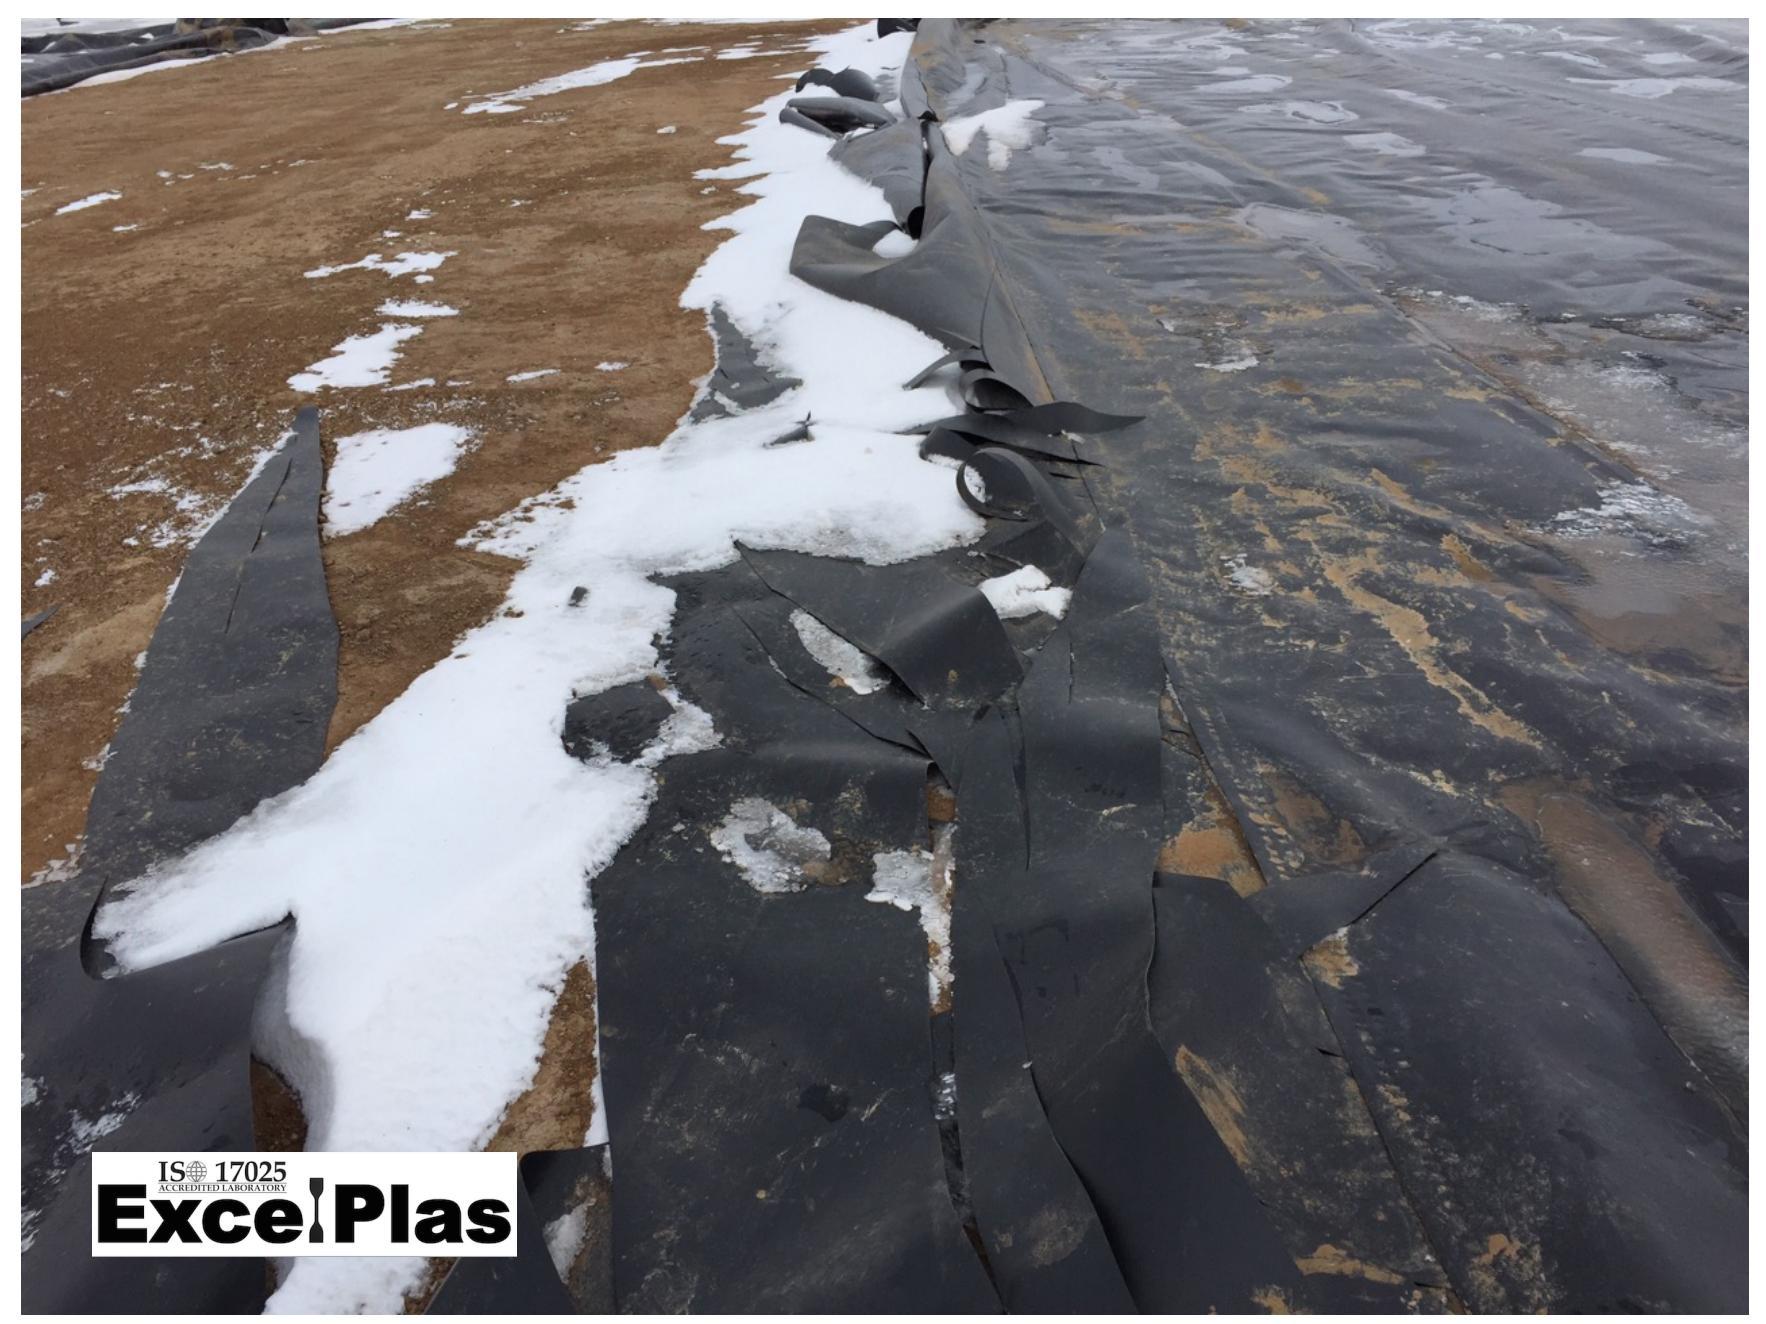
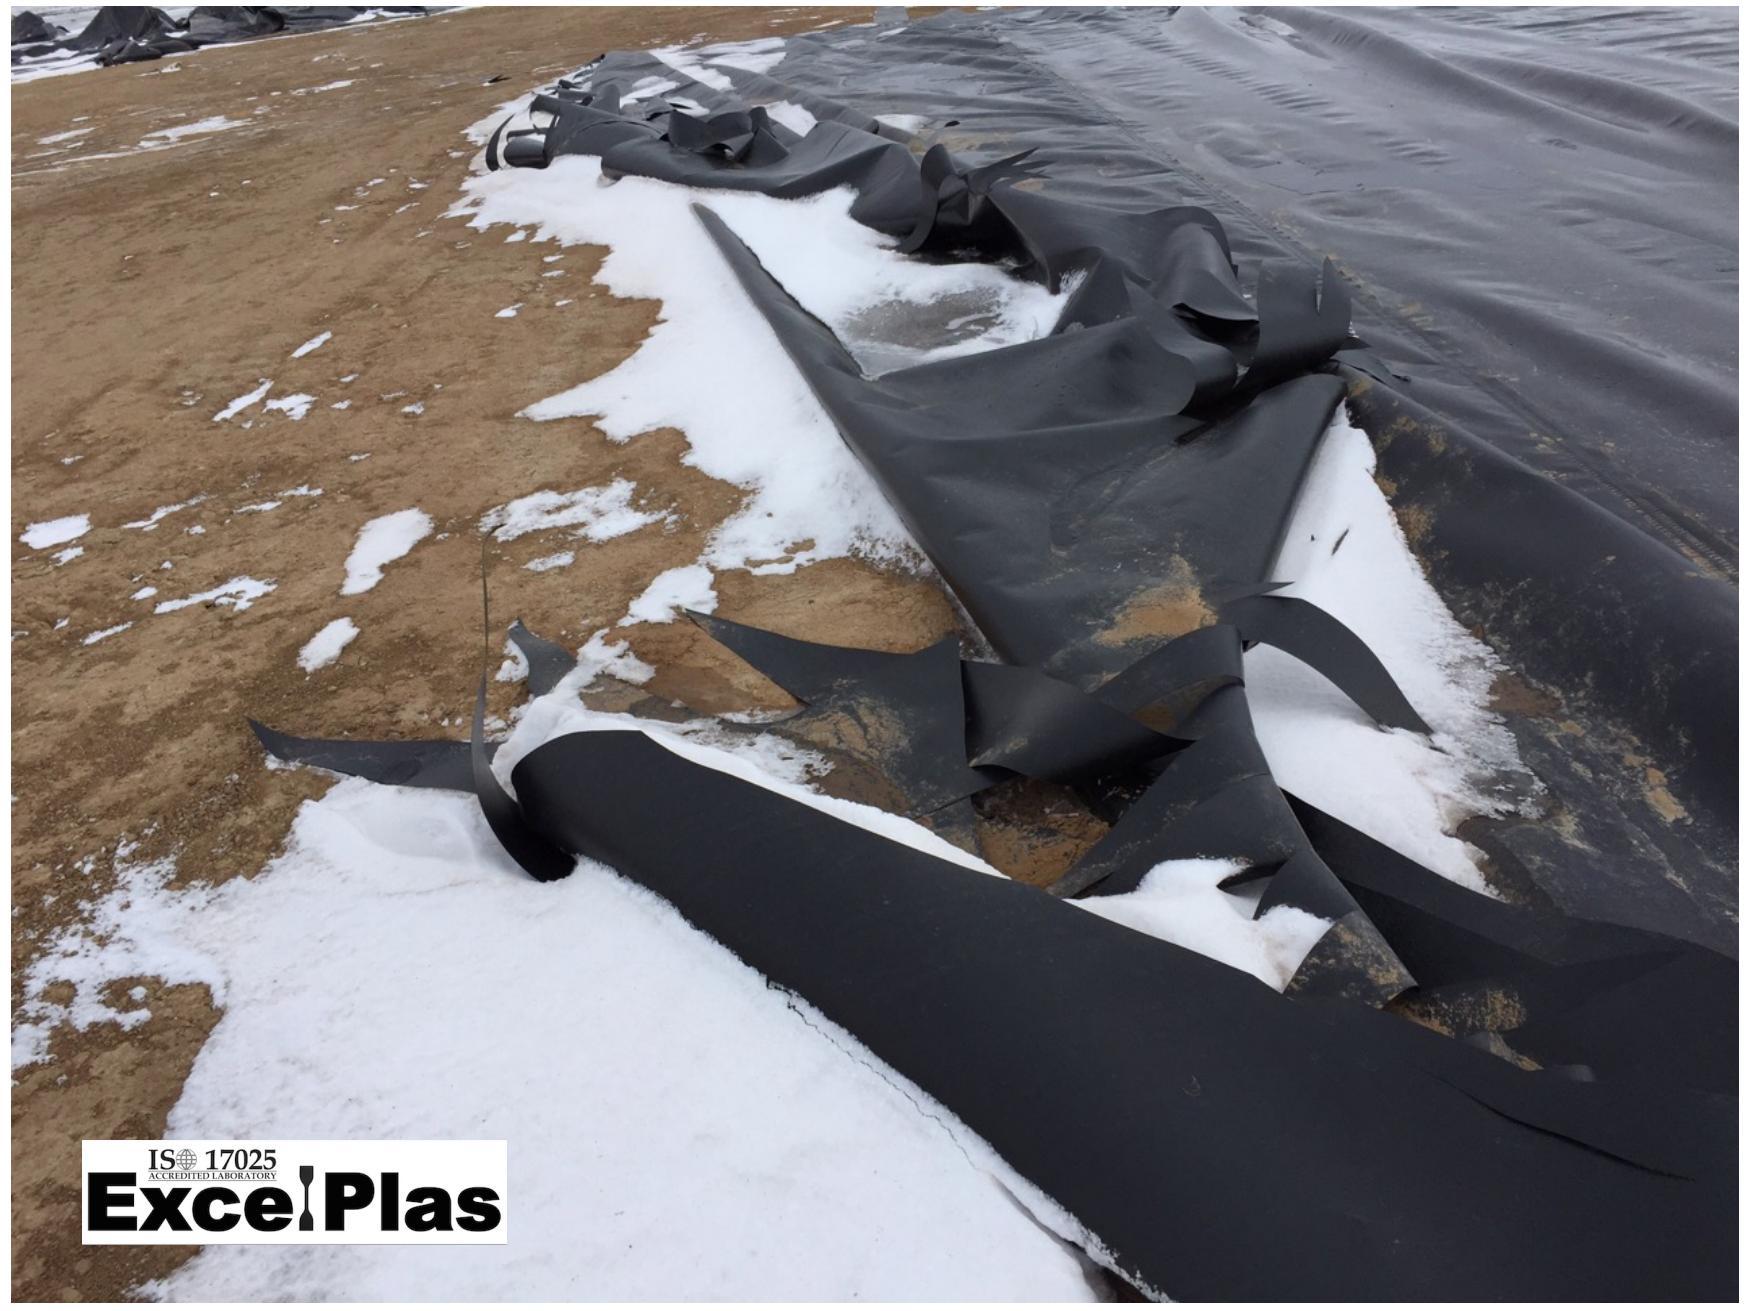
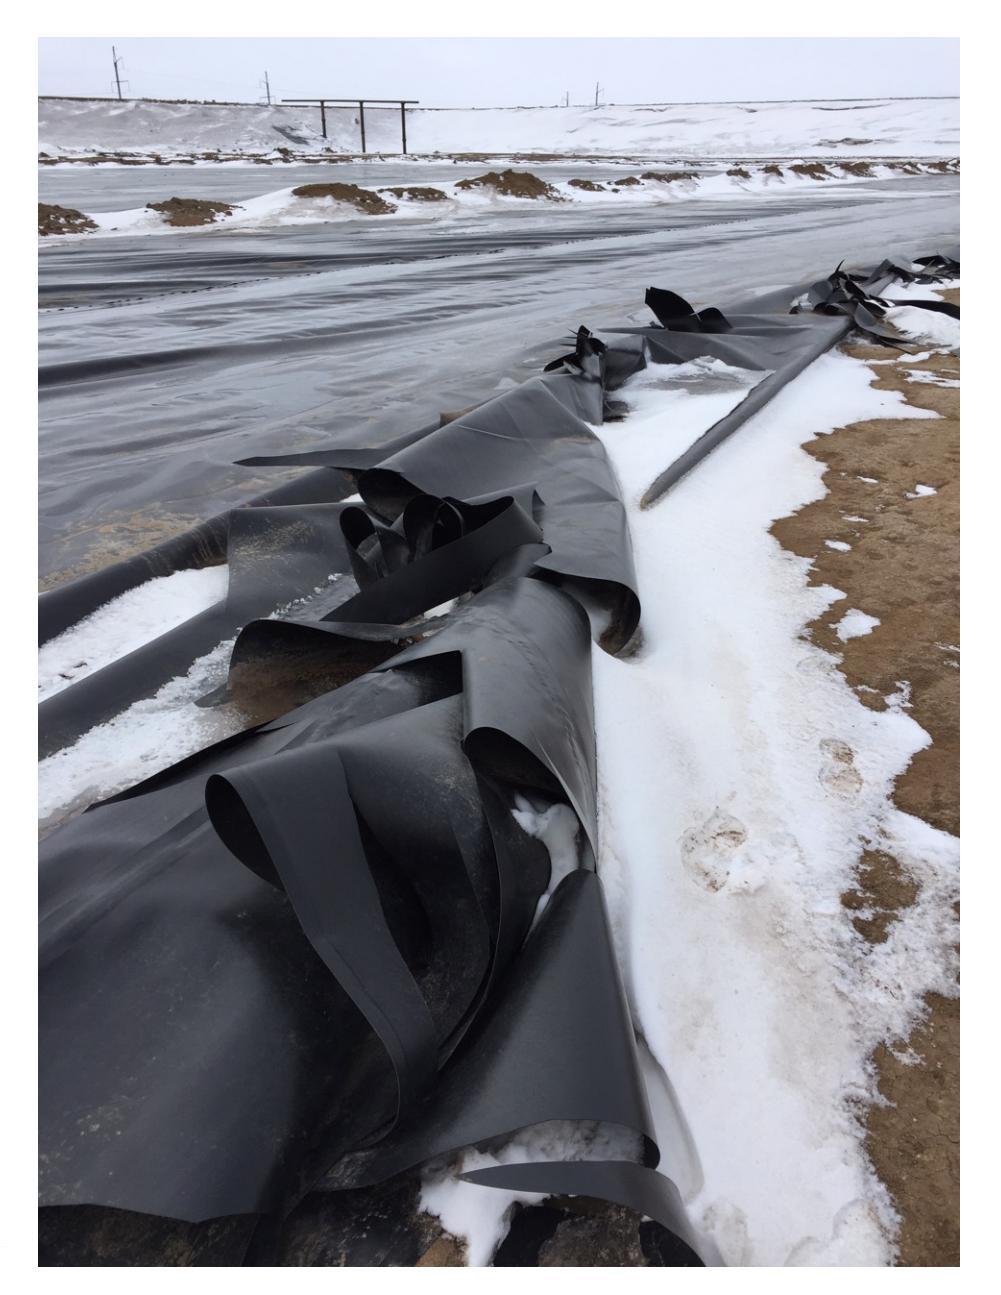
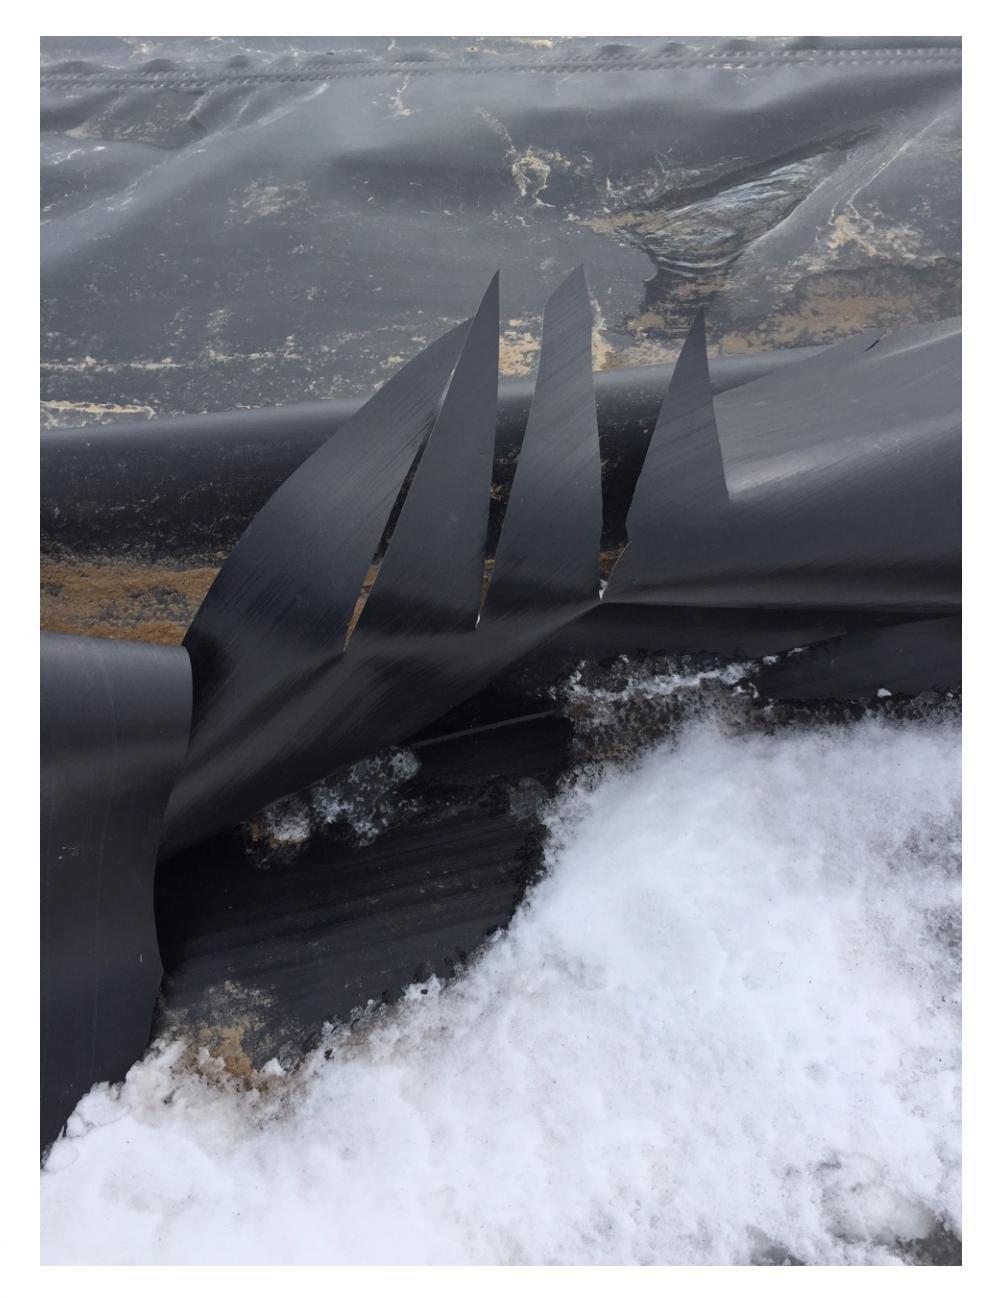
- Rapid Crack Propagation of exposed HDPE geomembranes can initiate at over-heated welds especially extrusion welds where S-OIT values of the liner have reduced to below 2 mins.
- In particular this can occur in areas of accumulated heat history where multiple extrusion beads have been placed on each other or close together or where extrusion beads intersect with wedge welds.

- RCP of exposed HDPE geomembranes can initiate at over-heated welds especially extrusion welds where S-OIT values have reduced to below 2 mins. In particular this can occur in areas of accumulated heat history where multiple extrusion beads have been placed on each other or close together or where extrusion beads intersect with wedge welds.
