## Compendium of Geomembrane Failure (2017)

## Cold Cracking of HDPE Geomembranes

## **Case History**

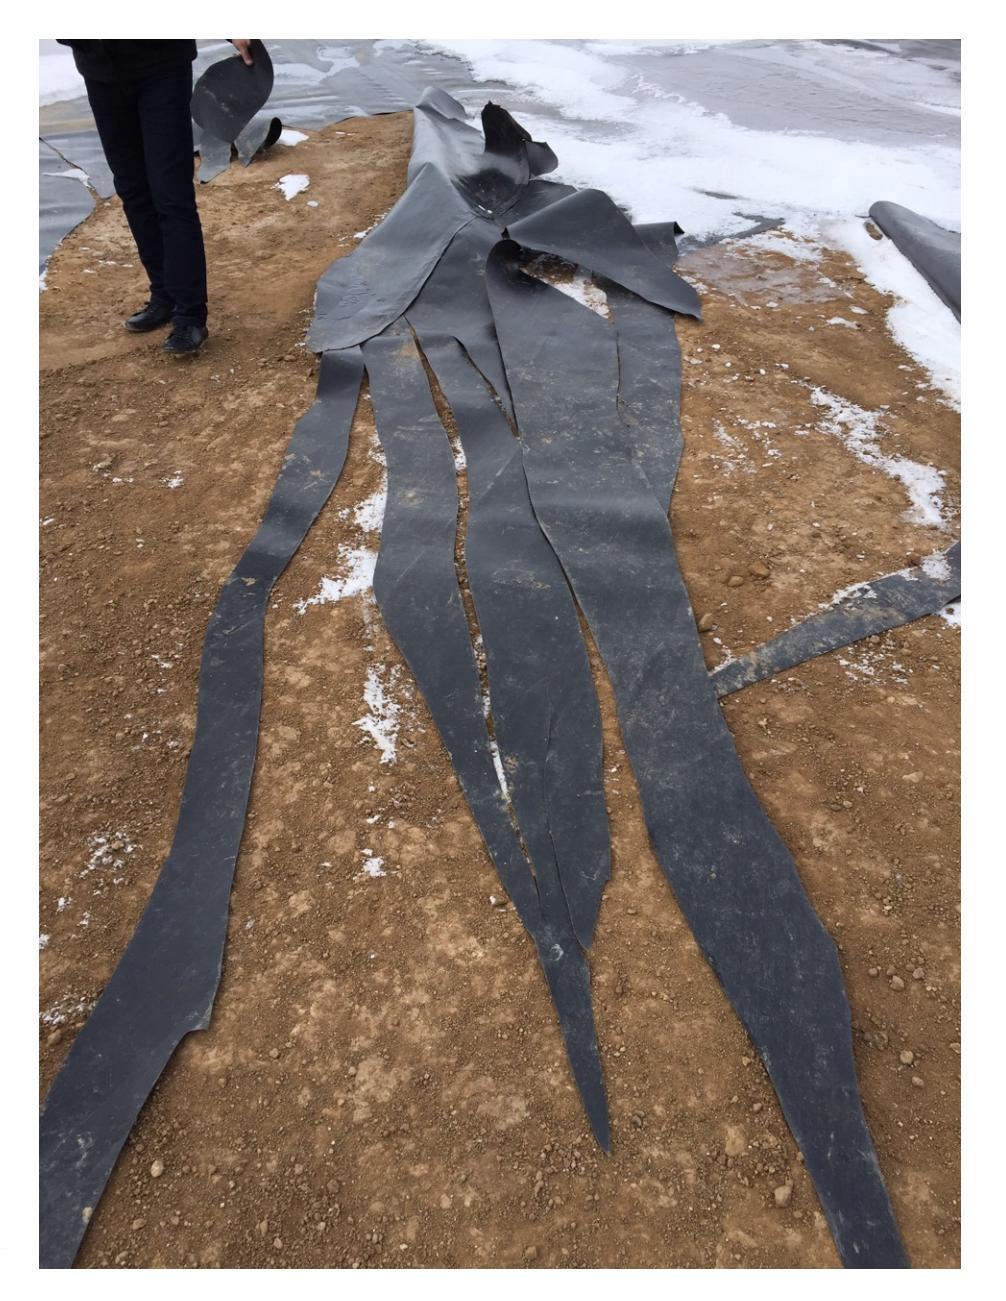
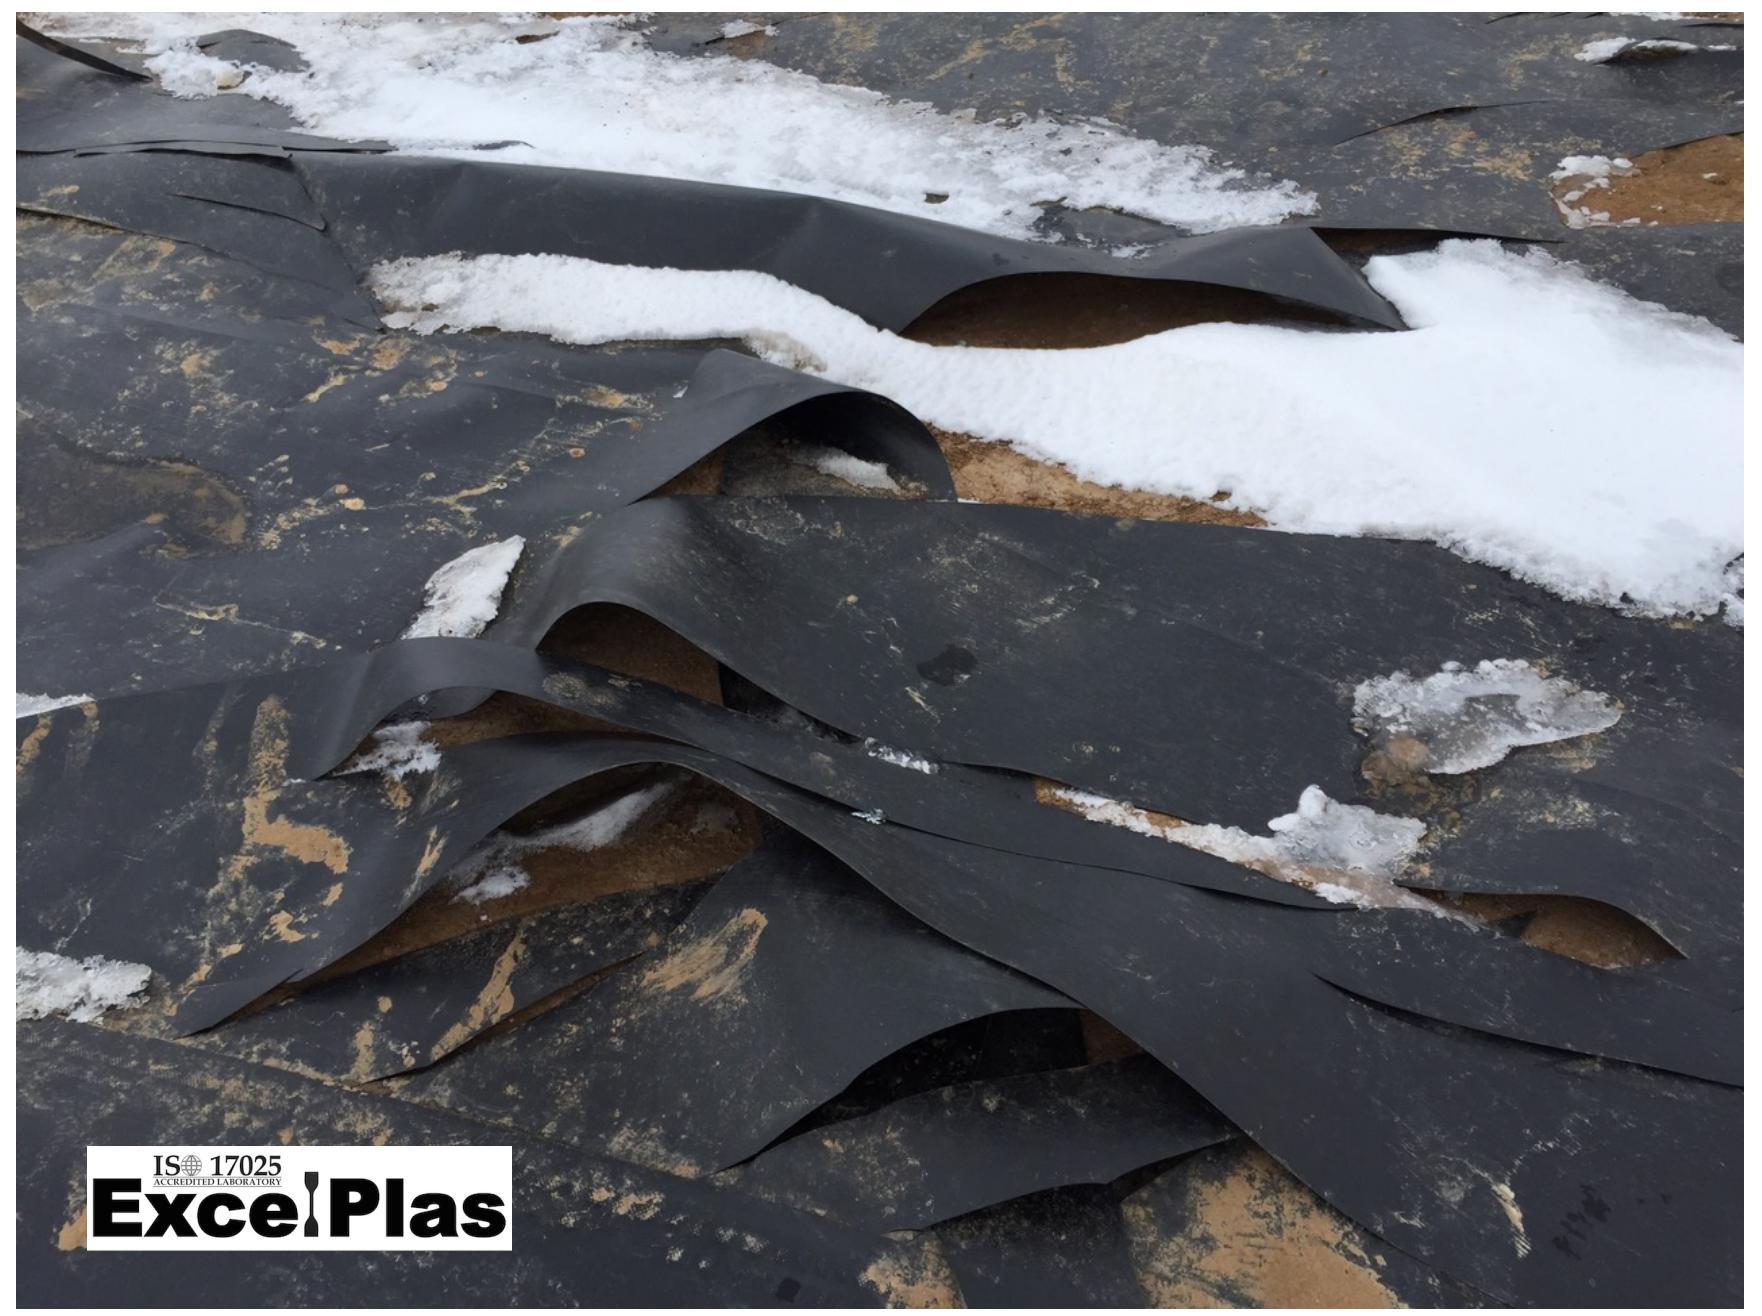
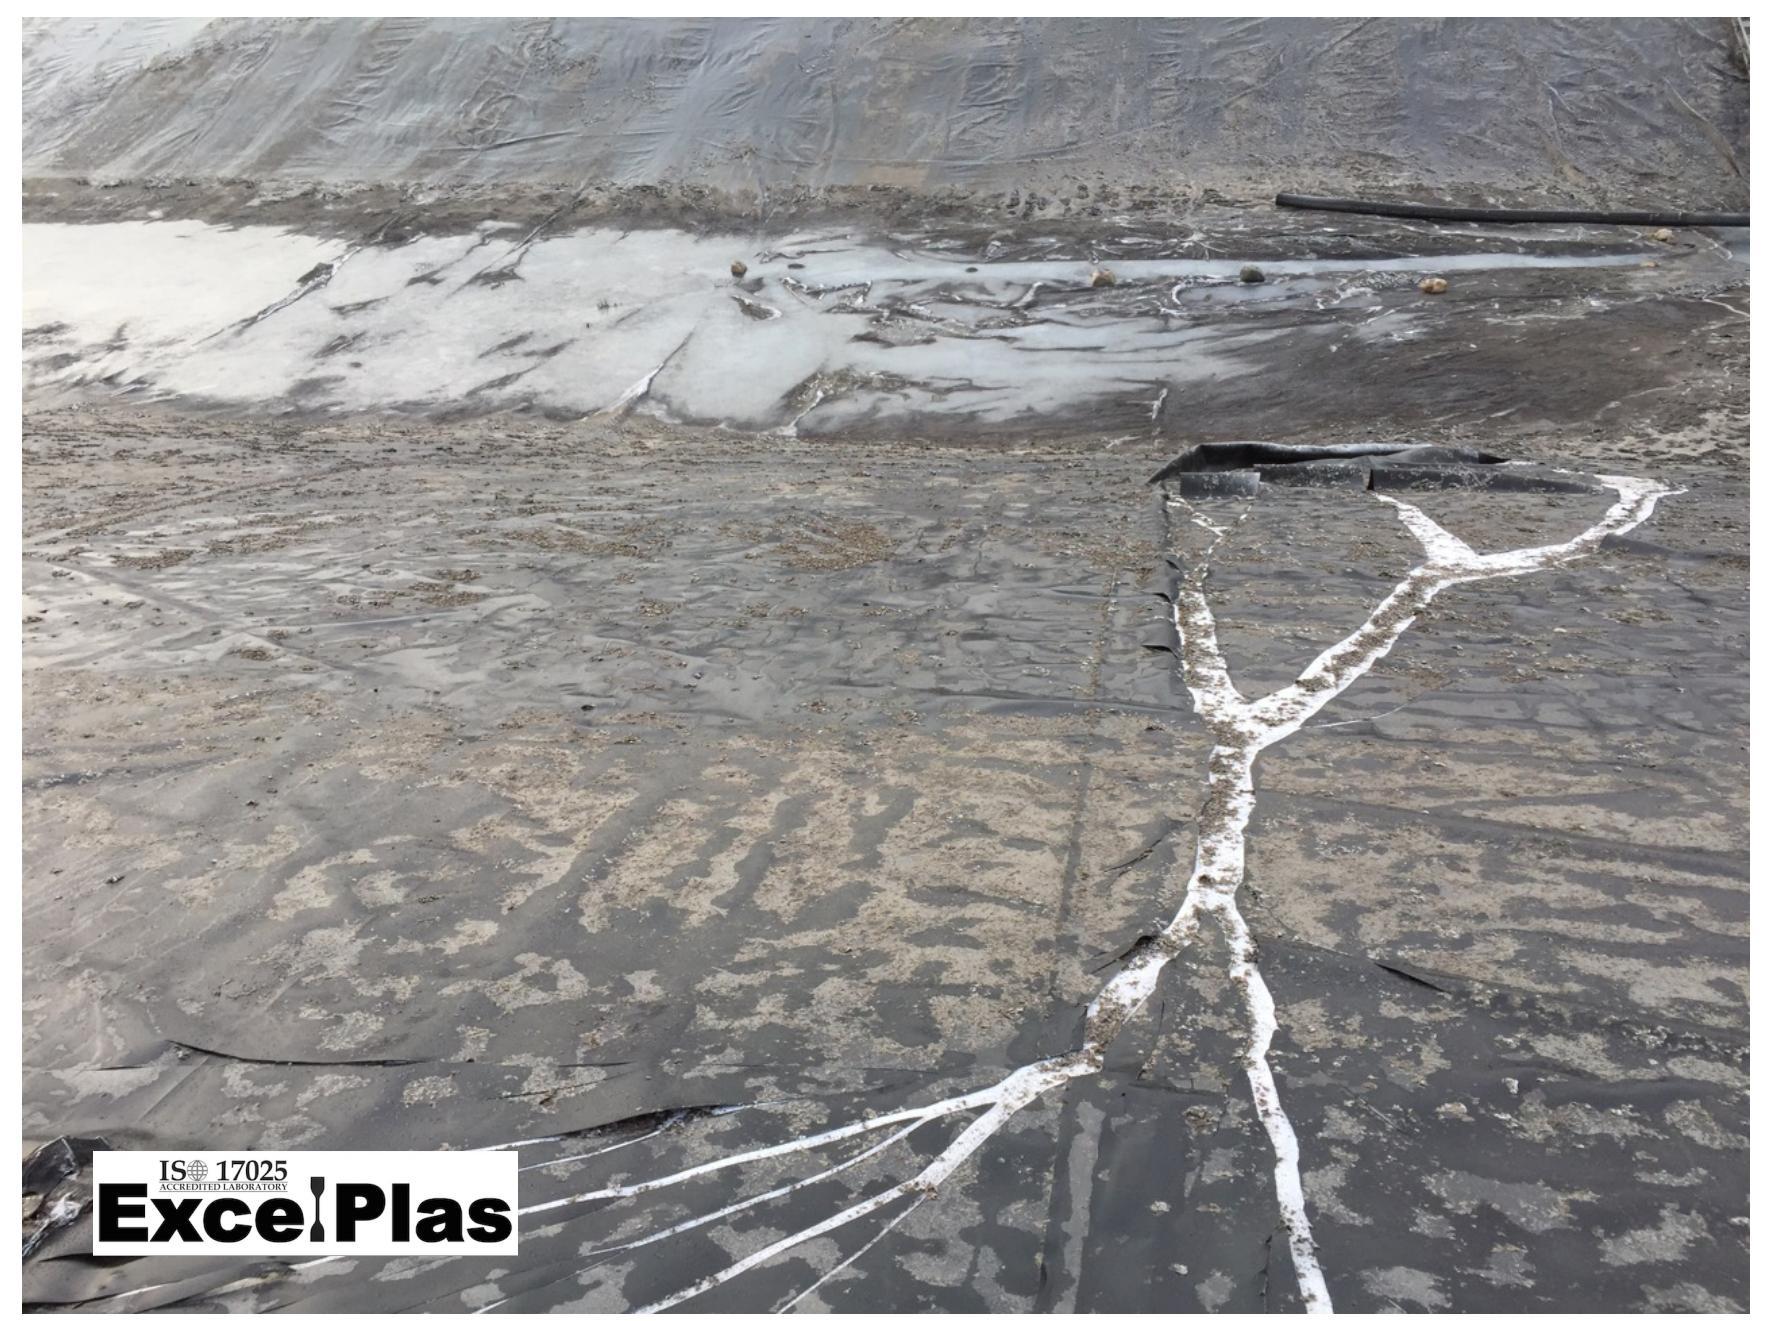
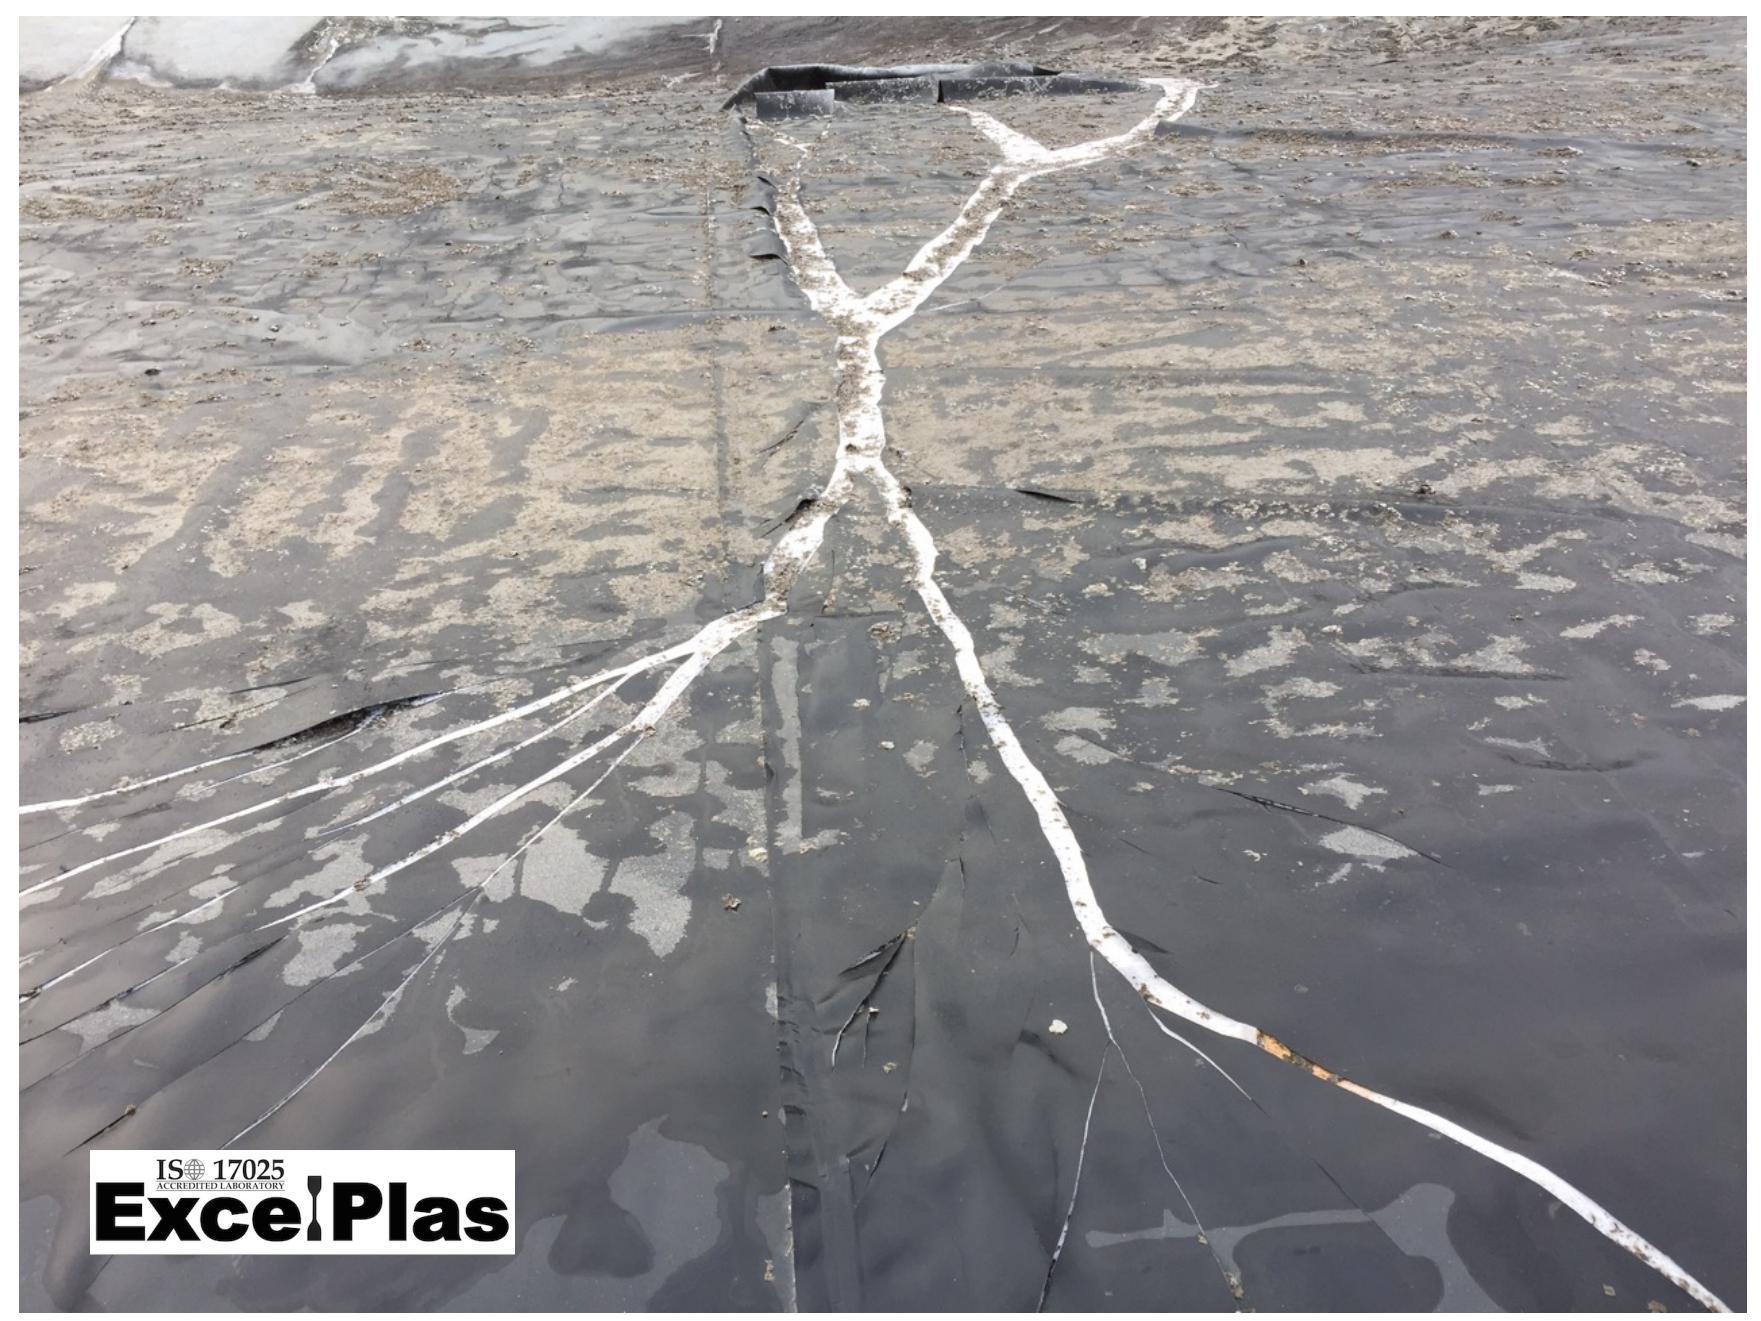
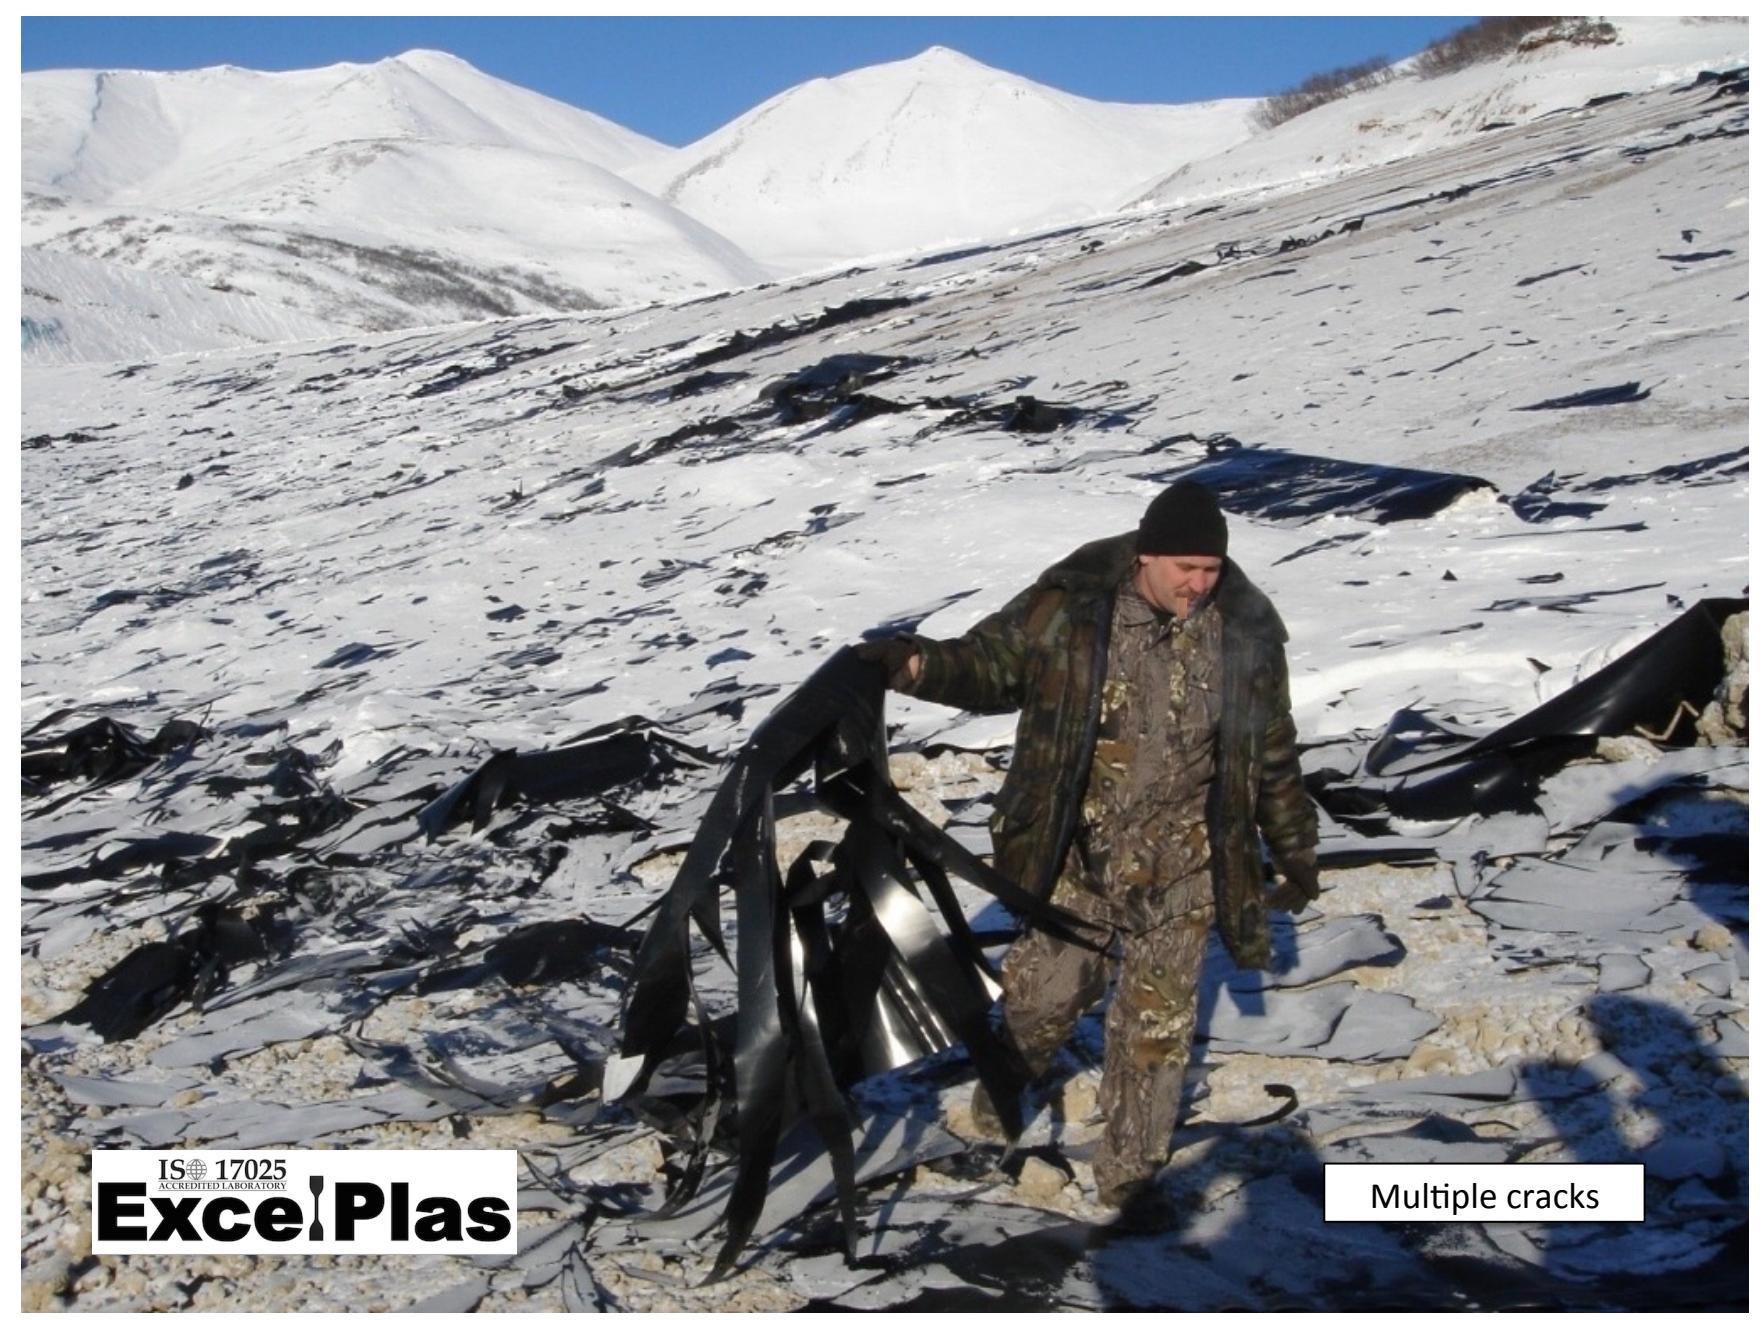
- The localised recrystallisation of the HDPE and associated shrinkage stresses can set up the right circumstances for the formation of the initial stress cracks. These stress cracks can then propagate under particular environmental conditions of sub-zero temperatures and strong gusting, uplifting winds to cause widespread spontaneous HDPE geomembrane failure.
- This failure is characterised by the formation of longshards of cracked geomembrane with the crack edges having a completely brittle appearance. Another important factor appears to be the rate of temperature drop which leads to the formation of damaging contraction stresses that place critical welds under rapid tension.

- The localised recrystallisation of the HDPE and associated shrinkage stresses can set up the right circumstances for the formation of the initial stress cracks. These stress cracks can then propagate under particular environmental conditions of sub-zero temperatures and strong gusting, uplifting winds to cause widespread spontaneous HDPE geomembrane failure. The failure is characterised by the formation of long-shards of cracked geomembrane with the crack edges having a completely brittle appearance. Another important factor appears to be the rate of temperature drop which leads to the formation of damaging contraction stresses that place critical welds under rapid tension.
