## HDPE Geomembranes Used in Fish Rearing Ponds Suspected in Causing Shifted Sex Ratios

By GNA Editor

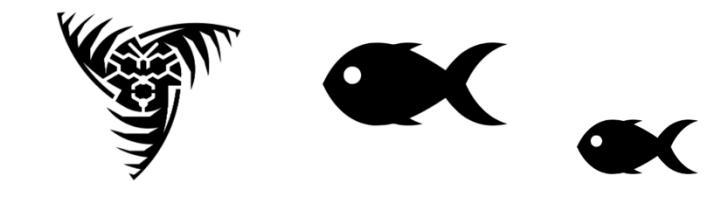
**2,4 DTBP**

- 2,4-di-tert-butylphenyl (2,4 DTBP), a known breakdown product of the antioxidant Irgafos 168, which has demonstrated estrogenic activity in vitro (Shi et al., 2020).
- Hindered Amine Light Stabilizer (HALS) by-products such as:
  - Alkylated piperidines
  - Nitroxyl radicals like TEMPO
  - Carboxylated derivatives with high environmental persistence (Deng et al., 2024).
