Powering Up

Painting Stacks on the Fast Track

From JPCL, July 2021

By Paul Atzemis and Tony Persutti, Carboline Company

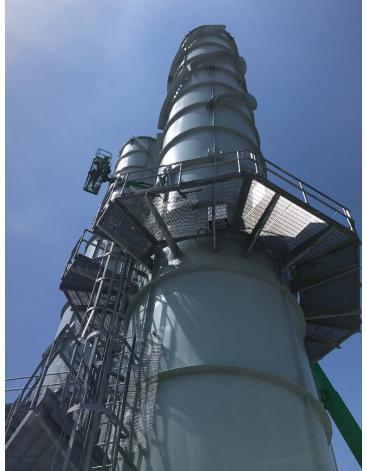
Shop-primed with zinc in advance, the 185foot-tall stack structures were delivered from overseas and erected prior to surface preparation, spot-priming and coating application. Cranes and lifts were utilized throughout the project to apply coatings at heights exceeding 185 feet.

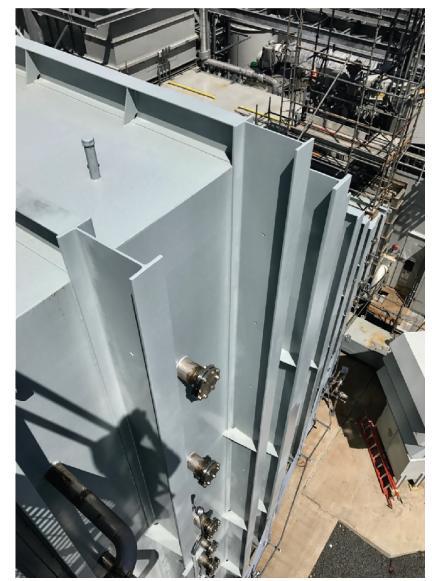
Nuts and bolts and tight angles required brush and roller application to ensure full coverage.

well as Hand and Power Tool Cleaning (SSPC-SP 2 and SSPC-SP 3) in order to ensure the surface was free from dirt, dust, oils, debris and other contaminants, and suitable for the subsequent protective coating. Welds and repair areas were spot-primed with organic zinc, and then the entire surface was finished with a full coat of the silicon coating at 1.5–2 mils. Typically, LNG stacks can reach heights of 150 feet and more, and the stacks involved in this project exceeded that at 185 feet in height. Hence, the possibility of getting overspray on adjacent structures even a quarter of a mile away was of major concern. To mitigate this possibility, the applicators used high-volume, low-pressure (HVLP) spray guns, and brushes and rollers on small areas such as nuts and bolts, and tight, back-to-back angles.

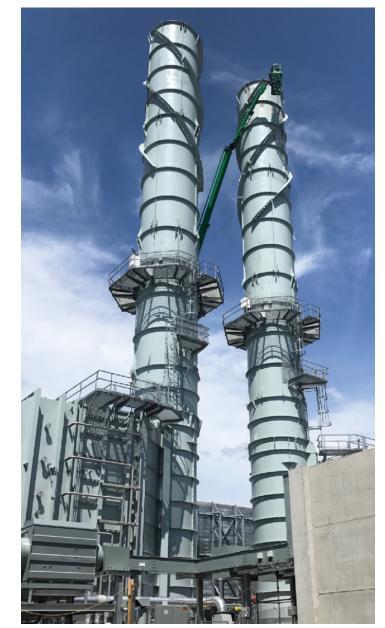
The coating on the finished stacks is designed to protect the steel at service temperatures of up to 500 F.

After two years of continuous scalding temperatures and Mother Nature's wear and tear, the stacks today look like they were painted yesterday—the results of diligent application and the selection of the right coating for the job.
