Common misconceptions about plastic piping can complicate residential plumbing repairs

The top 4 issues relating to CPVC and PEX piping materials.

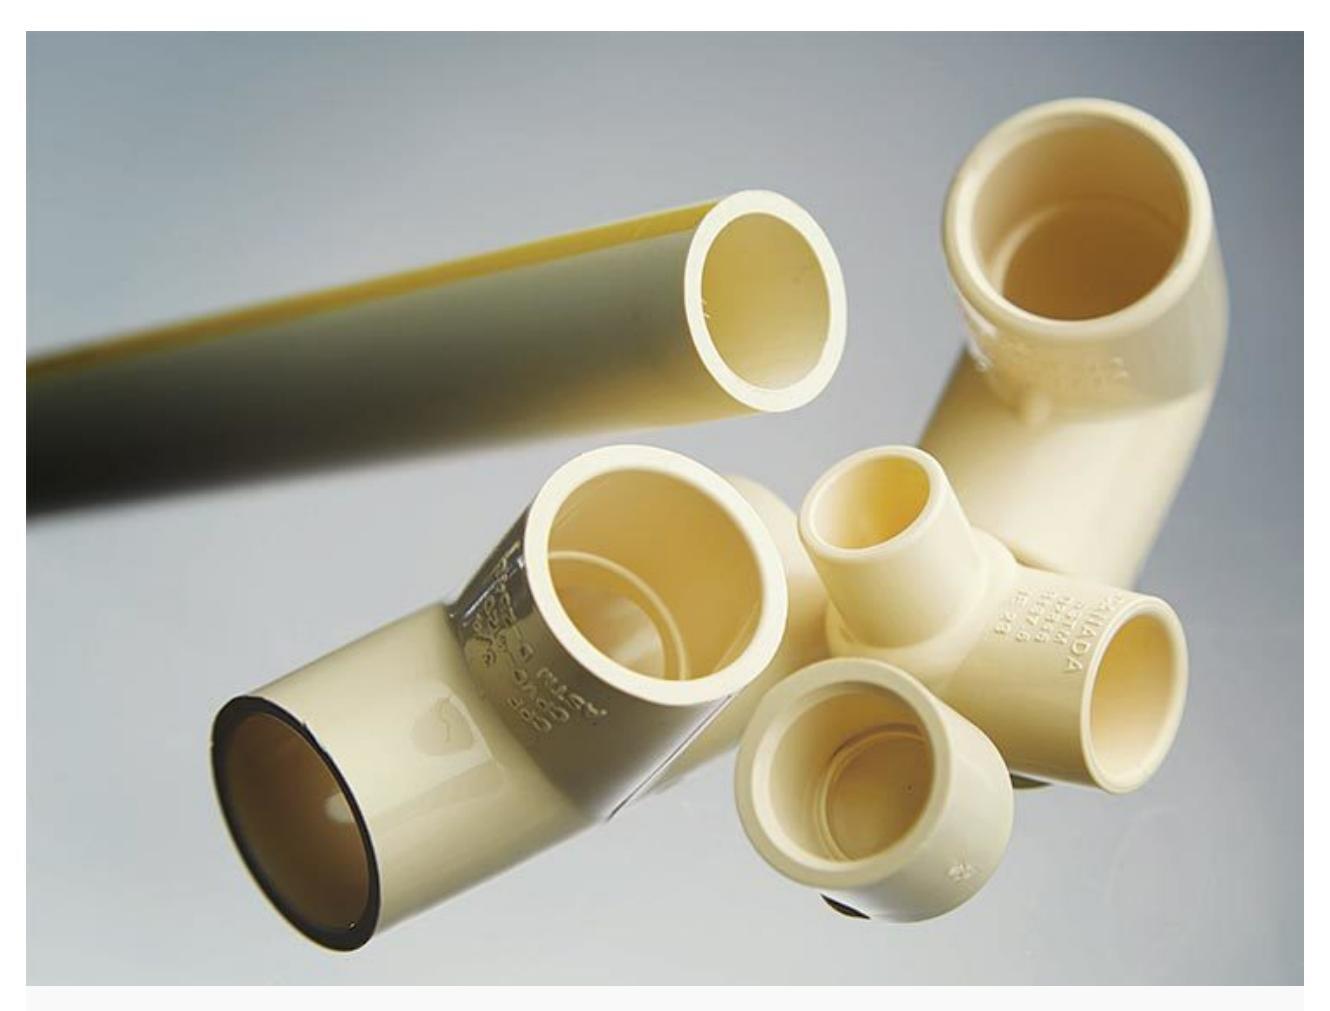
A NEW WAVE | Service plumbers are encountering a new wave of plastic piping systems when making resider repairs, including a rise in CPVC piping and fittings such as the above from FlowGuard Gold CPVC.

PEX and CPVC use very different style fittings. CPVC uses a solvent weld process in which the pipe slides into the fitting, maintaining full flow through the pipe. Use of the right size dauber in applying the solvent cement helps ensure an even coating that results in a strong bond. This is best achieved with a dauber one-half the size of the pipe diameter.
