Coatings Industry News

CA Awards \$274M Contract for Dam Repairs

Wednesday, April 19, 2017

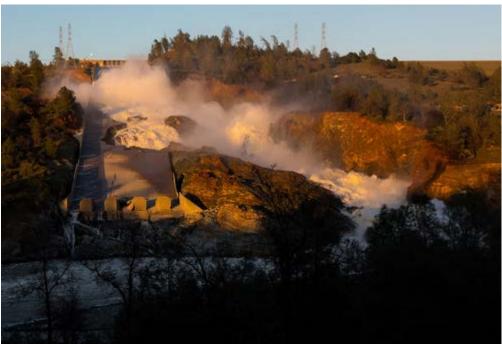
The \$275 million contract includes repairs to both the main spillway—which revealed a crater nearly as long as a football field in early February and was shut down—and the auxiliary spillway.

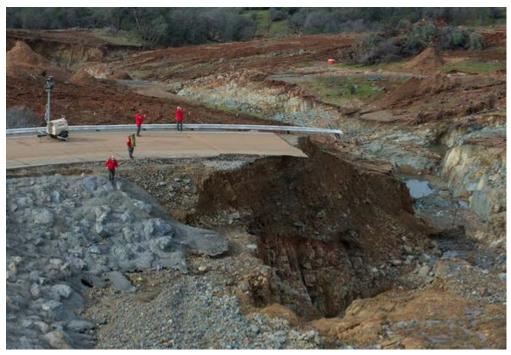
The use of the auxiliary spillway, which had never been put into service before, caused erosion on the hillside extending down from the lake.

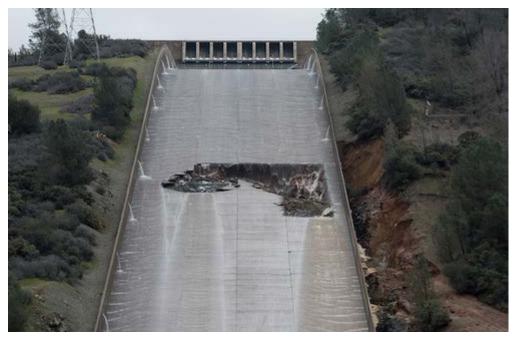
UC Berkeley professor emeritus Robert Bea says the failure occurred at the spillway's "weakest point."

According to the *Times*, Bea says the spillway failed "at its weakest point," an area over a clay drain pipe where the concrete floor is just 4-6 inches thick. Bea says the drain pipe itself was likely clogged by tree roots, causing an uplifting force exerted on the concrete above it.

On Tuesday (April 18), the Los Angeles Times reported on a new independent failure analysis asserting that flaws in the original design of the dam left it vulnerable to structural problems. The review, issued by University of California Berkeley's civil engineering professor emeritus Robert Bea, says that the concrete floor of the spillway was not made thick enough, and did not call for continuous steel reinforcement.

Bea recommends taking a hard look at similar dams throughout the state and beyond to assess whether unforeseen issues like those at Oroville could be looming.
