Chevron's Use of EonCoat[®] To Permanently Prevent Corrosion On Steel

Keywords: Chevron; permanent corrosion protection; refinery best practice; CUI; corrosion under insulation

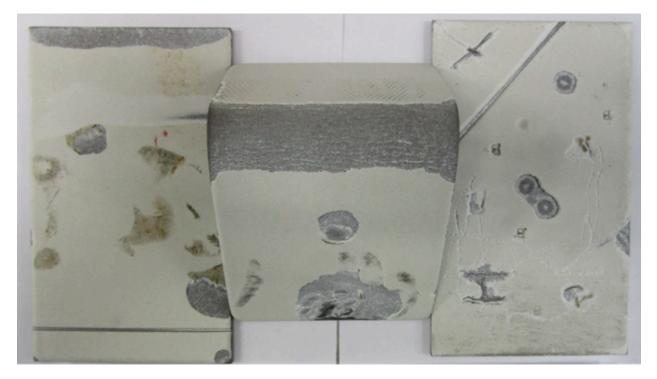
To test the mechanical integrity of EonCoat, panels were intentionally damaged. Damage was inflicted in a number of different ways – (i) Impact damage with a ball being dropped on the panel, (ii) The panel was dropped from a height of 3-4 meters onto the cement, (iii) A saw blade was used to make a cut like mark in the protective layer (but not cut through the steel itself), (iv) Various hardness tests (designed to inflict mechanical damage) were done on the panel, and (v) A mechanical polisher was used in some areas. In the most extreme case, one of the panels was bent at a 90° angle. This bend did bring new steel to the surface. Figure 1 shows the panels after damage and before B117 exposure.

Figure 1 – EonCoat panels with intentional mechanical damage.

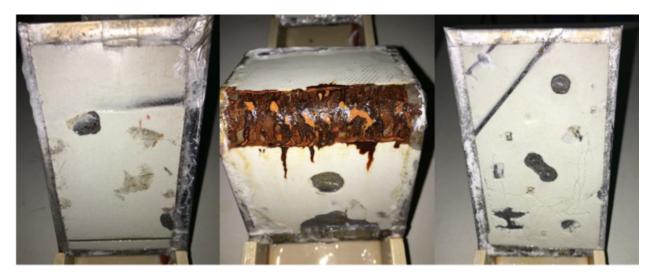
Then the panels were subjected to ASTM B117 conditions; the figures show the duration time for the panels. In the pictures below, we show the panels before B117 testing and then after 335 hours (Figure 2) and after 1,870 hours (Figure 3). In all cases, there is not rust in the areas where the panels were intentionally damaged, aside from the 90° bend in the panel. Again, the panels show no sign of rust. Organic coating would have failed to control the corrosion in these conditions.

Figure 2 – EonCoat panels with intentional damage after 335 hours of B117 exposure.

Where new steel is exposed, that section of the panel rusted, as expected. But notice on the portion of the panel that was bent – at the edge of the EonCoat, there is no rust along the entire line. Meaning, when the EonCoat forms a chemical bond with the surface of the steel, the protective layer is formed. When this occurs the mechanical integrity is maintained. (It should be noted that in the field, if a section of tank or pipe incurred mechanical damage as severe as a 90° bend, that steel would be taken out of service as it would be permanently deformed.)

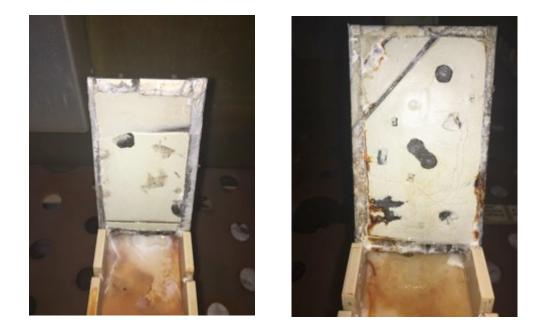
Figure 3 – EonCoat panels with intentional damage after 1,870 hours of B117 exposure.

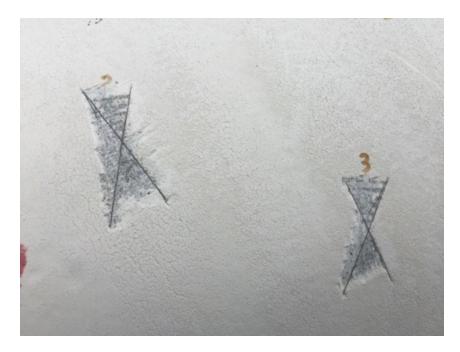
Field-testing of EonCoat in CUI conditions continues. Figure 4 (below) shows cross-cut adhesion into the coating. The cross-cut adhesion was performed in February 2018 and then re-examined in June 2018. The picture in Figure 4 shows the cross-cut picture from June 2018 after the pipe had been placed back in service. The pipe service, insulated with blankets, is running at temperatures ranging from 120 to 138 $^{\circ}$ C.

Figure 4 – Cross-cut adhesion of EonCoat – June 2018 after 4 months of being insulated and in service.

Like the intentionally damaged panels above, again, the EonCoat shows no rust. Organic coating would have failed this test.
