Risk remains in river: Prof says waste pits cap still vulnerable

Christopher James | Jun 24, 2018 Updated 18 hrs ago

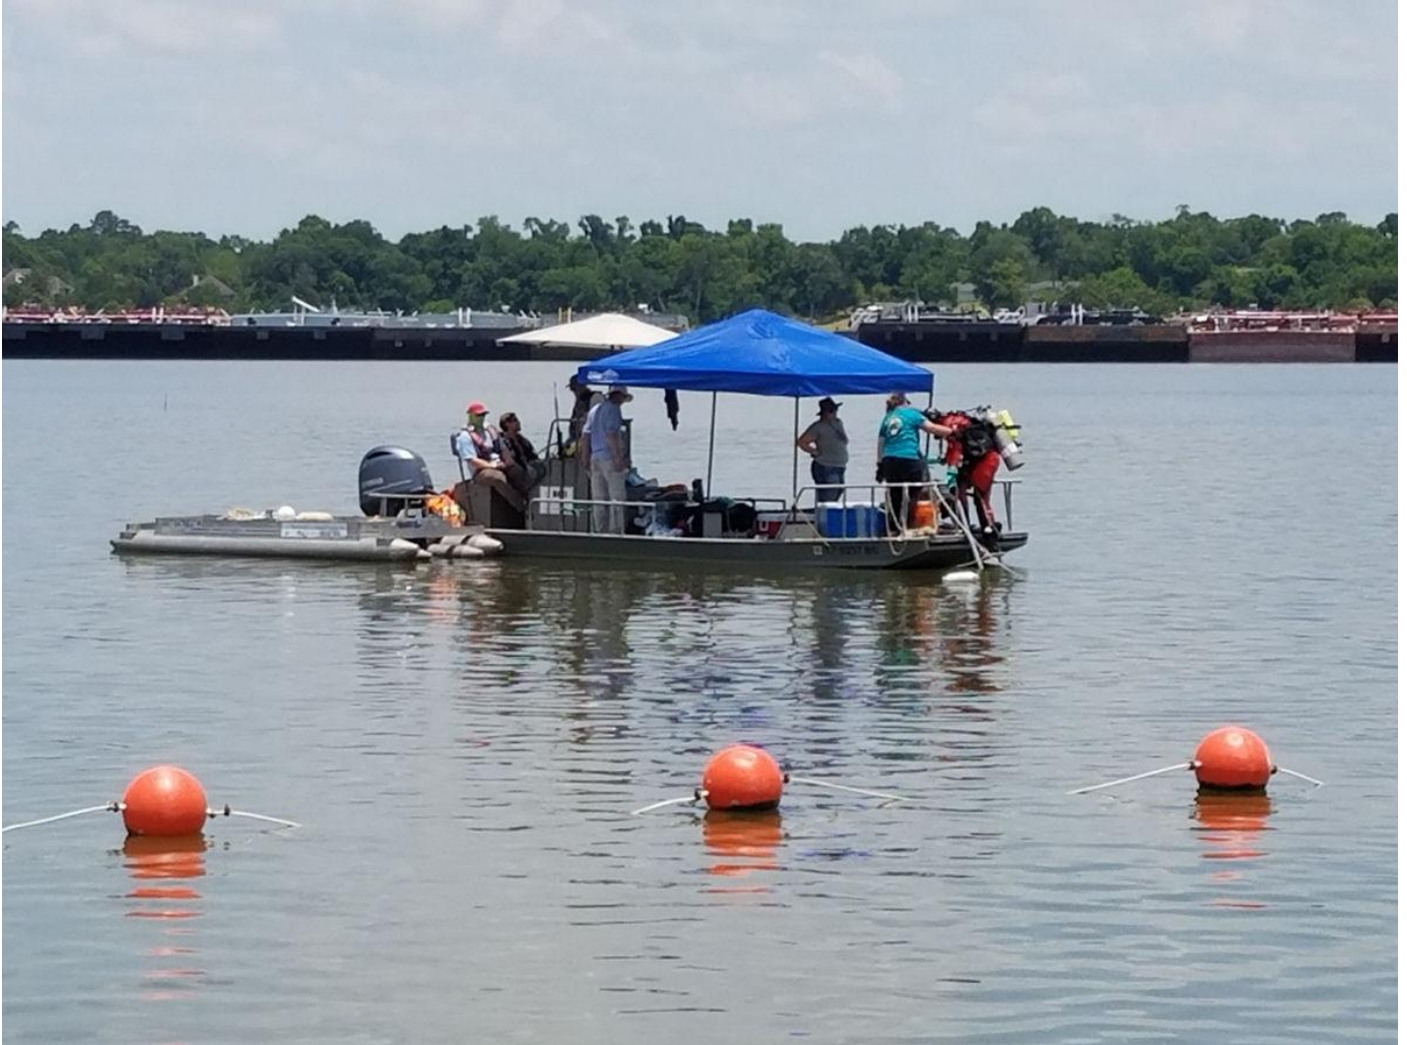
Submitted photo

Divers for EPA Region 6 inspect the northwest corner of the San Jacinto Waste Pits.

The northwestern side of the site was an area with the most concern because it has no geotextile in the area because it has a very steep slope there.

The EPA wanted to focus on this problem area and took 14 sediment samples. And one of the samples confirmed the protective cap had been damaged and the underlying waste material was exposed. The EPA said the sample showed dioxins at 70,000 nanograms per kilogram, which is the highest concentration found outside of the cap. To put it into perspective, the EPA level for cleanup is 30 nanograms per kilogram. However, it was a small release.
